Non-Structural Vulnerability Assessment of Hospitals in Nepal

**National Society for Earthquake
Technology-Nepal**

December 2003

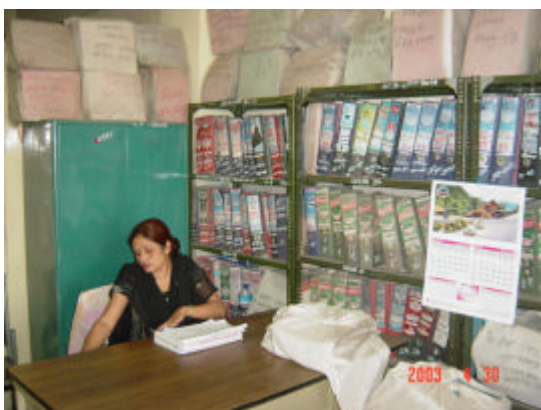
Photo 1: These document packs stored on the top of book shelves and cupboards are a life safety hazard.

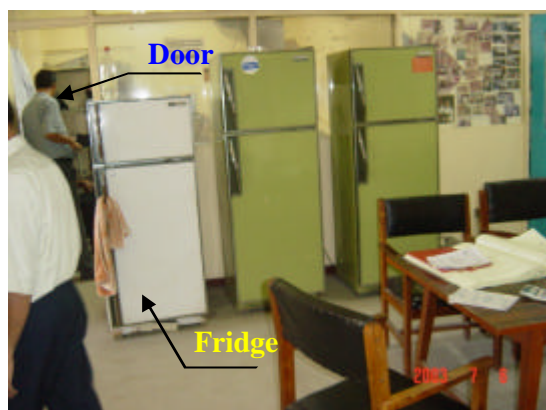
Photo 2: The fridge kept near an exit door is a life safety hazard.

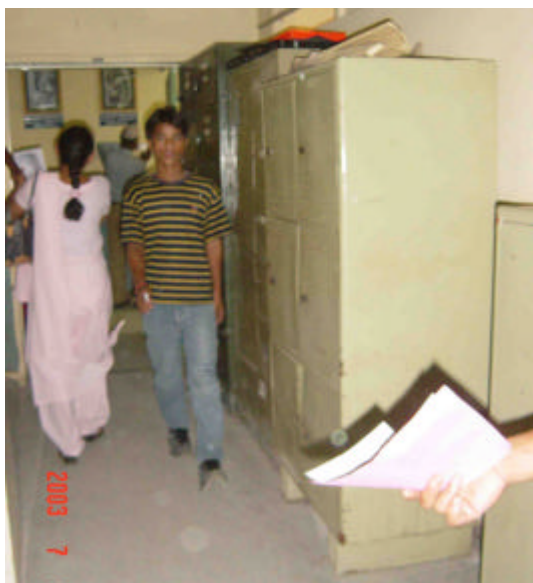
Photo 3: These cupboards can block the corridor and are a life safety hazard.

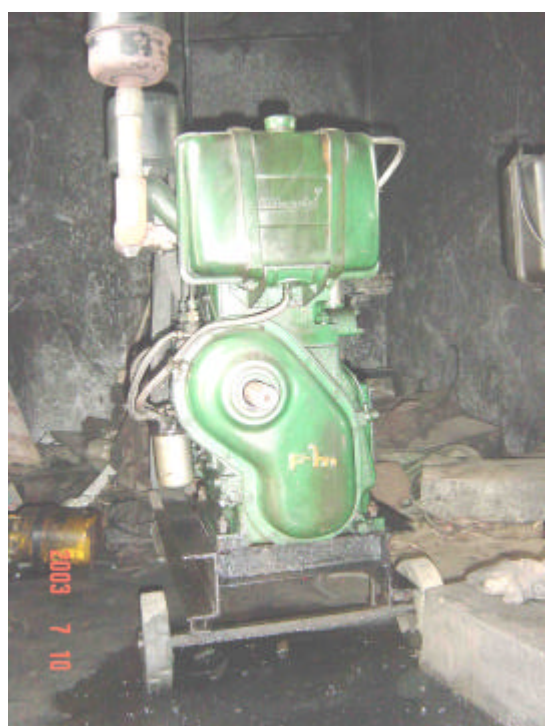
Photo 4: A generator on rollers can slide and overturn in an earthquake causing functional loss.

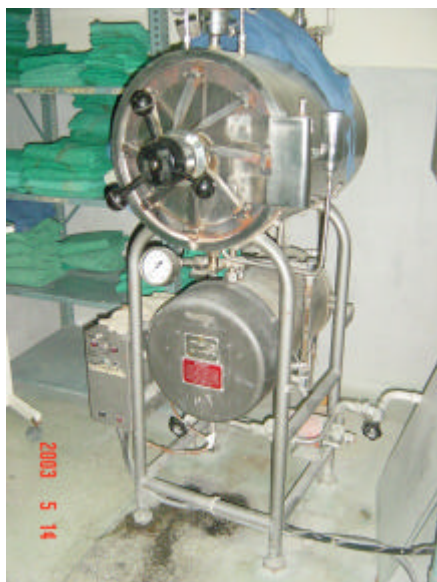
Photo 5: Autoclave machine without anchorage.

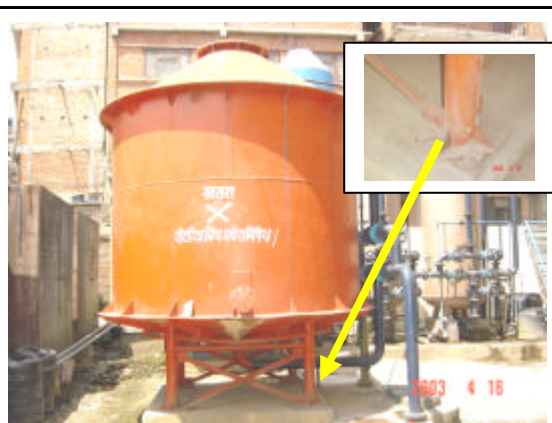
Photo 6: Water treatment tank which has a provision for bolting at the base but was found not bolted.

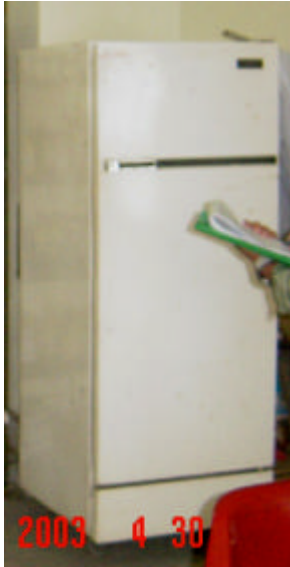
Photo 7: Tall and narrow objects like fridges can easily overturn during earthquakes.

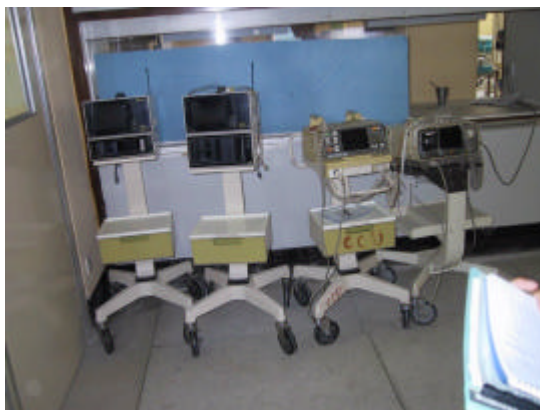
Photo 8: ECG monitors on rollers with potential risk of sliding and overturning.

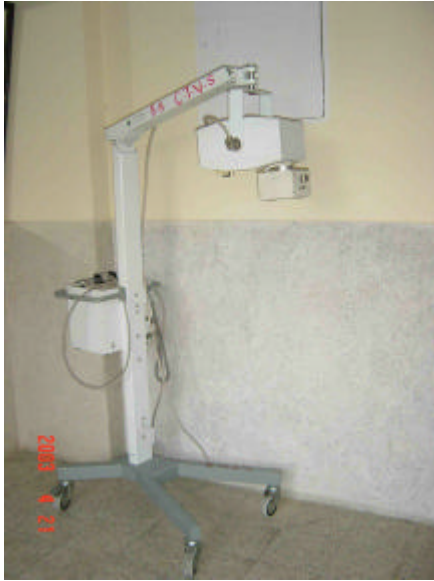
Photo 9: Mobile X-ray on rollers.

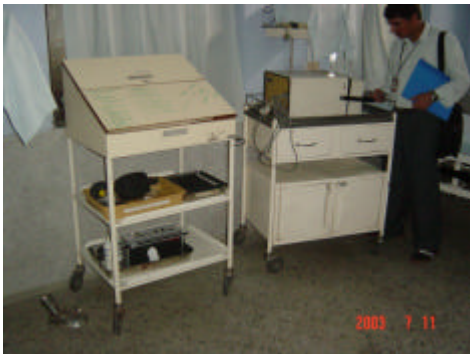
Photo 10: Resuscitation equipment on roller trolleys.

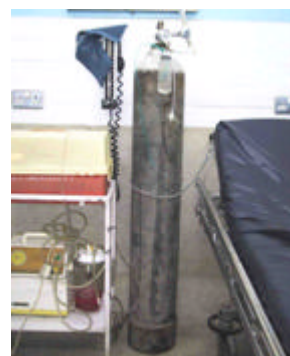
Photo 11: Un-hooked oxygen cylinders may fall over.

Fig 9: Hooking the cylinder with a chain can save the cylinder from falling.

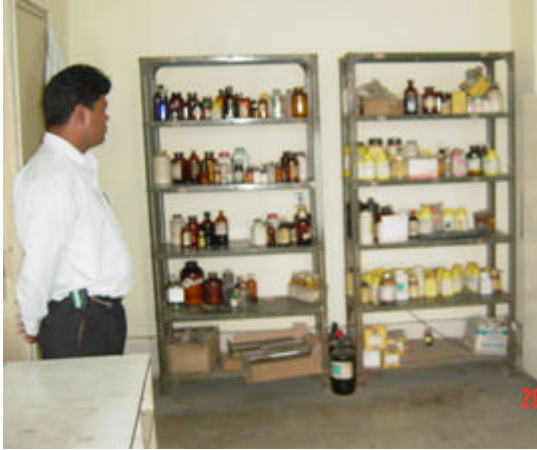
Photo 12: Chemical and medicine bottles on shelves pose a risk of falling.

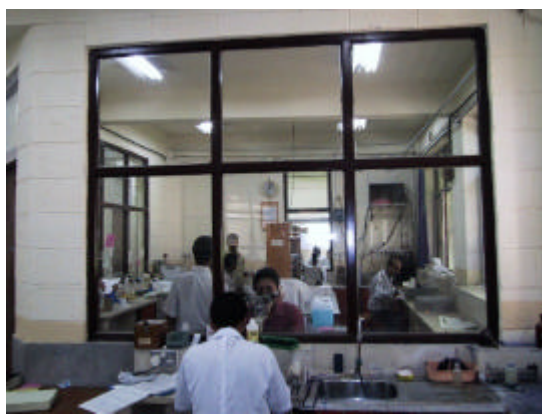
Photo 16: This window glass can cause a life safety hazard.

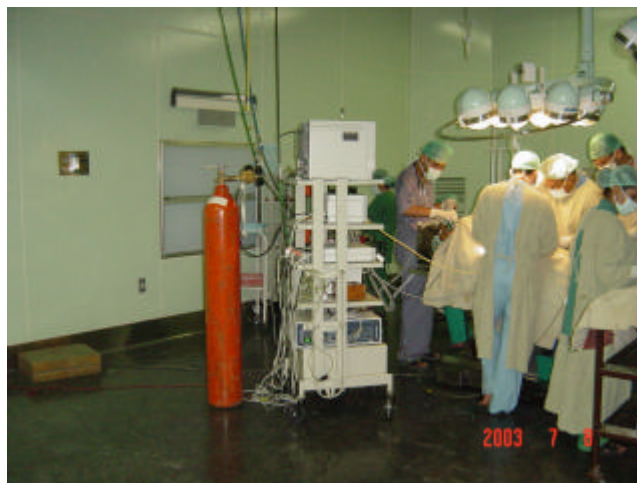
Photo 17: Most equipment is on roller trolleys (equipment racks) in operation theatres. The risk of falling down is high.

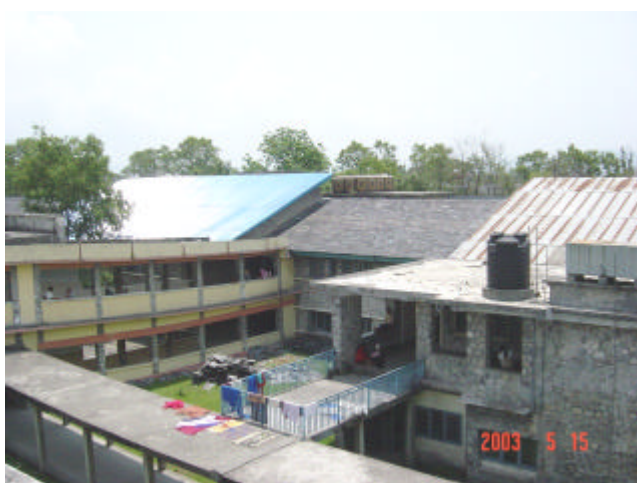
Photo 1: Buildings of different height, shape and structural properties connected with each other can cause severe pounding during earthquakes.

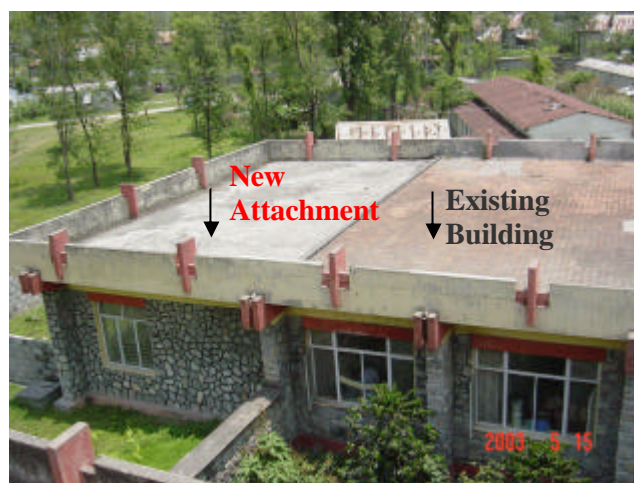
Photo 2: A new attachment to existing buildings with no seismic gap has made both the existing and the new building vulnerable.

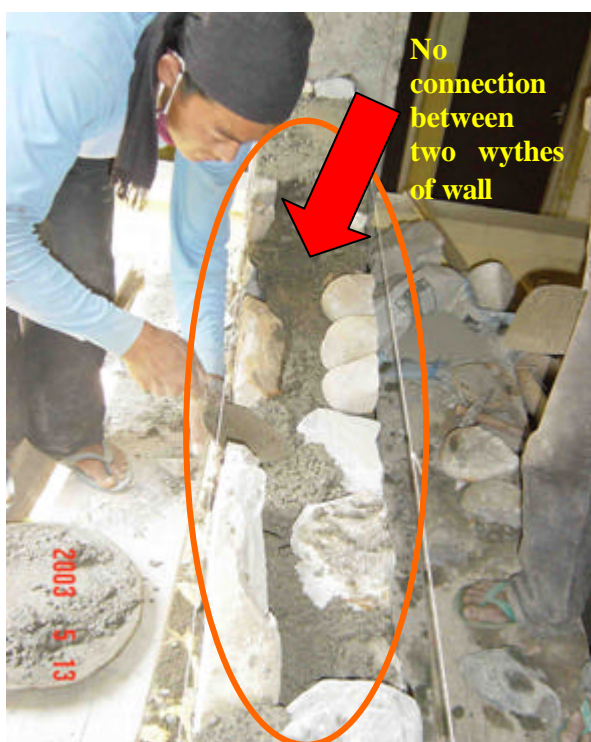
Photo 3: A stone masonry infill wall construction in the new building. There is no proper connection between the stone units making it a very vulnerable wall. The mortar used is 1:6 cement: sand mortar.

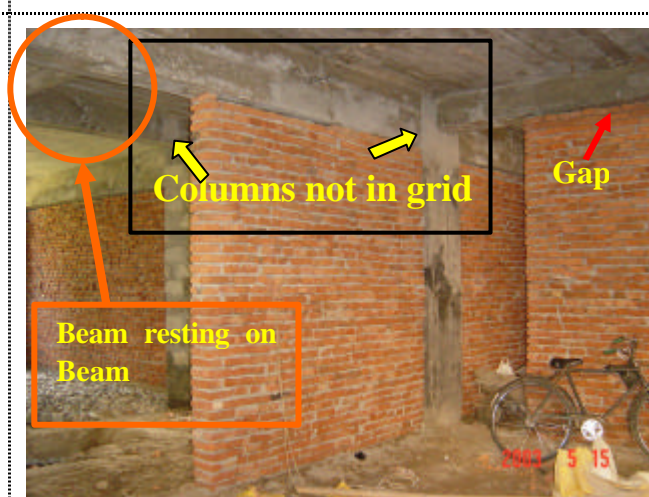
Photo 4: The structural system and load path of the new building is not proper. The columns are not in grid, beams are just connected with beams and there is a lack of columns. Improper connection of infill walls with the frame has made the infill walls more vulnerable.

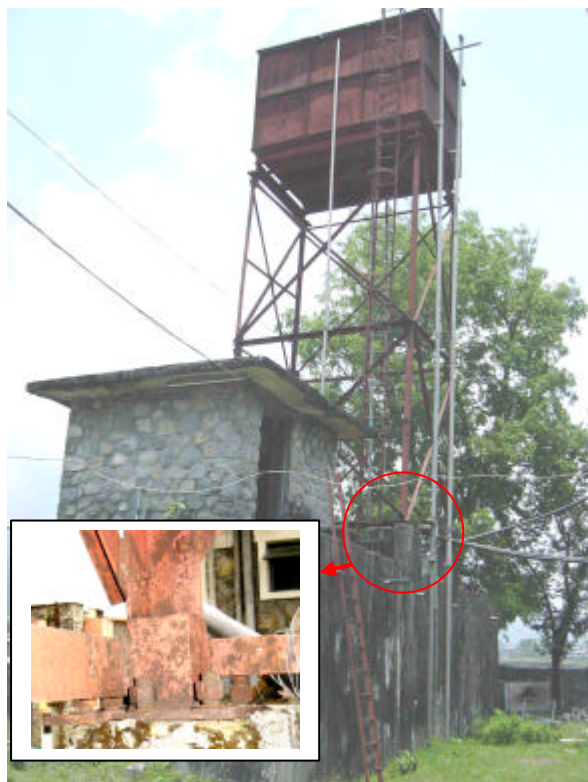
Photo 5: The base of an overhead tank; the bolts are not properly fixed and are rusted, the base is weathered.

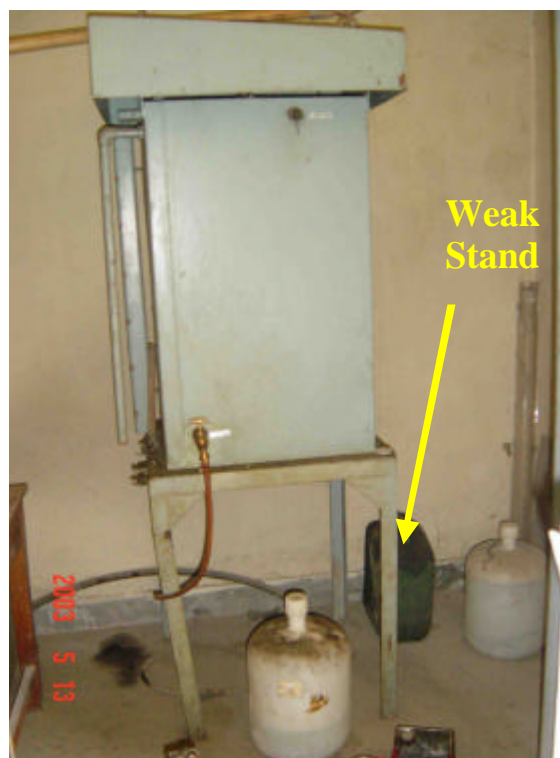
Photo 6: 300 litres fuel tank of the generator; on a weak stand without anchorage and lateral support.

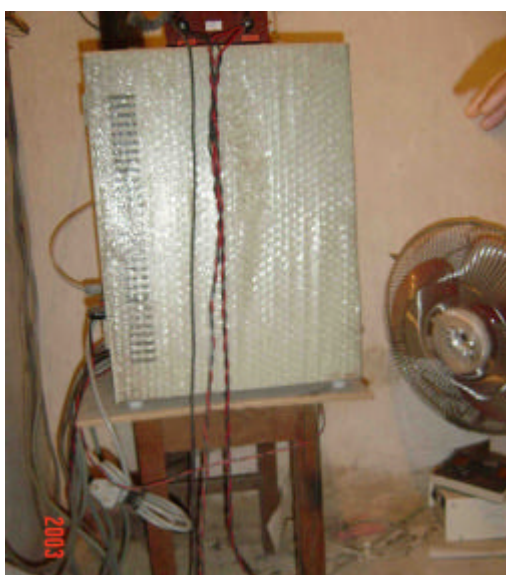
Photo 7: Communication equipment on a temporary type stand. It needs a proper stand with anchorage and fixing.

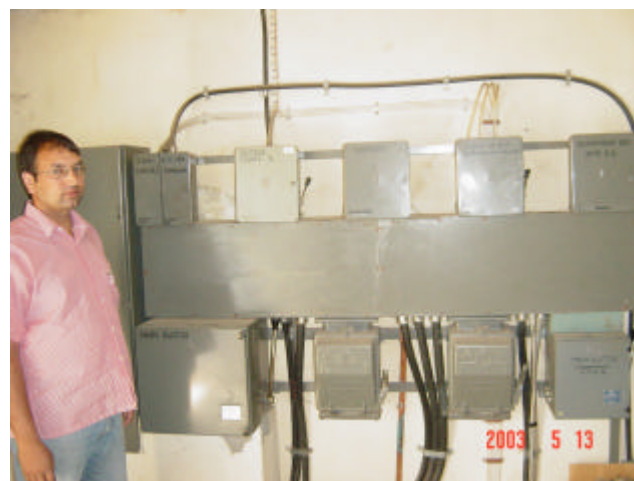
Photo 8: The main board for electricity distribution within the hospital; properly anchored on the wall and with low vulnerability.

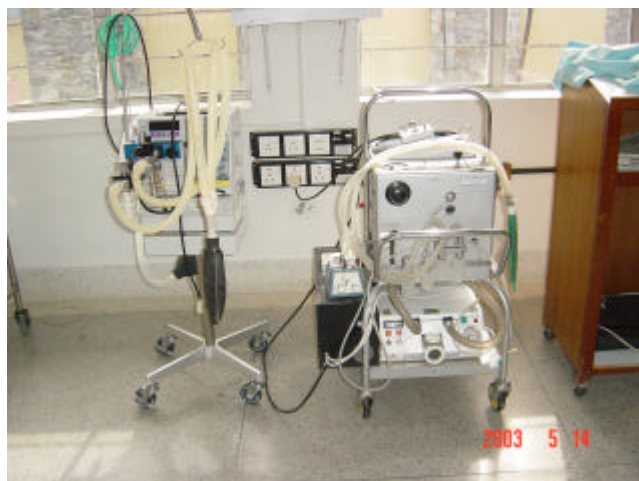
Photo 9: Equipment on rollers in the operation theatre and other places is vulnerable as it may roll and impact with other objects.

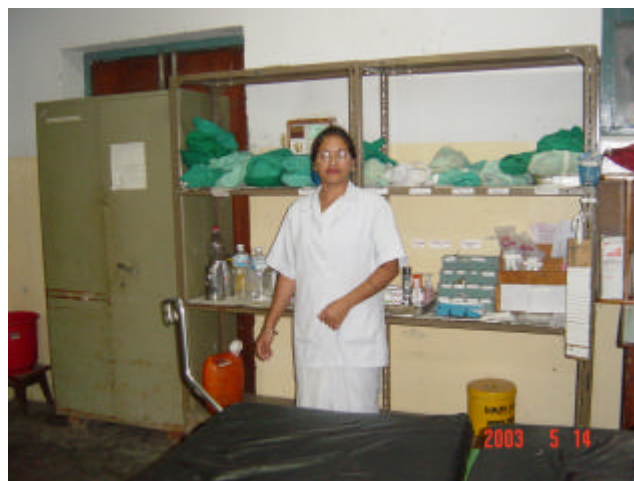
Photo 10: Cupboards and racks storing important equipment, medicines and chemicals are vulnerable because they are not fixed to the wall and strapped.

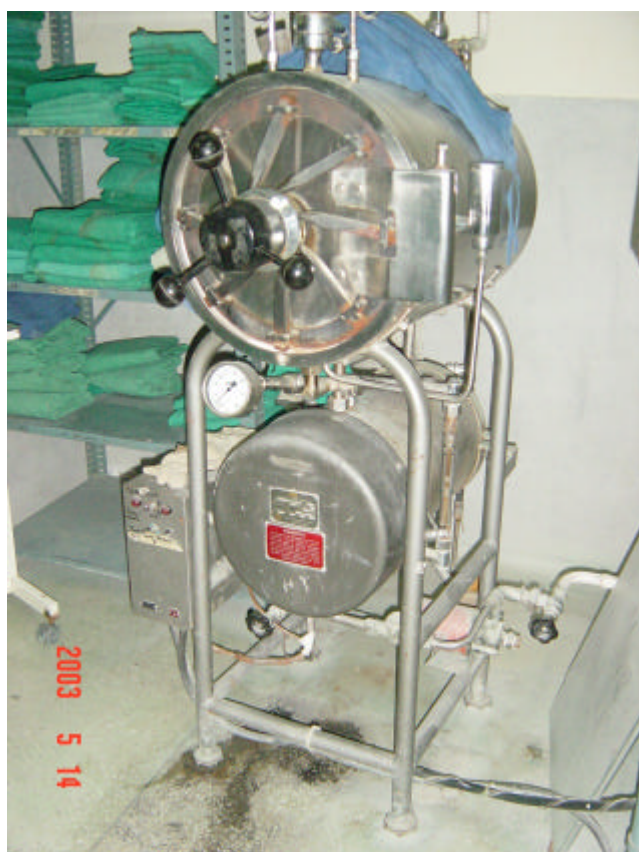
Photo 11: Autoclave machine needs anchorage at the base.

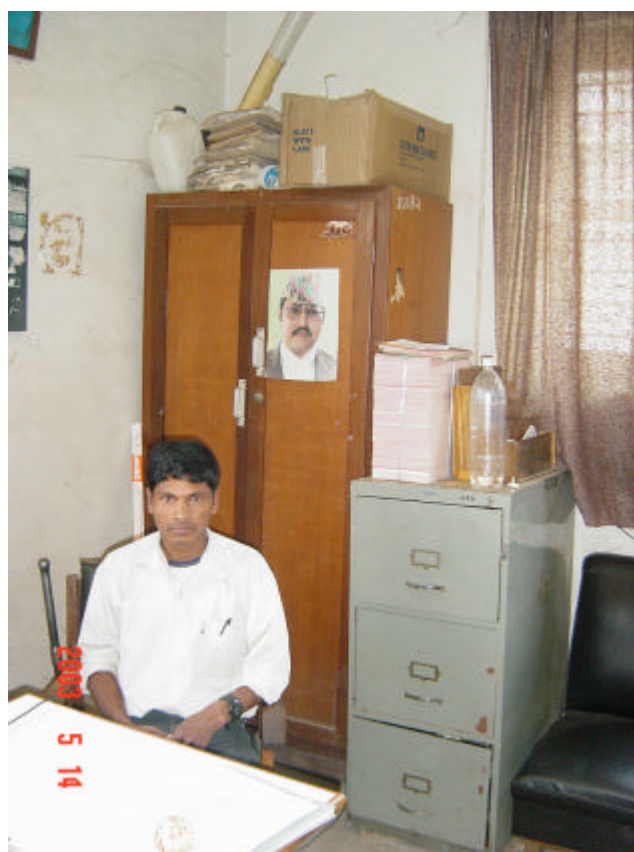
Photo 12: The cupboards and racks near working stations in the administration and other places of the hospital can be life safety hazards.

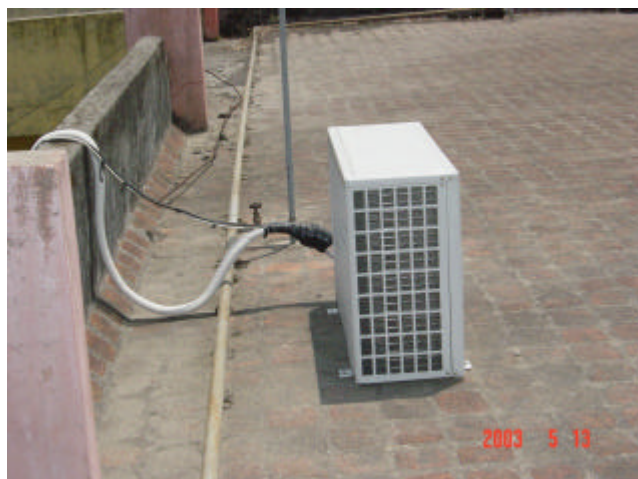
Photo 13: The air conditioning equipment for the OT is kept on the roof with no fixing.

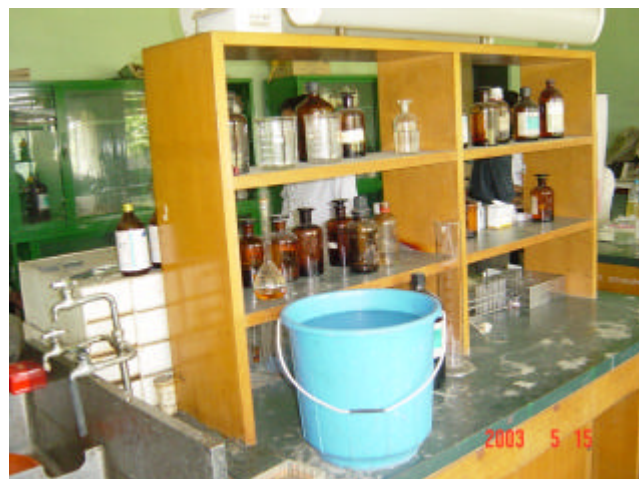
Photo 14: Racks containing chemicals in laboratories should be anchored; chemical bottles should be strapped or relocated to improve safety conditions.

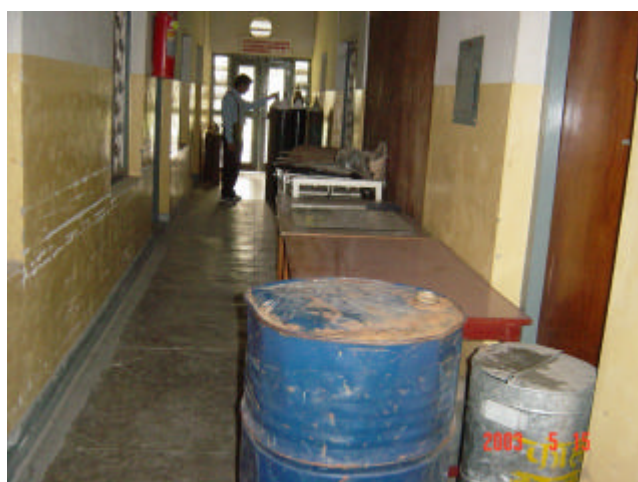
Photo 15: Cupboards and other objects in the corridors can block the exit ways during earthquakes.

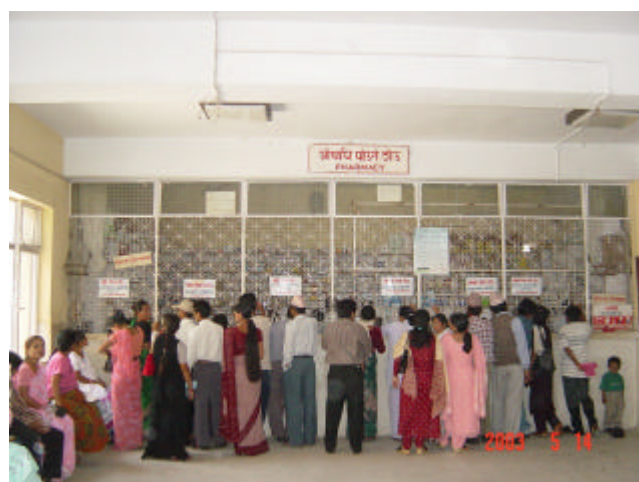
Photo 16: Window glasses or glass partitions are life safety hazards and need plastic lamination.
