Final report - Review of built infrastructures

Khammouane Province - Laos 2017

Title:	Construction review in Laos - Final report
---------------	--

Date and place:	Luxembourg – 2017.02.10
Project name & code	Laos constructions review – 24LA00
Service client	AI Croix-Rouge luxembourgeoise – Beatrice Winandy

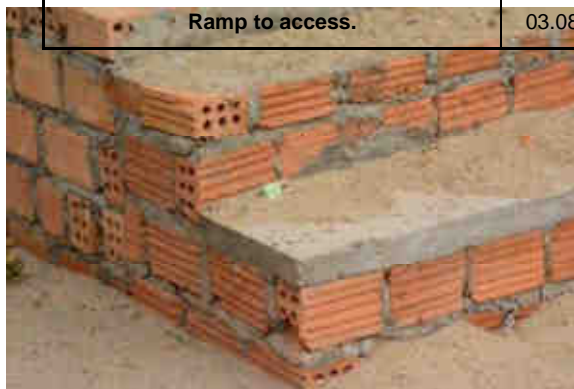
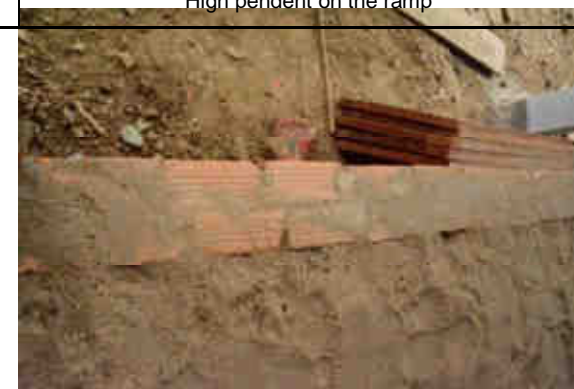
the sand by itself.	
Stairs to access.	03.08.2017	Interview + picture + measure	L=4m; stair in brick changed only one stair built	The stair in the rear side of the building have to be done
Stairs to access.	03.08.2017	Interview + picture + measure	L=9.35m; stair on brick over slab	General aspect is good but the dimensions in the steps are different
Ramp to access.	03.08.2017	Interview + picture + measure	3x2.5; stair on brick over concrete slab	High pendent on the ramp

Stairs with brick and concrete slap

Side view with ramp

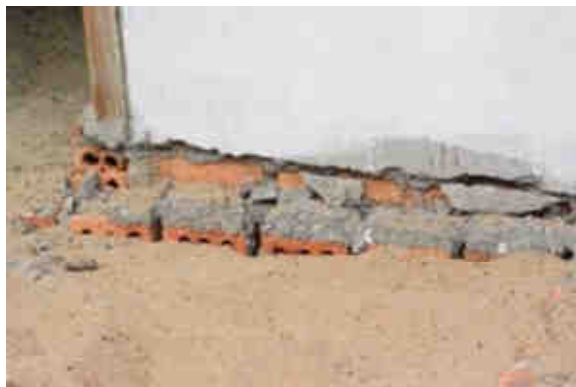
Ceiling of inner spaces	03.08.2017	Interview + picture + measure	up 75x75cm down 2x75cm not treated against insects Nailed on the walls not over the wall	Construction company changes without advice the first time that district realise this change is today. That shows the poor technical follow up of the constructions.
Int/Ext Painting	03.08.2017	Interview + picture + measure	Not fully painted	To hand-paint but not finished

Interior wall base
view of interior ceiling

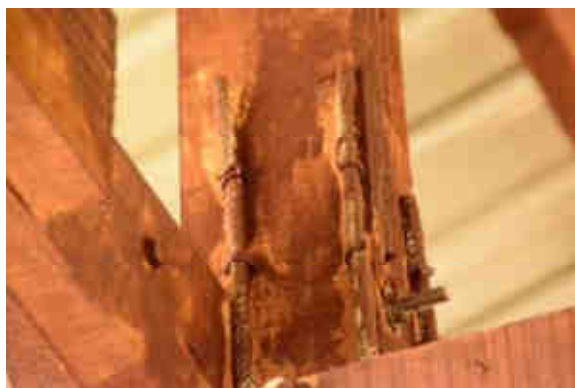
Met al she etin g roof ove r woo d ribb ons and trus ses	03.0 8.20 17	Intervie w + picture + measure	<p>Metallic sheet 0.4mm measured Structure: Missing diagonals on the roof Additional diagonals on pillars No metallic plates in the unions, some L Dephile on small joints double beams in only one direction union of timber with nails in critical places wood not fully protected against insects metallic plates changed by wood pieces</p>	<p>The construction company changed or built the roof structure with less quantity of pieces. The technical control/follow up don't inform about changes, missing pieces or irregularities. These modifications need to be solved as soon as possible to finish the structure as defined in project</p>
Met al she etin g roof ove r woo d sub stru ctur e (TOI LET)	03.0 8.20 17	Intervie w + picture	<p>Metallic sheet 0.4mm measured Structure: No metallic plates in the joints, Some L Dephile on small unions joint of timber with nails wood not fully protected against insects metallic</p>	<p>The construction company changed or built the roof structure differently (adding some additional reinforcements). The technical control/follow-up didn't inform about changes, missing pieces or irregularities.</p>

Metallic plate missing over the pillar

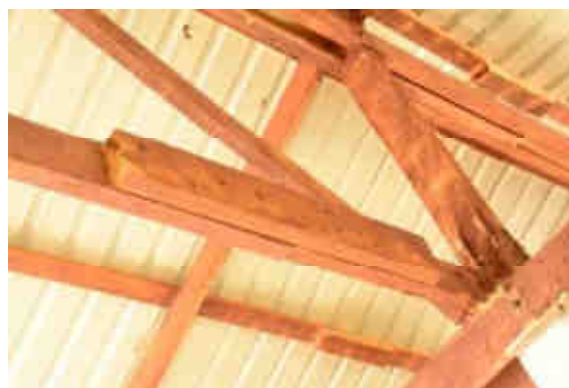
Piece joint with nails

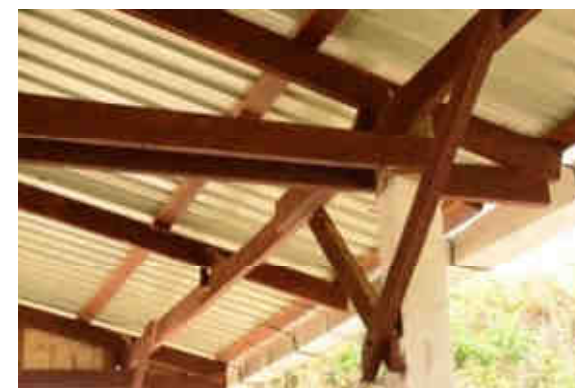
External beam with piece missing

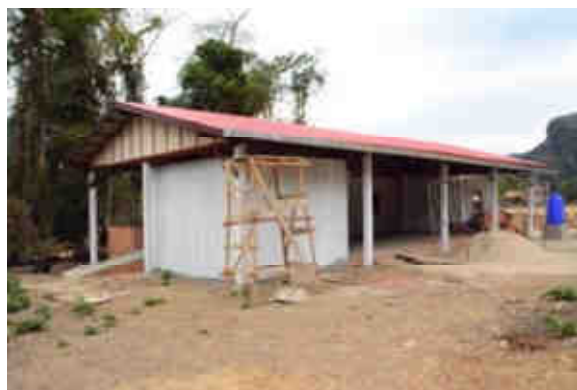
General view of the community centre without exterior fence

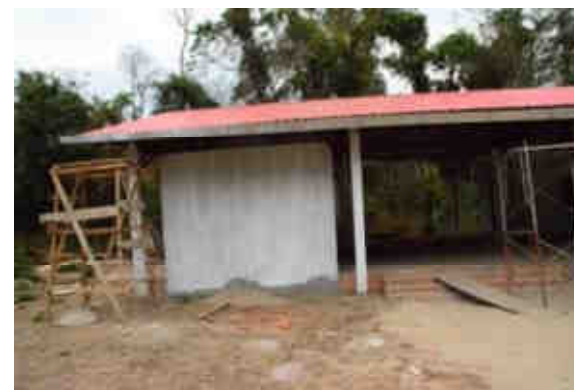
Front view the works are not finished

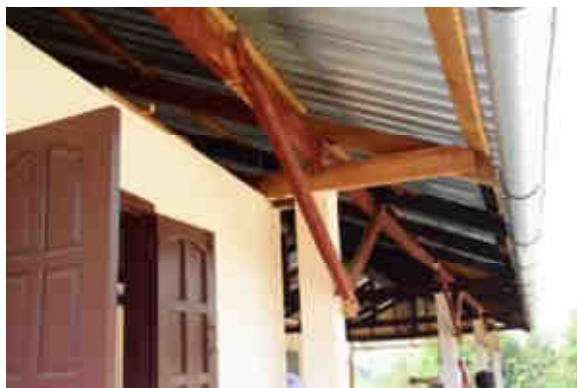
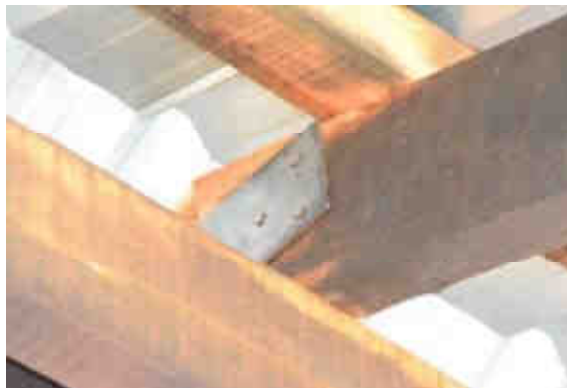
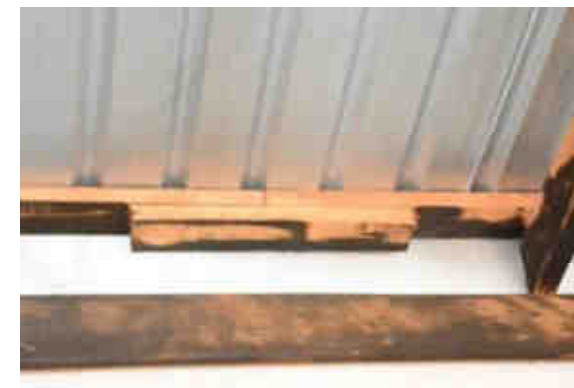
ROOF COVERING	Date of visit	Measure of verification	Collected data	Comments
Metal sheeting roof over wood ribbons and trusses	2017.03.11	Picture + interview	Aluzinc anoy e=0.47 in place Structure: Missing diagonals on the roof Additional diagonals on pillars Metallic plates only in some joints but in general with nails double beams in only one direction union of timber with nails in critical places wood not fully protected against insects metallic plates changes by wood angles	The construction company changed or built with less quantity of pieces in the roof structure. The technical control/follow up didn't inform about changes, missing pieces or irregularities.
Metal sheeting roof over wood substructure (TOILET)	2017.03.11	Pictures + interview	Metallic sheet Aluzin 0.47mm picture Structure: No metallic plates on the joints, some L Dephile on small unions junction of timber with nails wood not fully protected against insects	The construction company changed or built the roof structure differently (adding some additional reinforcements). The technical control/follow up didn't inform about changes, or irregularities

Roof structure with one missing piece
 Joined on to wood with nails

Junction with metallic plate but nailed

Kaengpakham	Primary school	<ul style="list-style-type: none"> ○ The construction is not finished (preliminary estimation around 80 to 85% of work done) need to be finished! ○ Roof structure has to be done according to the project including: Metallic plates, bolts, full protection against insects, double wood pieces on beams and brazing in all defined directions. With particular attention in the missing pieces and in the brazing. Joints/splices in structure timber are not allowed without specific written authorization from the technical responsible (in English). ○ Metallic gutter needs to be done according to the project. In addition has to be easy to access and clean for maintenance purposes. ○ Bamboo shades have to be done according to the project. ○ Pedestrian road to access the latrines have to 	<ul style="list-style-type: none"> ○ The level of the water tank can be raised. The bottom part of the tank has to be at least at the same level as the highest tap. If the tank height does not allow this, two tanks of 500l each can be placed in line connection and with the criteria of height described before. ○ Full protection against insects in all the wood/bamboo elements. 	<ul style="list-style-type: none"> ○ Adjust the finishing on ceiling, doors, windows and any other termination that will provide a good aspect. ○ Test all the sanitary systems with water in real conditions ○ Document all the changes and relevant actions according to the agreed documents.

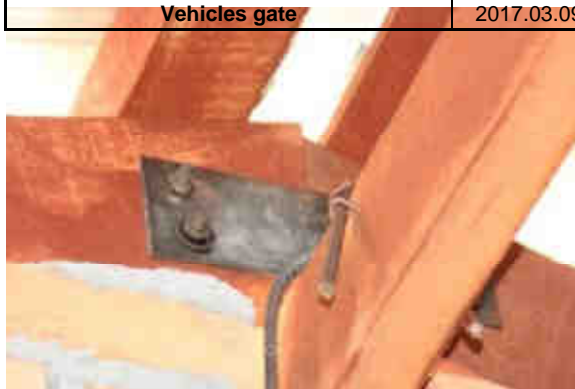
Junction with metallic plate and bolt

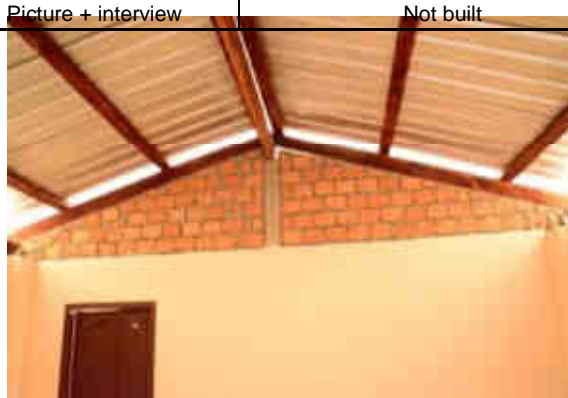
No fully plastered wall and general interior view
