OCHA

Fuel Spill and Fire
Rapid Environmental Emergency Assessment
Mukuru-Sinai slum, Nairobi Kenya
October 2011

JOINT
UNEP / OCHA
ENVIRONMENT UNIT

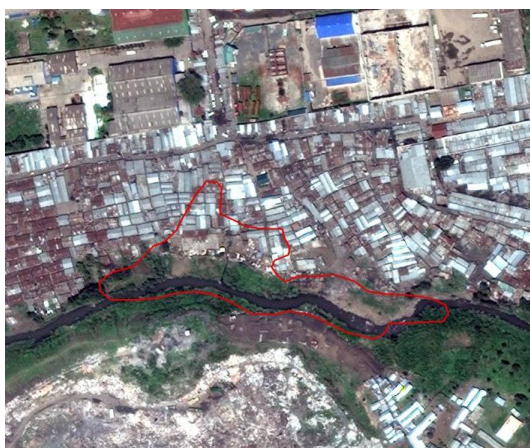
Undamaged zone before the explosion: 20 November 2010

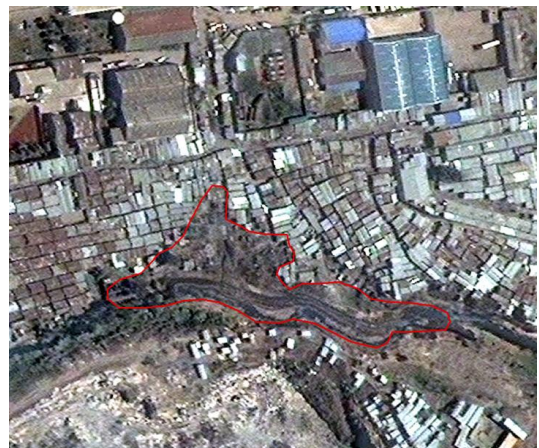
Damaged zone after the explosion: 22 September 2011

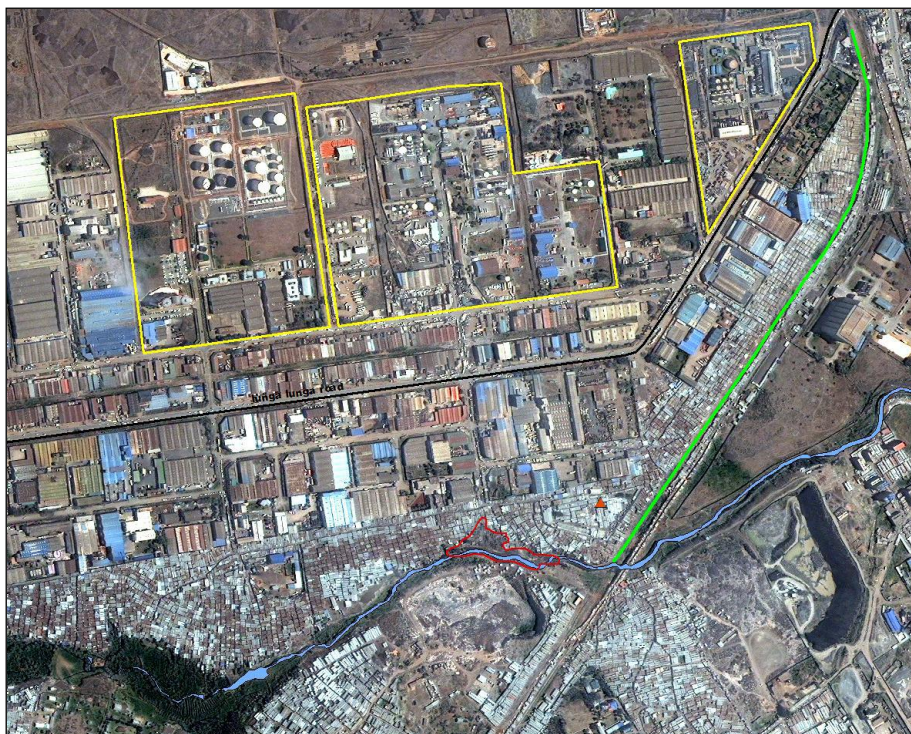
The satellite image on the left shows the industrial area of Lunga Lunga (in yellow) including a site of the Kenya Pipeline Company, the suspected pipeline (in green) and the affected area (in red) adjacent to the Ngong River).

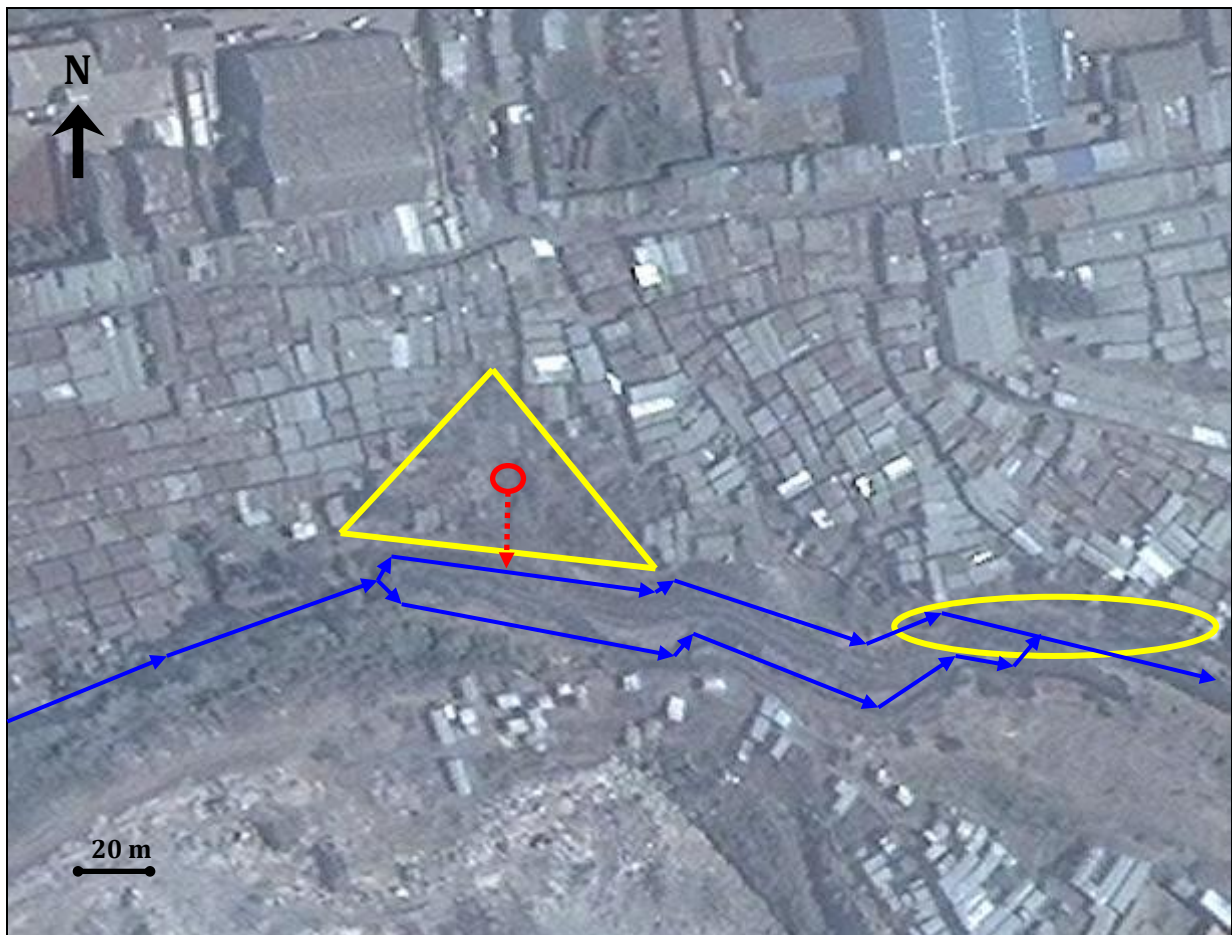
The primary affected site is centred on the outlet of a storm water drainage system situated approximately 15 meters from the Ngong River (marked red in the picture below).

The outlet runs into an open gutter which flows into the Ngong River.

The site visit also allowed the identification of a second area affected by the fire, further downstream of the Ngong River. The primary and secondary site have been visualised on the satellite imagery below. The distance between the two sites is approximately 80 meters.

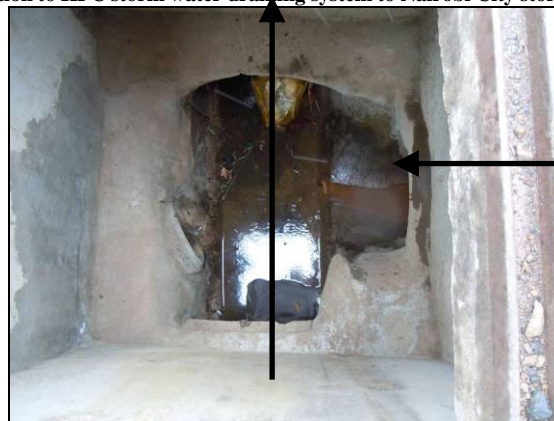
Photography of connection to KPC storm water draining system to Nairobi City storm water drainage system

Notably, the KPC underground storm water drainage system, composed of a concrete culvert network, is connected, outside the deposit facility, to the underground storm water draining system of the City of Nairobi.

KPC storm water drainage system and flow direction

Nairobi city storm water drainage system and flow direction

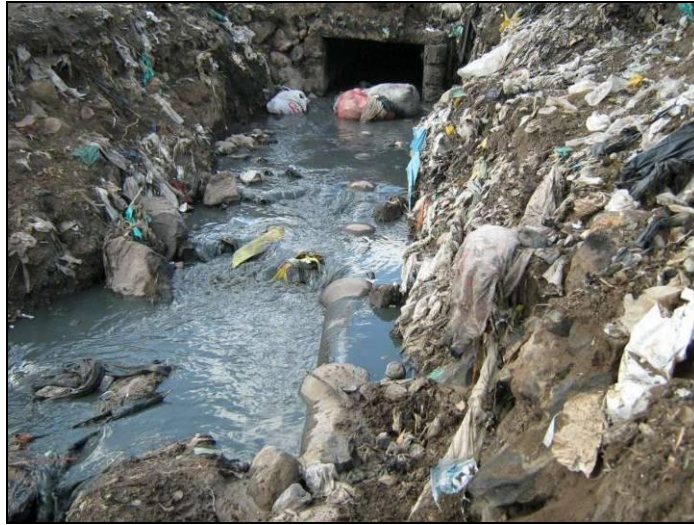
View of the outlet of the storm water drainage network in the slum

Located at one kilometre downstream of the leaking area, the city's storm water drainage system washed out in the Ngong River, by a 15 meter long open ditch, located in the middle of the Mukuru-Sinai slum.

At the open outlet of the city's storm water drainage system, extremely flammable vapors formed on the surface of the hydrocarbon spill and created an explosive atmosphere in the slum and the surrounding dwellings. The flammable vapor cloud was dispersed following the flow direction of the petrol spill in the Ngong River.

In these conditions, any spark caused by metal contact, a discarded cigarette, or an open fire in a dwelling could have caused the ignition of petrol fumes present in the atmosphere. The ignition could have taken place at different places due to the dispersion of the vapor cloud from the ditch to the river, as well as the movement of burned people and animals.

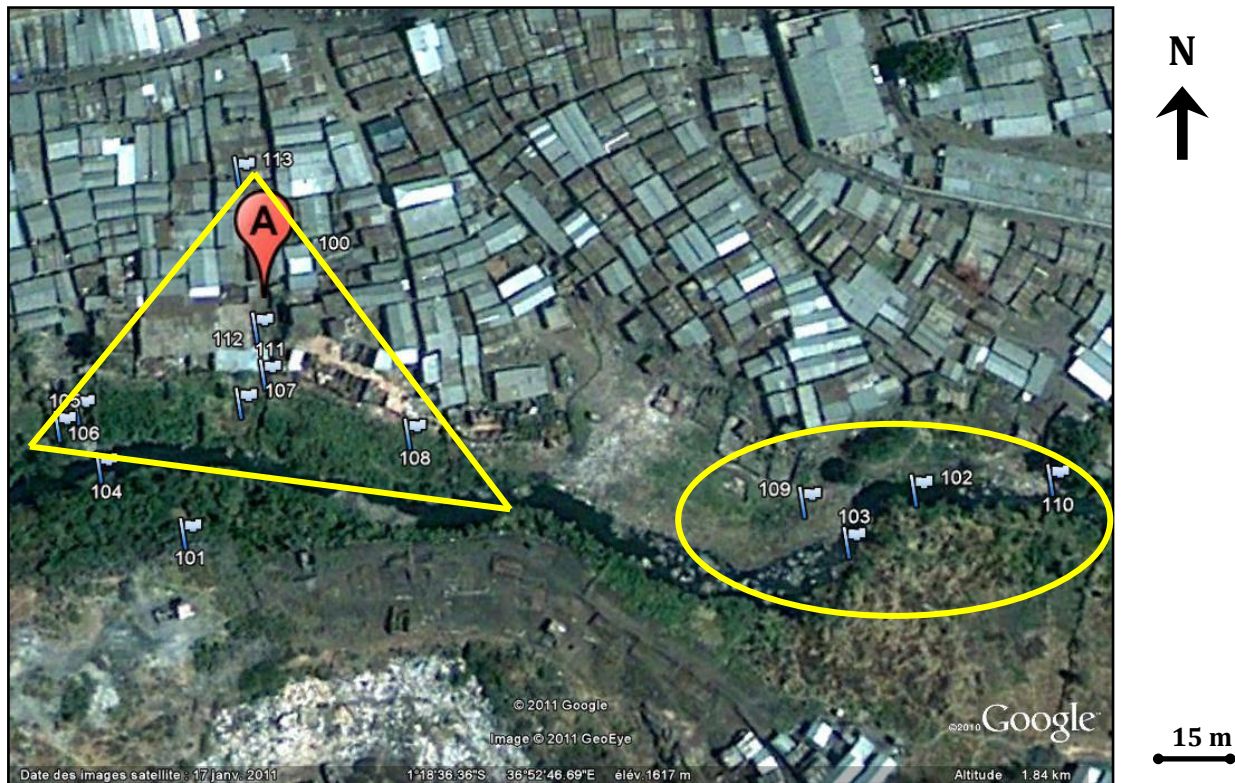
Aerial photography of GPS waypoints data – Campaign on the 13th of October 2011

Based on the field observations described above, representative measurements and samples of soil and water were taken at four separate points at the affected sites. During the entire field visit, the portable explosimeter did not detect any explosive conditions.

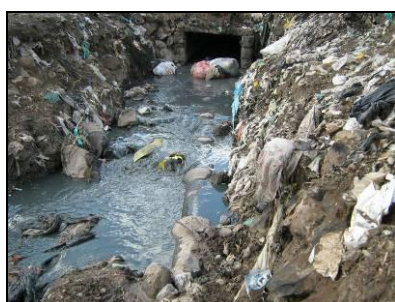
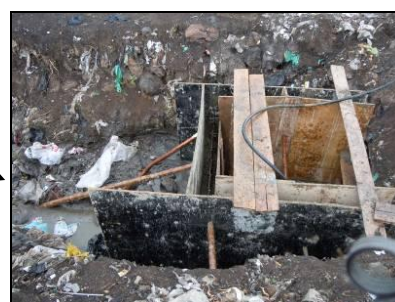
During the second field visit on 13 October, construction works were observed on the outlet of the storm water drainage system, connecting it to the municipal waste water system (GPS waypoint N°111 and see pictures below).

The outlet of the storm water drainage system before (left) and during (right) the alterations

Although the exact reasons for this construction work could not be verified on-site, it should be noted that if this is intended to avoid the collection of potential hydrocarbon releases in the storm water drainage system by the slum inhabitants, there will be limitations to achieving this, because:

- In case of newly released inflammatory products in the storm water drainage system, the hydrocarbon spill would be dispersed in the waste water network, releasing flammable vapors in the inspection hole (especially in the manhole identified by GPS waypoint N°111) and the explosive conditions in the slum would still be present;

- The municipal waste water network runs into one of the waste water treatment plants of Nairobi. However, as waste water treatment plants of the city are exclusively equipped for the treatment of domestic effluents, the risk of the treatment facility malfunctioning due to the existence of possible industrial releases could be realized;

- Due to the small diameter of the two connected networks (storm water draining system in Ø 800 mm and the municipal waste water network in Ø 300 mm) high hydraulic pressures could destroy the current construction works under way, causing a possible leak at the connection point and further risks of pollution.

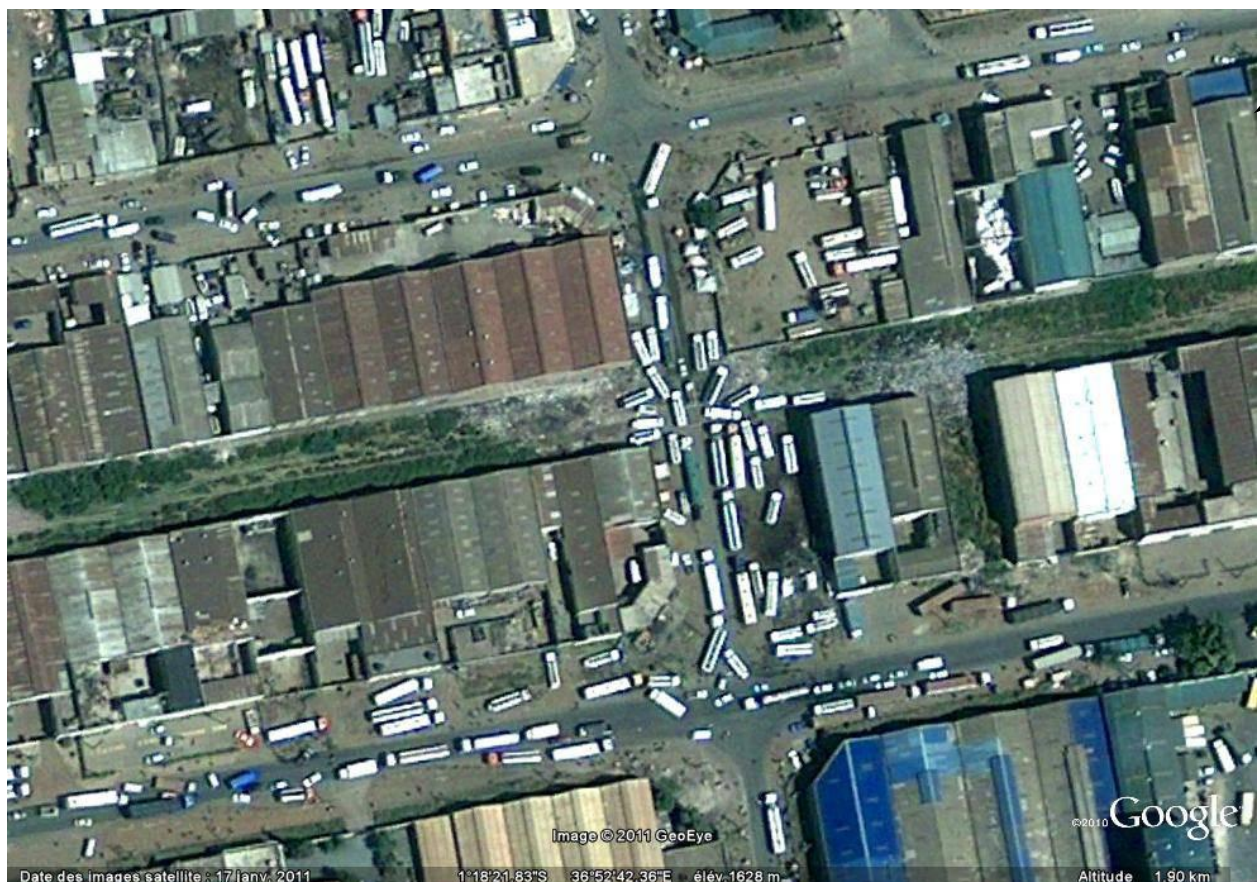
One of the most obvious potential sources of pollution of the storm water drainage system, which could cause a similar type of accident with grave human and environmental consequences, was observed at a loading bay and parking for tank vehicles. Tank vehicles, which can contain up to 30,000 liters of petrol, are parked on the sidewalk, without any specific precautions. The parking areas are not equipped in case of accidental leak nor is there any regard or enforcement of basic safety regulations such as a ban on smoking or the use of potential heat sources. As no retention basins exist to contain a potential leak, or the polluted water from simple washing of the trucks, any spilled petrol will penetrate the soil or, if in large enough quantities, flow into the storm water drainage system.

Aerial overview of the tank vehicles parked in the industrial area of Lunga Lunga

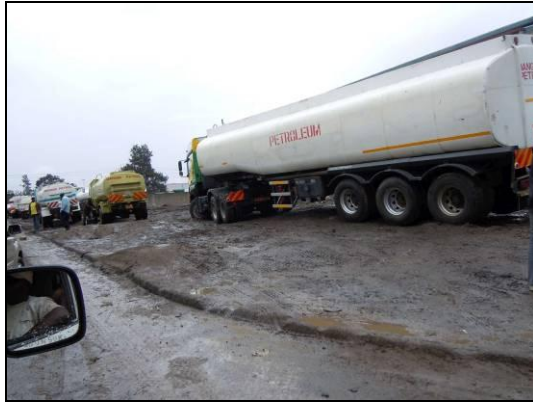
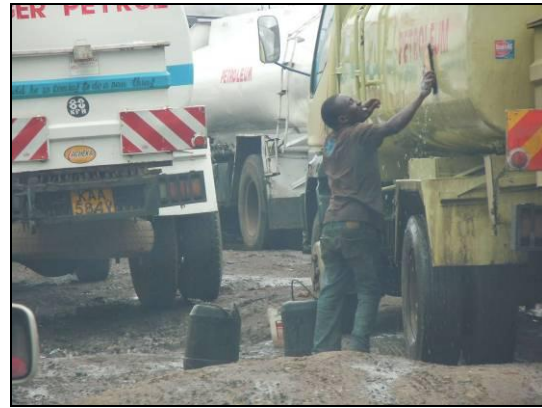
Overview of parking and washing of tank vehicles
