## Cobalt-60 Contaminated Metal Source Recovery Djibouti City, Djibouti April 2011

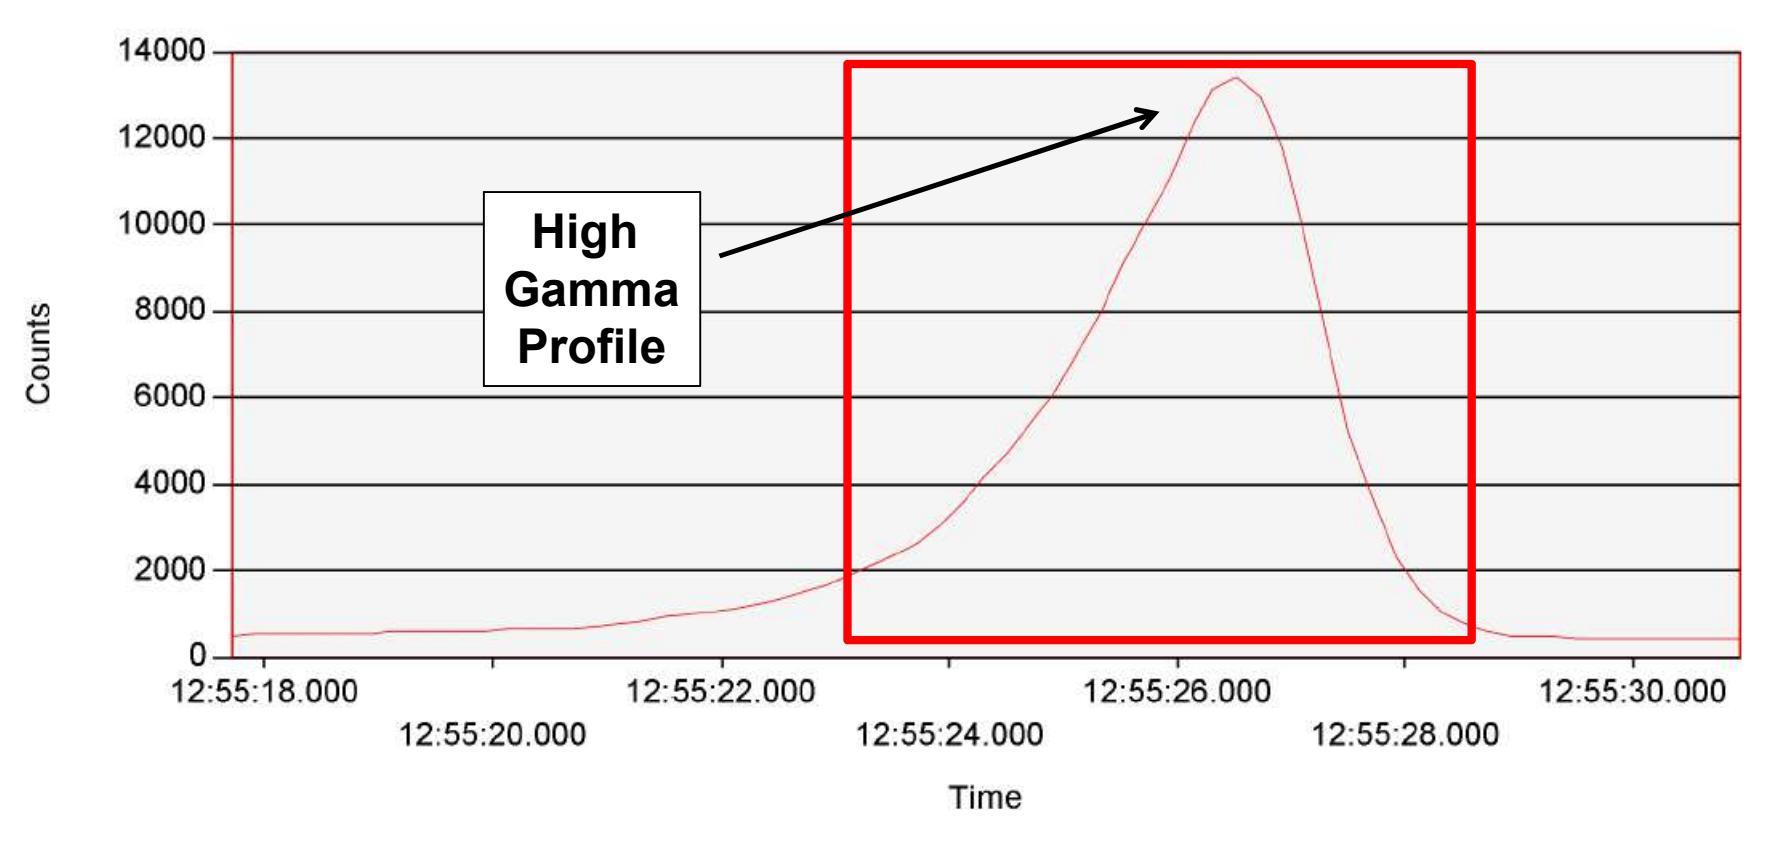
Gamma Profile

The data show elevated gamma levels which were not uniformly distributed along the container. The manifest shows 1015 cartons of machetes and standard  $\frac{1}{2}$ " gate valves both of which should not be radioactive.

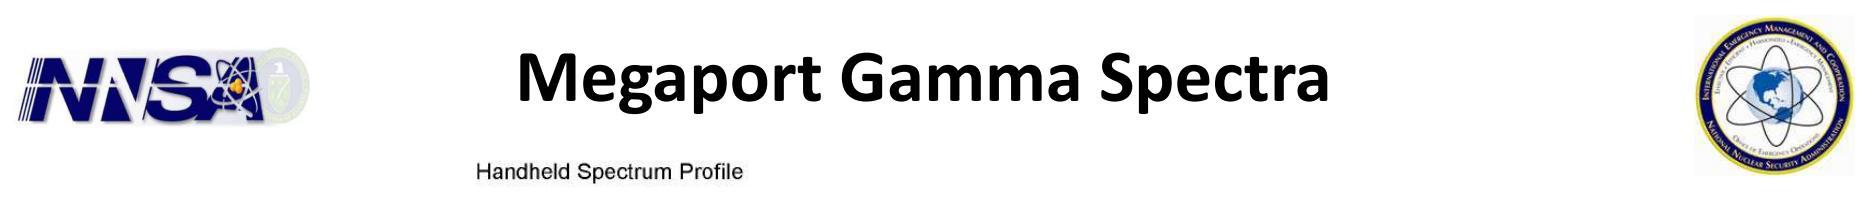
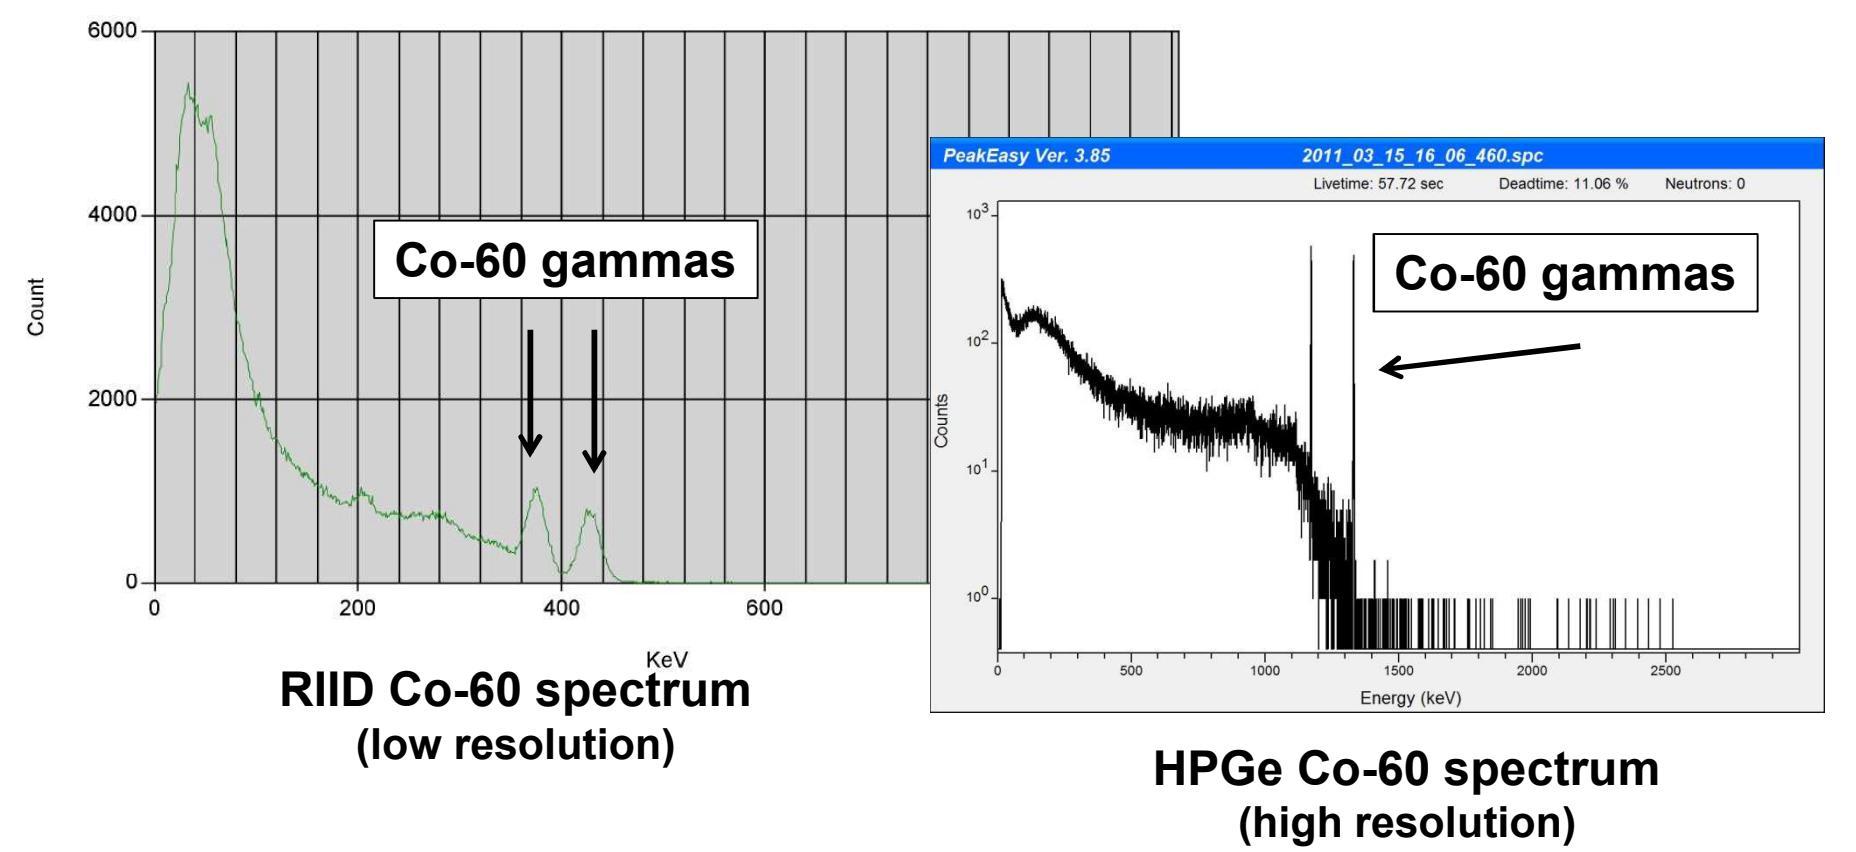
The spectra shown above were acquired by a Megaport operator and sent to DOE Triage for analysis. Both spectra clearly show the two characteristic gammas from Co-60 at 1173 and 1332 keV.

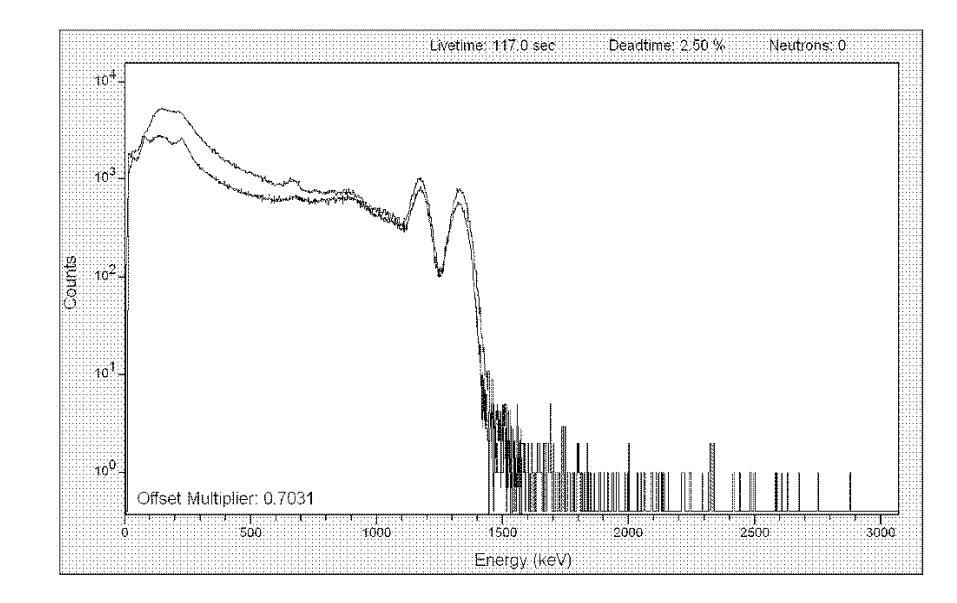
The material was identified as Co-60, a common industrial radionuclide. An estimate of activity for shielded Co-60, assuming a one meter distance from the radioactive material to the detector was approximately 0.5 to 1 mCi (20 - 40 MBq).

Figure 1. Identification – Cobalt 60 from the unknown item is in black, and matches a reference spectrum of Co-60 taken by the same type of instrument, shown above in blue.

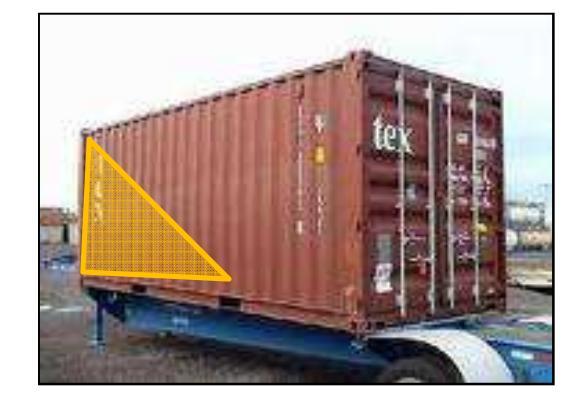
A cargo container with contaminated products may appear as a *distributed source* over a section of the container

The radiological characterization map shows a radiation source distributed over a triangular area with highest levels at the back of the container.

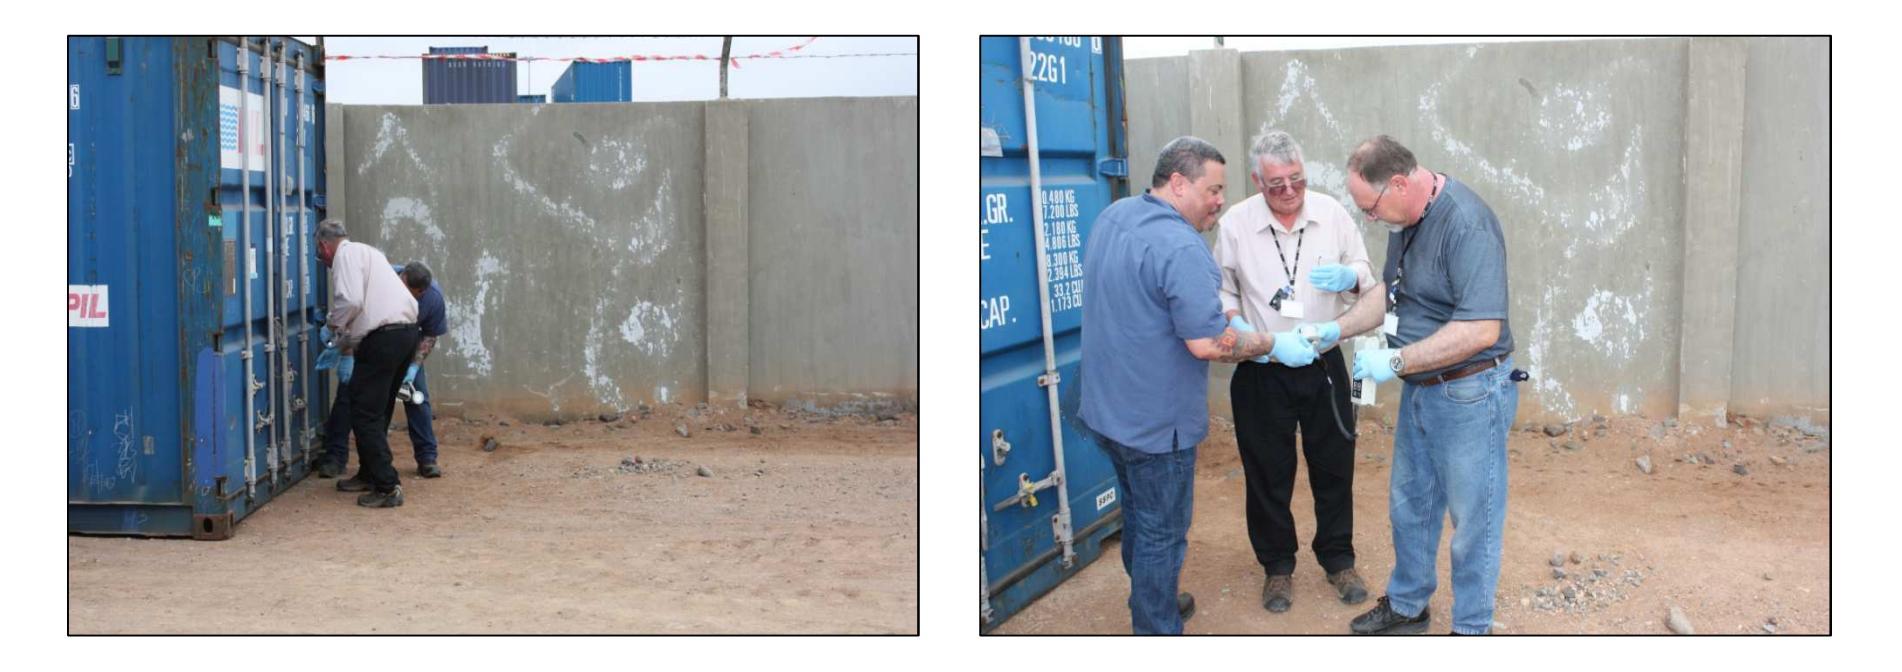
# External Container Surveyed for Contamination and Dose Rates

Two instructors don rubber gloves and dosimetry to conduct a survey of the door latch, door handle and vent using paper swipes to collect removable contamination. A third instructor uses a health physics beta/gamma probe to measure the swipes for contamination.

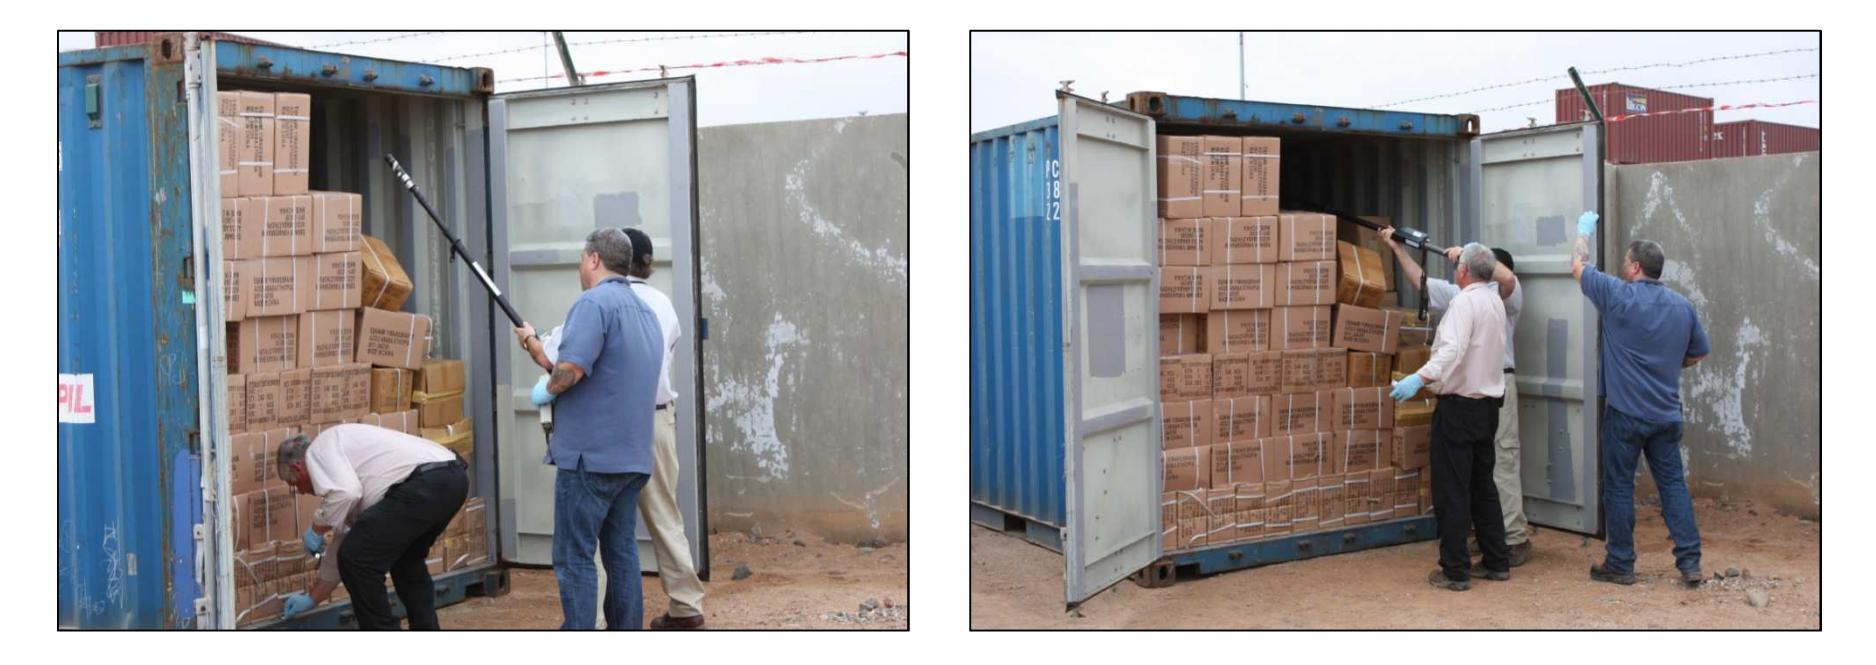
## **Container Opened and Surveyed for Contamination and Dose Rates**

No contamination detected on the inside and dose rates inside door are near background. The contents are found to also contain hardware items to include hammers and nails which provide shielding of the radiation source at the rear of the container. Using an extendable tele-probe, dose rates on top of the boxes were 0.13  $\mu$ Sv/h (13  $\mu$ R/h) middle container and 0.27  $\mu$ Sv/h (27  $\mu$ R/h) rear container.

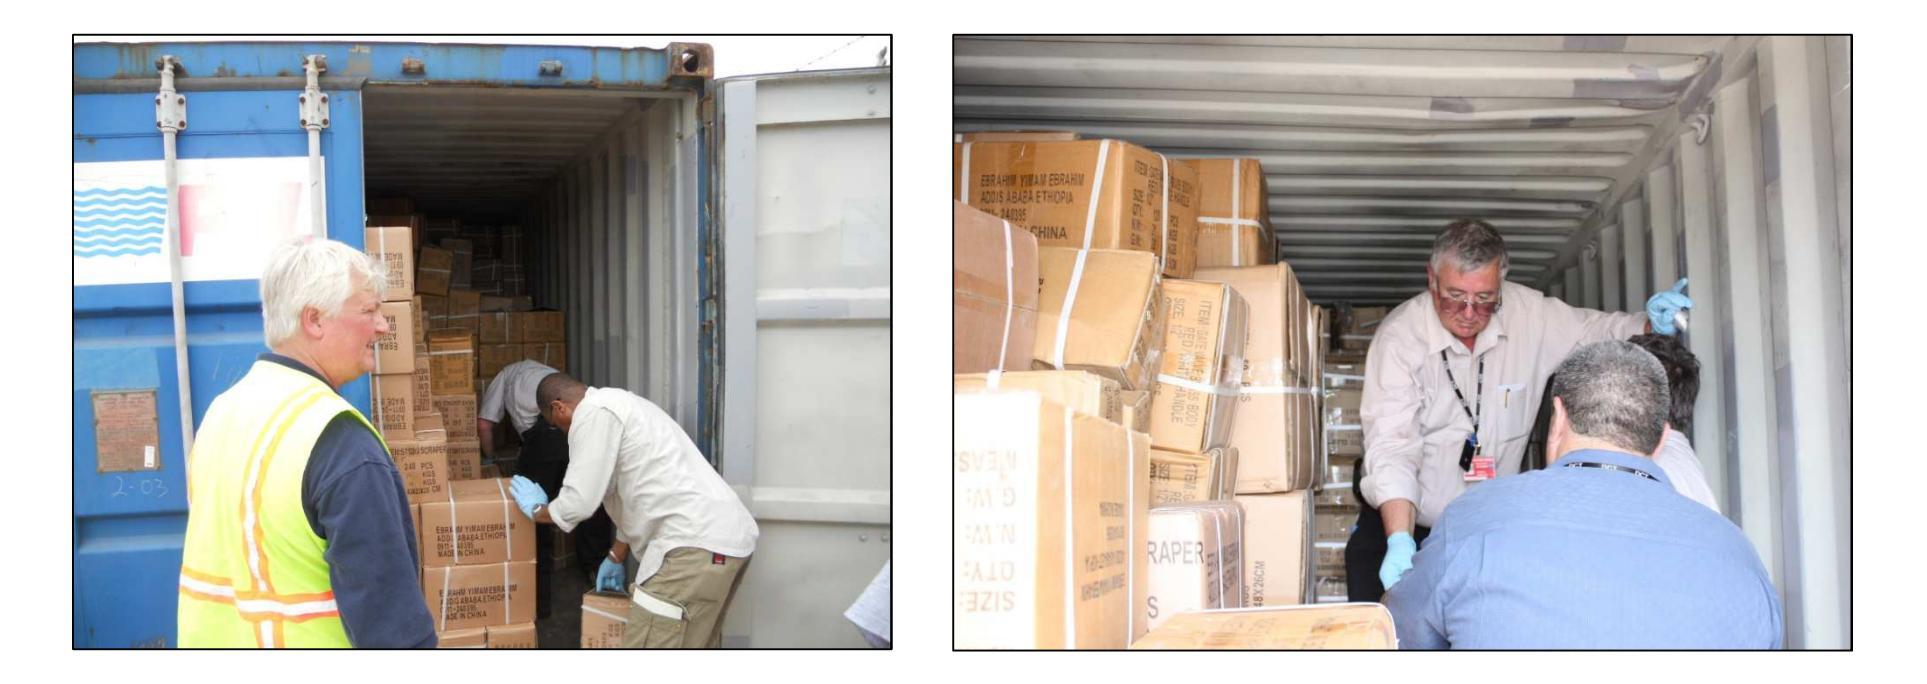
## Path Cleared along Right Side of Container to Source

Contamination and dose rate surveys conducted after each column of boxes removed. Contamination negative and dose rates near background. Boxes contained tools and hardware (hammers, nails, scrapers, machetes, etc.) which provide good shielding of the Co-60 source in the back of container.

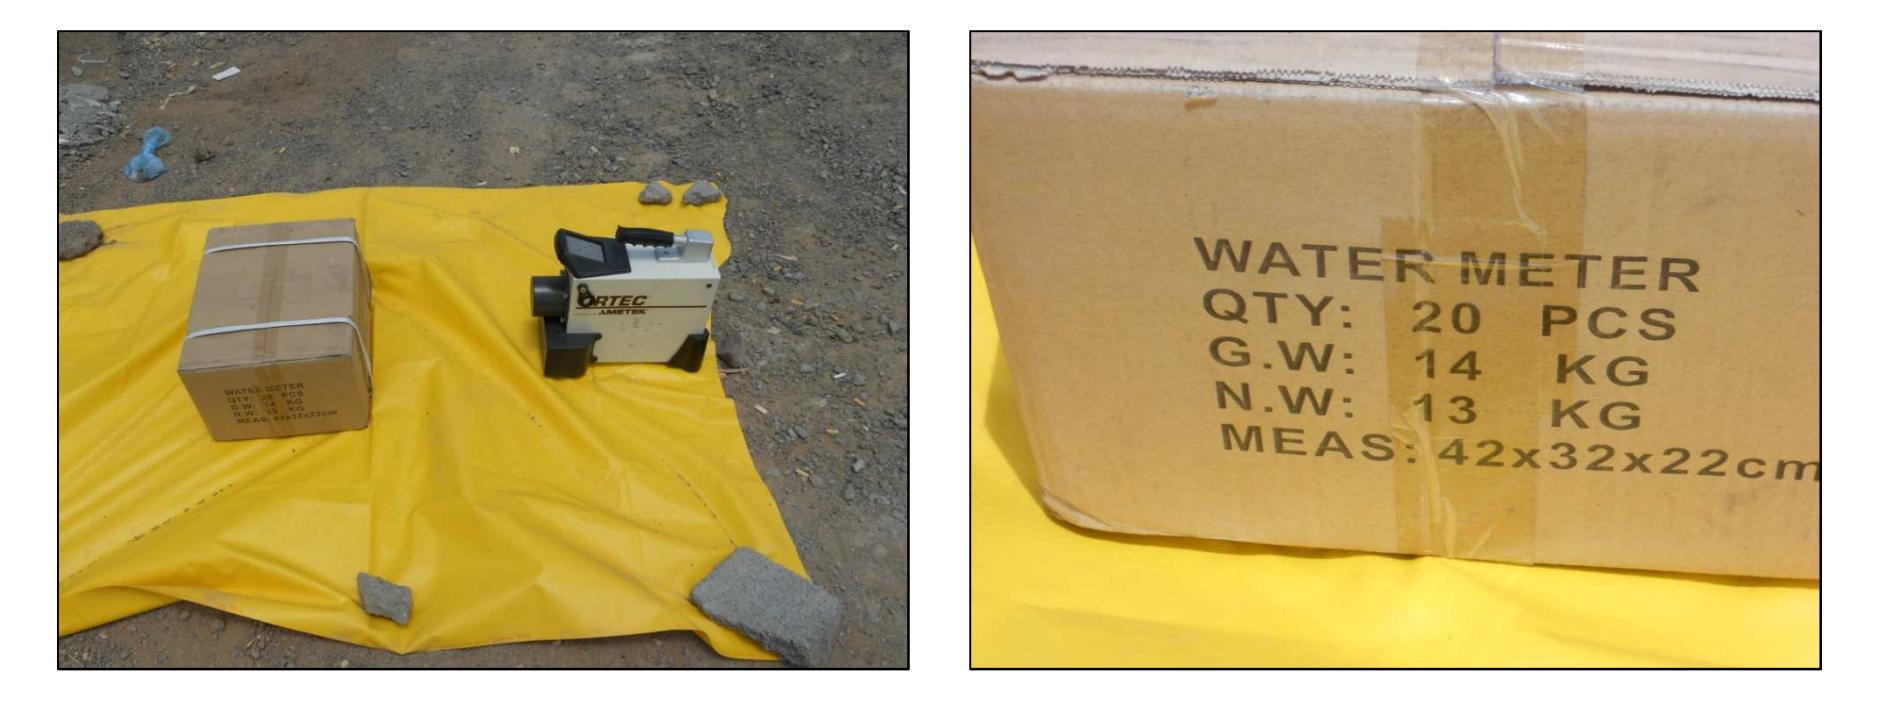
## Box with Elevated Dose Rate Readings Removed from Container

Contamination and dose rate surveys were conducted on a box with elevated readings. Removable contamination was negative and the dose rate was 6  $\mu$ Sv/h (600  $\mu$ R/h) on contact and 0.4  $\mu$ Sv/h (40  $\mu$ R/h) at 1 meter. The box contained 20 water meters and weighed 14 kg.

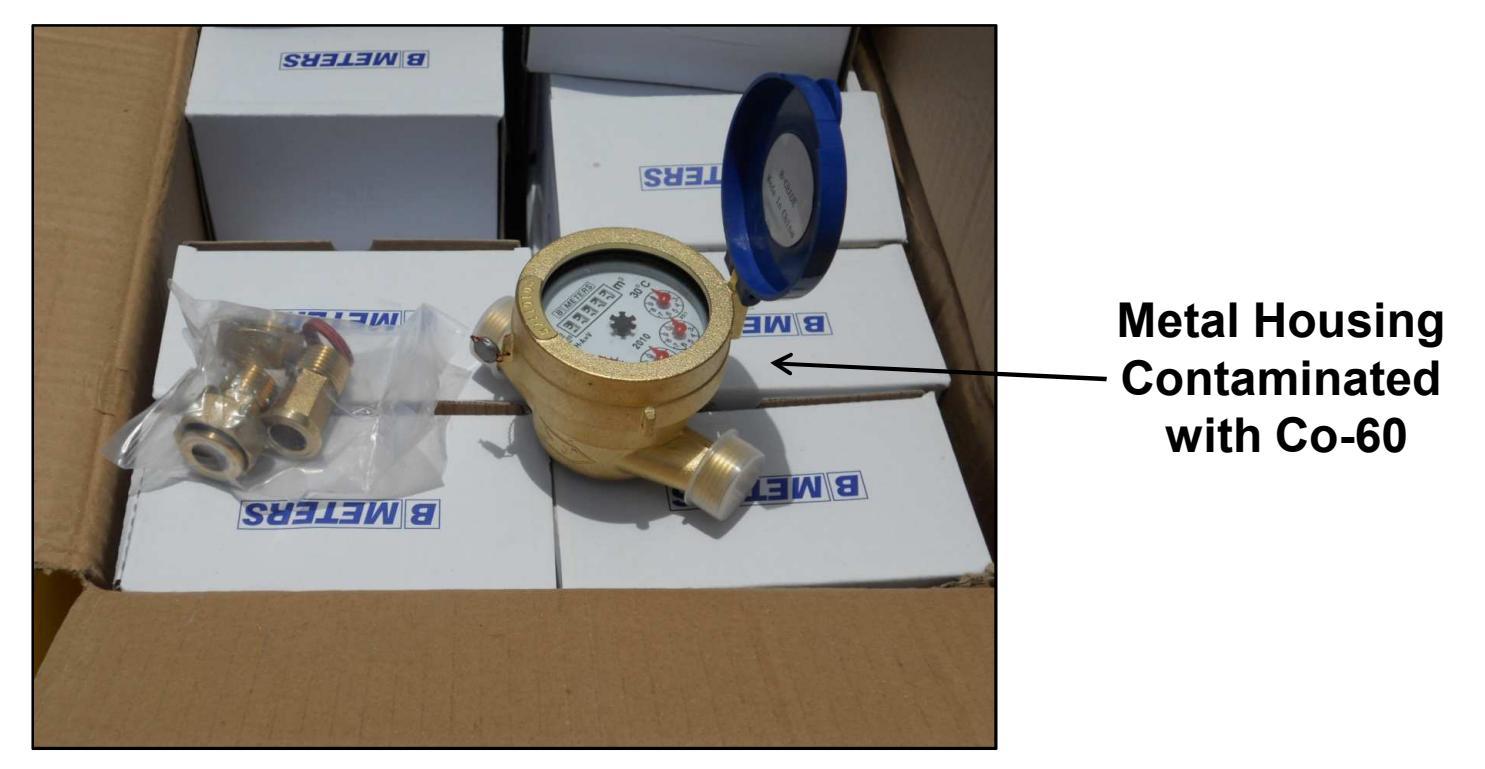
### **Single Water Meter**

Each water meter is 7.6 cm (3 inch) diameter x 10 cm (4 inch) long with threaded input and exit ports. Housing appeared to be brass metal. The Co-60 was smelted into the metal at a foundry and then the metal made into the housing. Swage nuts and washers in plastic bag showed no evidence of Co-60 contamination.

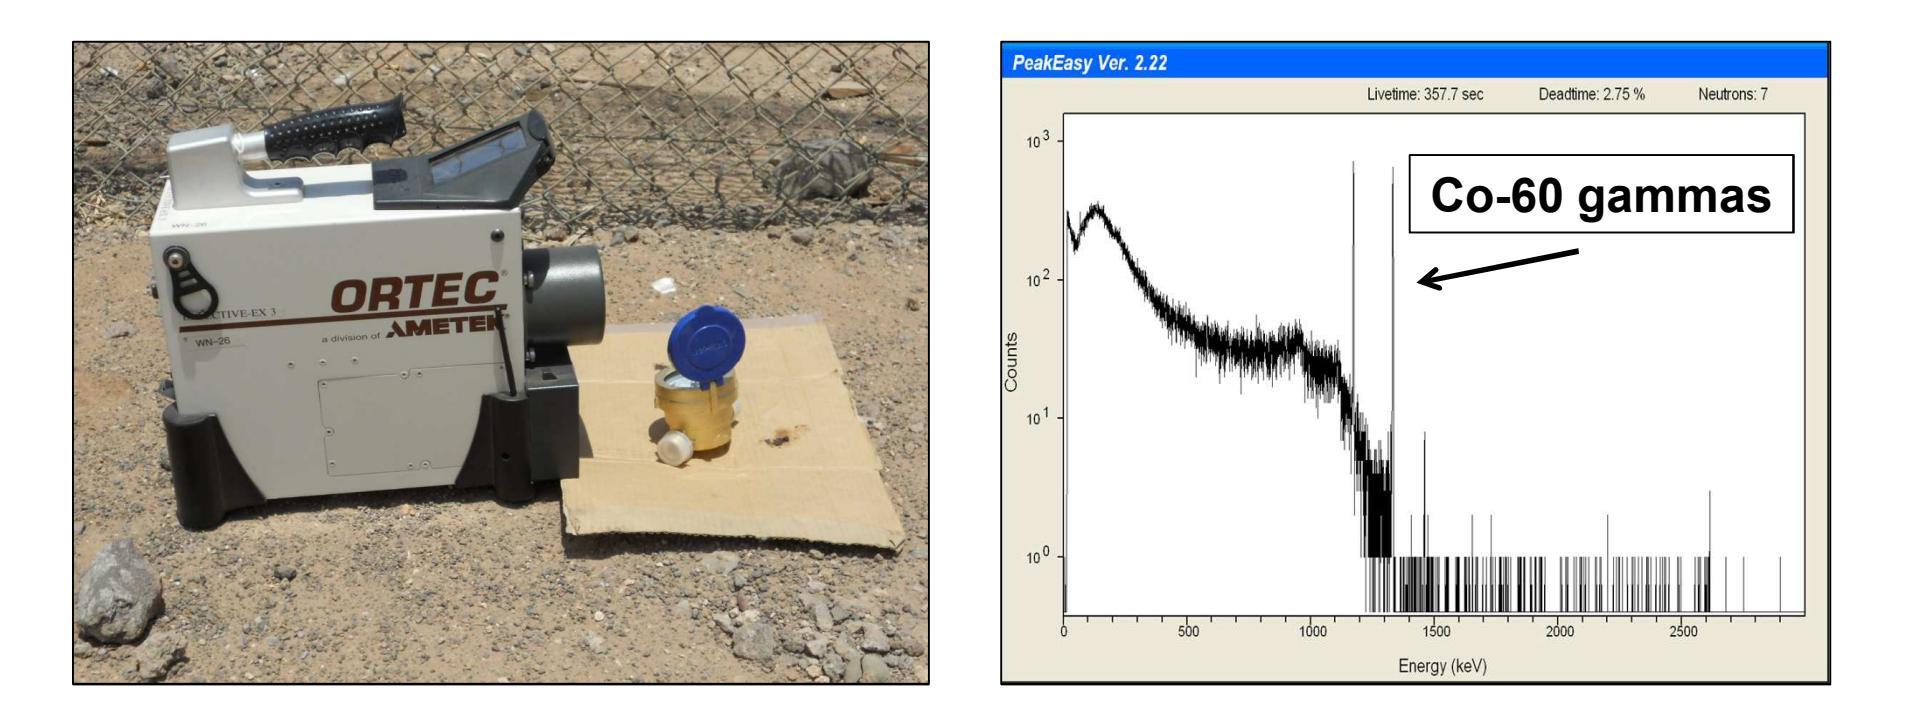
### HPGe Measurement of a Single Water Meter

Preliminary assessment of activity gives ~ 18 kBq (0.5  $\mu$ Ci) Co-60 per water meter. Assuming each water meter has about the same activity, the total activity for the 102 cases is estimated to be 37 MBq (1 mCi).

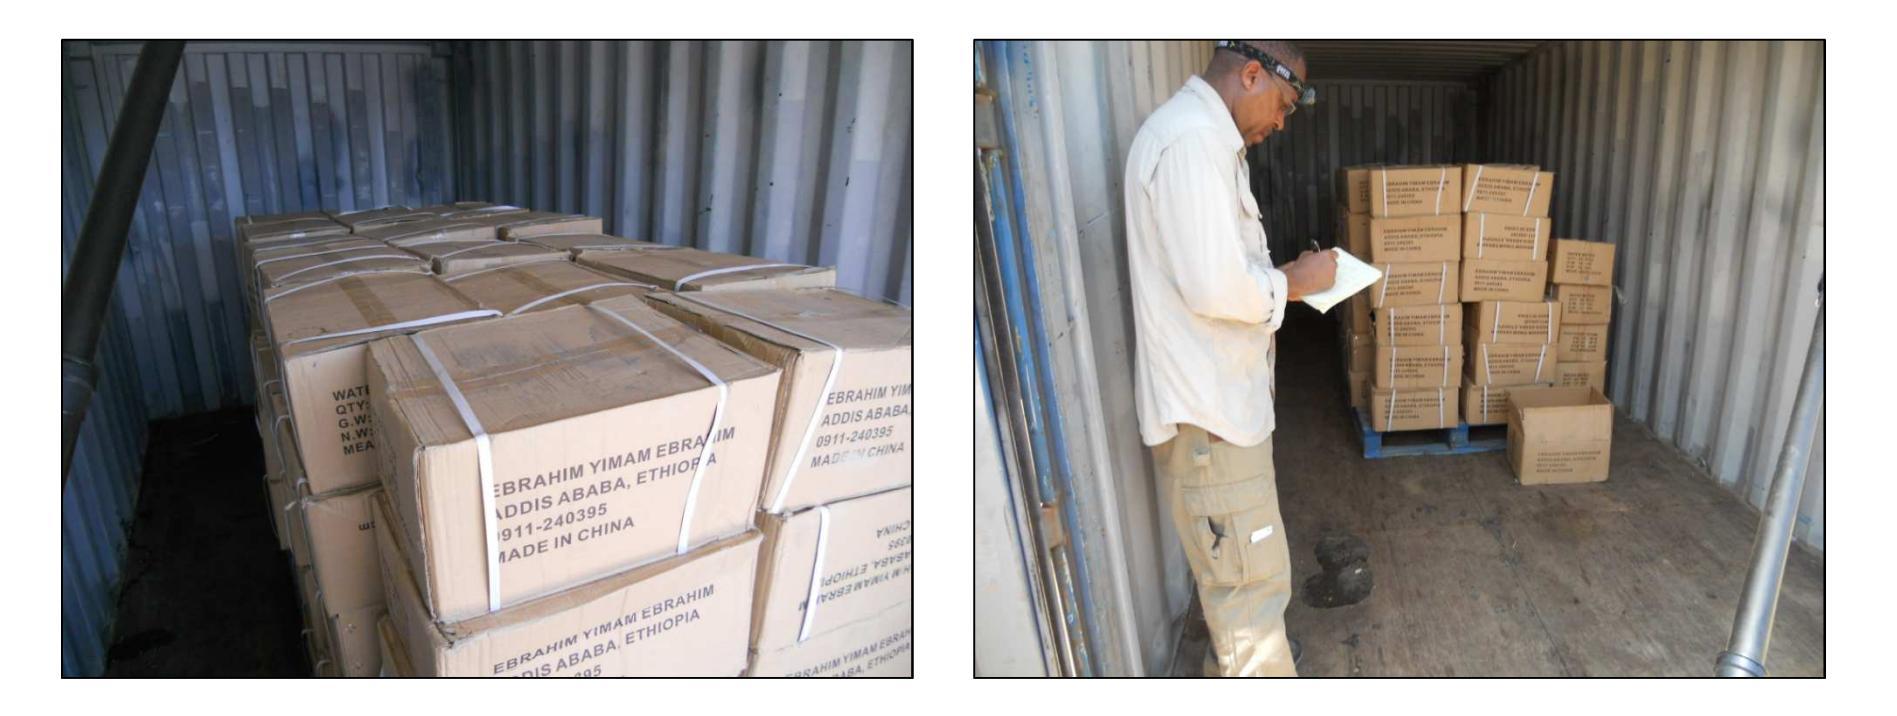
### Water Meters Segregated in Separate Container

The water meters were segregated in an empty container and inventoried. The dose rate on the center side of the pallet of water meters was 0.01 mSv/h (1 mR/h). The container was locked and secured. The detained container is surveyed to ensure all radioactive materials removed.
