GENERAL STRATEGY FOR RISK REDUCTION

LINKED TO ASBESTOS CEMENT

1.1. Impact of the Cyclone IDAI

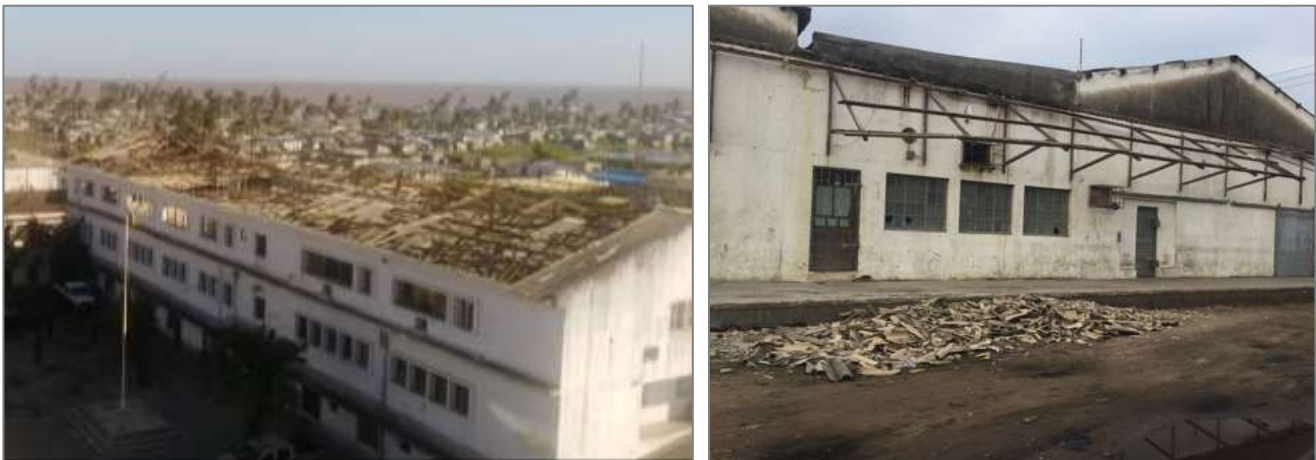
Figure 1 – Damaged fibre cement roofing in Publics and Commercial buildings in Beira city

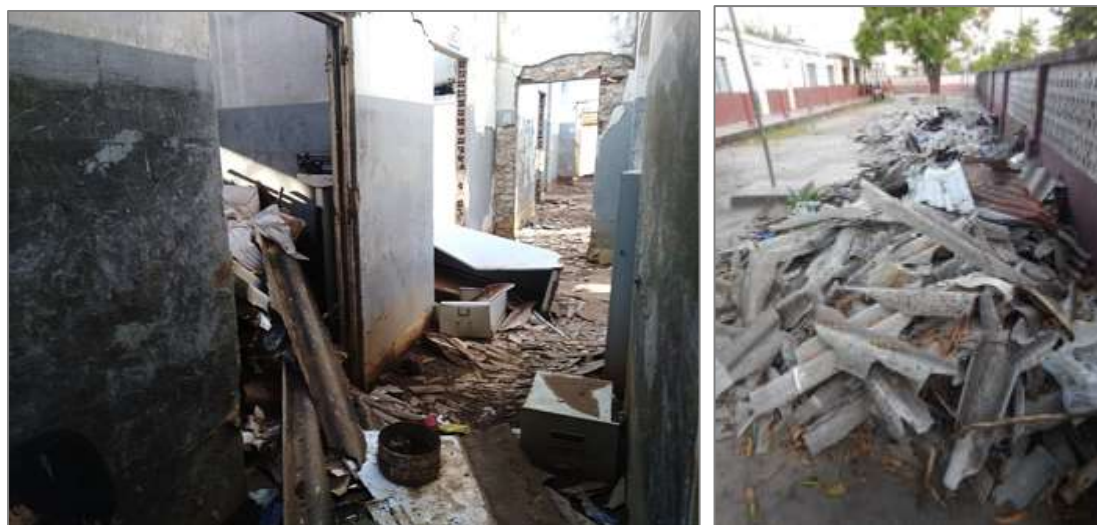
Figure 2 – Asbestos cement debris among rubbles in Buzi rural hospital (left) and in Beira city (right)

It was also possible to observe, as clearance activities started right after the cyclone, piles of asbestos-cement roofing debris along the roads and in the affected communities. On visits to the main Beira dumpsite (Munhava) and the emergency disposal site "Ceramica", fibre cement debris could also be observed mixed within the normal waste stream.

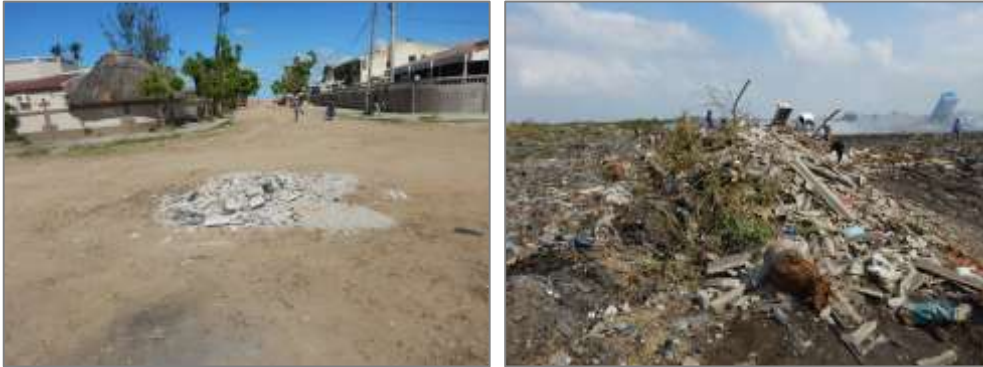
Evidence of crushing of damaged roofing sheet and re-use for filling of potholes and landfilling in affected neighbourhoods could also be observed.

Figure 3 – Filling of potholes with asbestos cement rubbles and disposal at Beira dumpsite

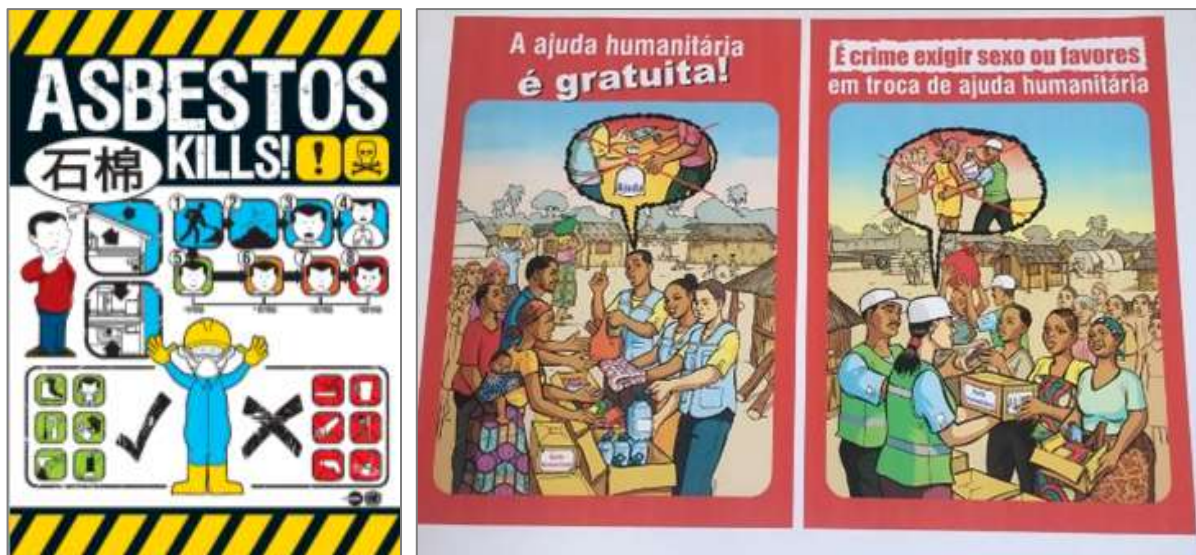
Figure 5 –Examples of IEC material for asbestos (left, example of China) and culturally adapted IEC material on Protection against sexual exploitation and abuse (PSEA, right)

Visual Information, Education and Communication (IEC) material could be developed to illustrate these key messages taking into consideration the need to be culturally sensitive for the message to go through (see Figure 5). Trained community mobilizers can support the divulgation of these messages, with direct involvement of institutions in charge (DPTADER, Local Authorities).

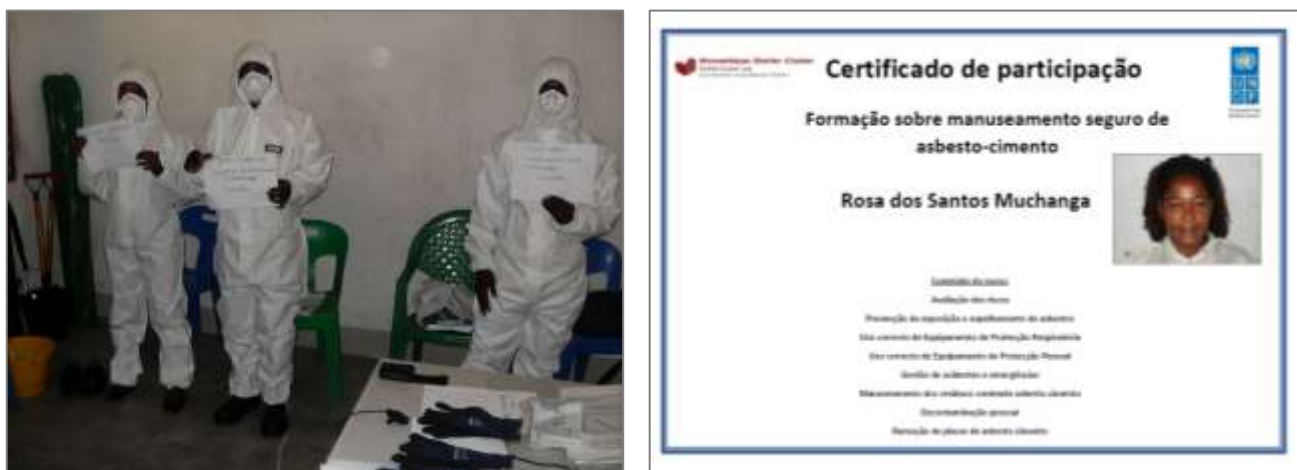
Figure 6 –Example of safe asbestos handling classroom training and certificate (training provided to Beira Municipality Solid Waste Management workers)⁸

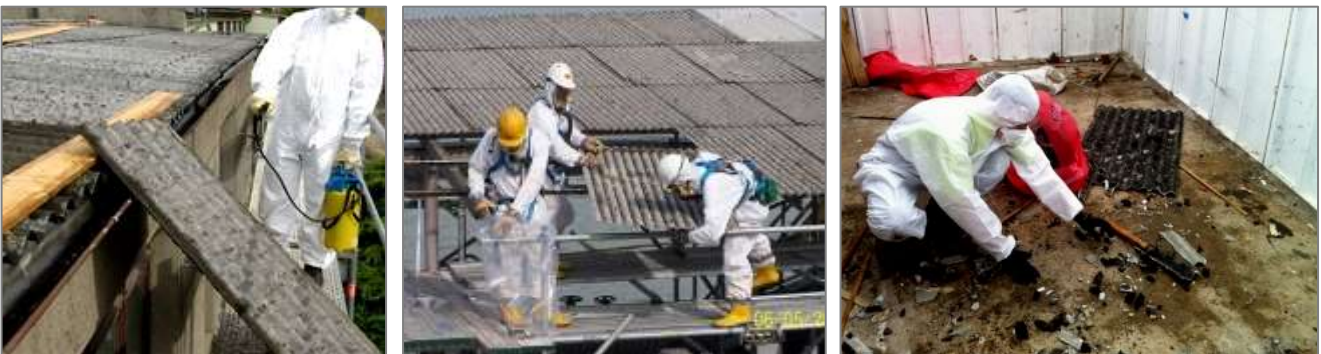
Figure 7 – Safe removal of asbestos cement roofing sheet and debris

Minimum requirements for safe removal and handling of asbestos cement have been compiled in a guidance note available in [Annex 3](#). It includes the need of having a specific plan of work and risk analysis before starting removal activities, training of workers, use of adequate Personal Protection Equipment (PPE) and Respiratory Protection Equipment (RPE) as well as work procedures to minimize the risk of exposure, and finally arrangement in place for final disposal.
