GENERAL STRATEGY FOR RISK REDUCTION

LINKED TO ASBESTOS CEMENT

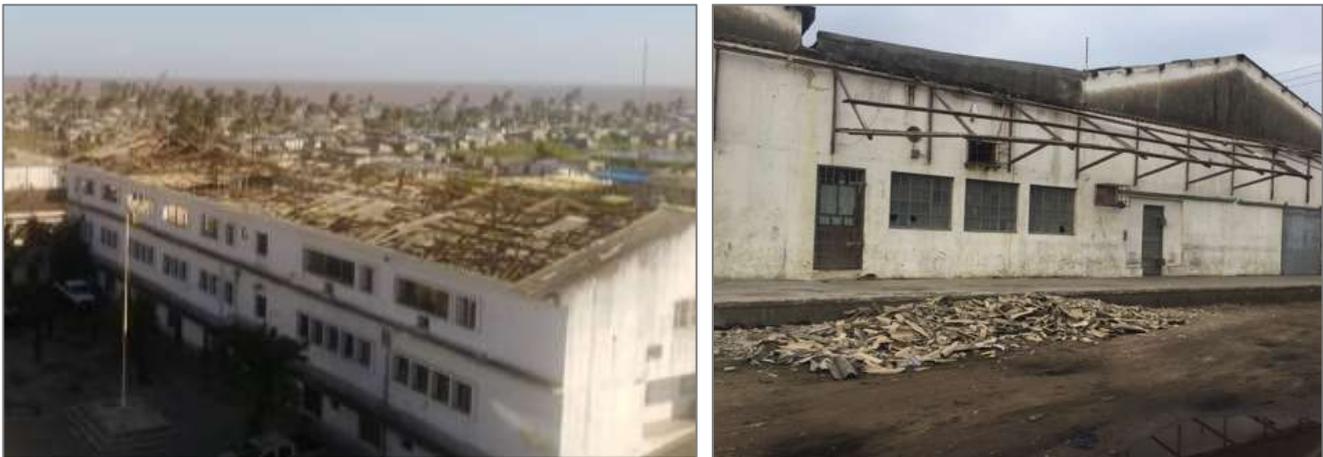
Figure 1 – Damaged fibre cement roofing in Publics and Commercial buildings in Beira city

Fibre cement material was produced in a local factory (“Lusalite”) located in Dondo city (30 km from the Beira City). Information from current owner of the factory indicate that the products are asbestos-free only since 2008³, so it can be assumed that most fibre cement products used until that date will probably contain asbestos.

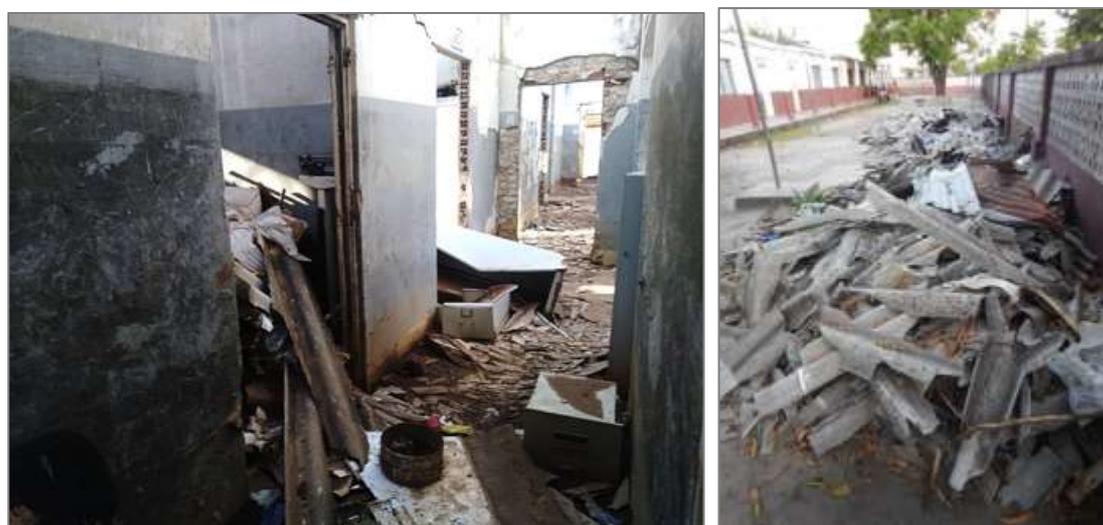
Figure 2 – Asbestos cement debris among rubbles in Buzi rural hospital (left) and in Beira city (right)

It was also possible to observe, as clearance activities started right after the cyclone, piles of asbestos-cement roofing debris along the roads and in the affected communities. On visits to the main Beira dumpsite (Munhava) and the emergency disposal site "Ceramica", fibre cement debris could also be observed mixed within the normal waste stream.

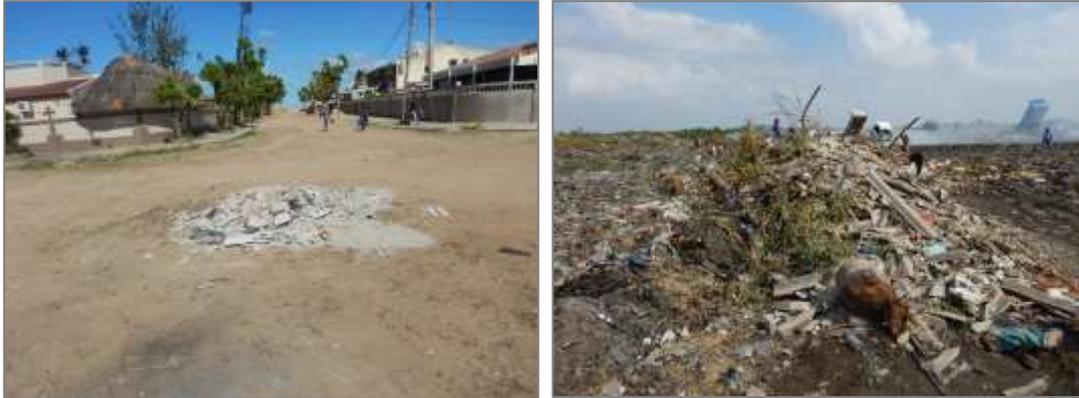
Figure 3 – Filling of potholes with asbestos cement rubbles and disposal at Beira dumpsite

Evidence of crushing of damaged roofing sheet and re-use for filling of potholes and landfilling in affected neighbourhoods could also be observed.

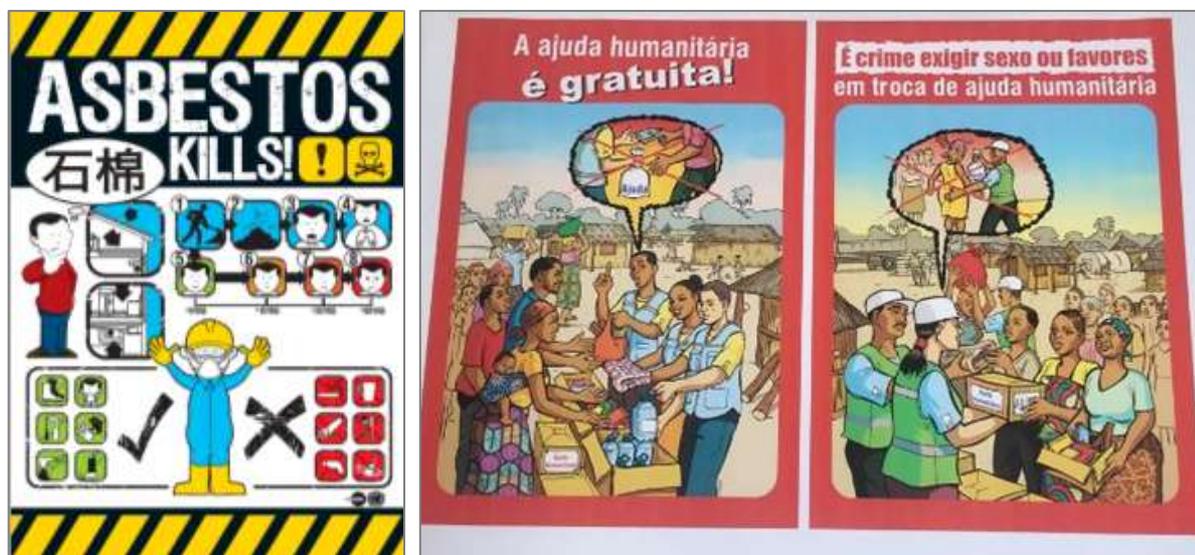
Figure 5 –Examples of IEC material for asbestos (left, example of China) and culturally adapted IEC material on Protection against sexual exploitation and abuse (PSEA, right)

Visual Information, Education and Communication (IEC) material could be developed to illustrate these key messages taking into consideration the need to be culturally sensitive for the message to go through (see Figure 5). Trained community mobilizers can support the divulgation of these messages, with direct involvement of institutions in charge (DPTADER, Local Authorities).

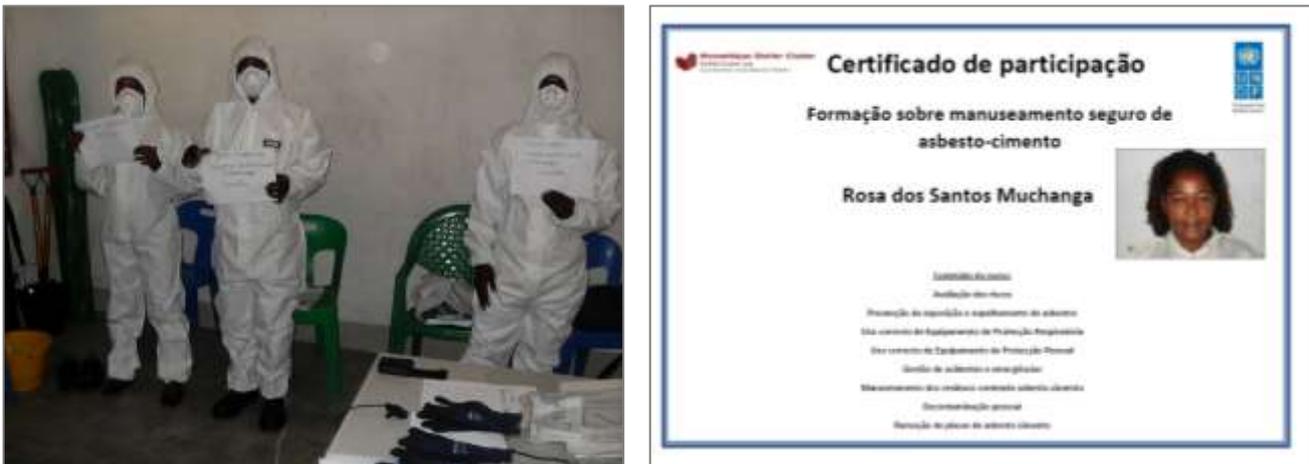
Figure 6 –Example of safe asbestos handling classroom training and certificate (training provided to Beira Municipality Solid Waste Management workers)⁸

⁸ During the months of May and June 2019 UNDP and Shelter Cluster’s Asbestos specialist implemented classroom training on safe removal of asbestos cement covering approximately 40 participants, including workers from Beira Municipality (Urban Services and Construction directorates) and technical staff from DPTADER.

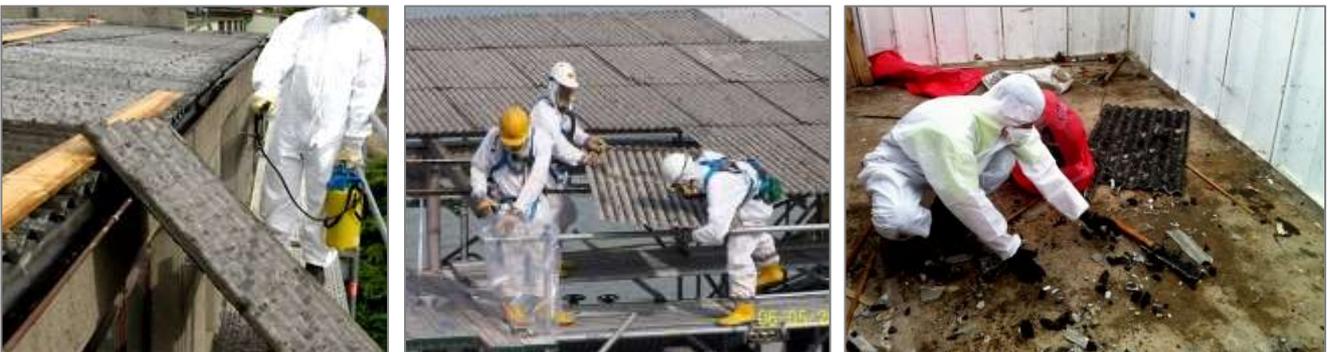
Figure 7 – Safe removal of asbestos cement roofing sheet and debris

Minimum requirements for safe removal and handling of asbestos cement have been compiled in a guidance note available in [Annex 3](#). It includes the need of having a specific plan of work and risk analysis before starting removal activities, training of workers, use of adequate Personal Protection Equipment (PPE) and Respiratory Protection Equipment (RPE) as well as work procedures to minimize the risk of exposure, and finally arrangement in place for final disposal.
