# Construction and Hazardous Waste Management

Tajikistan

June / July 2015

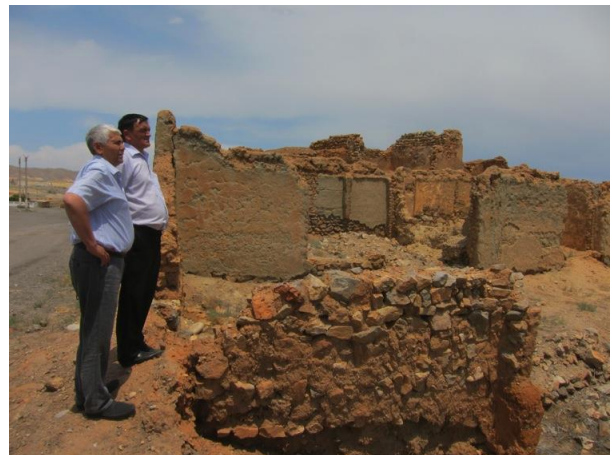
*Figure 2 – Abandoned buildings in former Kyrgyz part of the town*

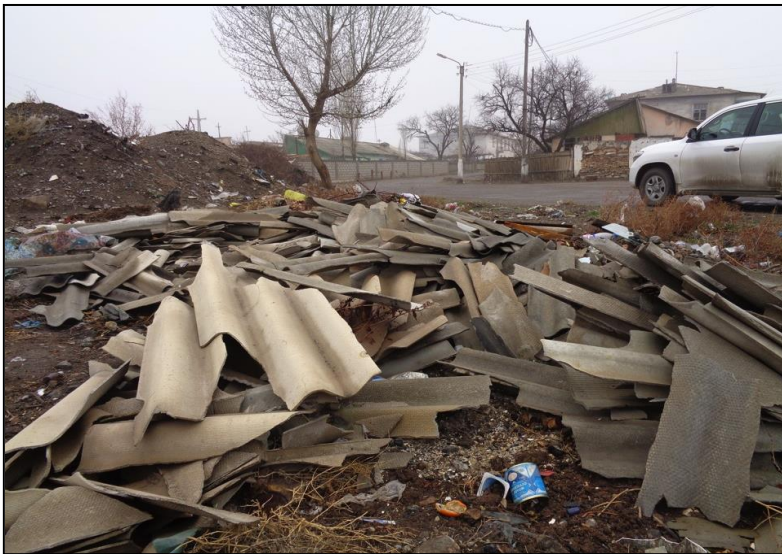
During the initial scoping visit in March 2015 the presence of asbestos within the town of Shurob first became apparent. Considerable quantities of broken roofing-sheets were observed dumped at multiple locations around the town. Further, it was noted that all of the two-storey buildings selected for deconstruction all possessed the same style of roofing-sheets. Visual inspection of the material by the expert raised concerns about the potential presence of white asbestos (Chrysotile) and this was subsequently confirmed by laboratory analysis at an accredited laboratory in the UK.

*Figure 3 – Large quantities of asbestos containing roofing-sheets were observed to be dumped around the town of Shurob*

| Item # | Item | Task | Time-frame | Responsible |
|---|---|---|---|---|
| 1. | Remove Existing Asbestos Debris | <ol style="list-style-type: none"> <li>Using the equipment provided by the UN (tractor, trailer, wheeled digger) commence the removal of existing asbestos waste dumped at numerous locations throughout Shurob.</li> <li>Ensure staff and residents engaged in these asbestos removal activities are provided with and use the appropriate personal protective equipment (PPE).</li> <li>Explore the option, and suitability, of engaging local residents to assist with the clean-up of asbestos waste from within their community. But first participants must receive the necessary training and be issued with, and use, appropriate PPE.</li> <li>Prepare trenches within the Shurob waste disposal site for the disposal of asbestos waste and cover with a minimum of 15cm soil at the end of each day's operations.</li> <li>Maintain records (photos/GPS etc.) of the location of the asbestos disposal trenches and record their presence within the appropriate land register to avoid potential public health risks in the future (such as those caused by redevelopment of the site in future years).</li> </ol> | 1-6 months | Shurob Municipality |

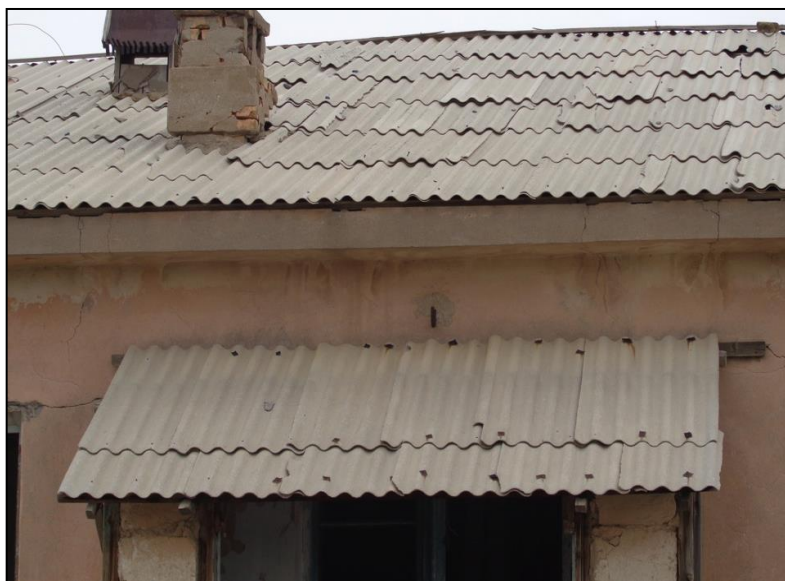
*Figure 4 - it was noted that all of the two-storey buildings selected for deconstruction possessed the same style of asbestos containing roofing-sheets*

Confirming the presence of a large quantity of asbestos containing roofing-sheets throughout the town of Shurob necessitated a change of approach for the proposed deconstruction plan and meant that specialist training, personal protective equipment (PPE) and specific operational procedures needed to be finalized in advance of any deconstruction activities proceeding.

| 9. | Undertake Comprehensive Asbestos Survey | <p>5. Having confirmed which buildings should be deconstructed via the completion of the necessary structural surveys, complete a comprehensive asbestos survey to identify all asbestos (paying particular attention to the higher risk asbestos containing sprayed coatings typically found in basements around hot-water piping, boilers and tanks) and develop an Asbestos Management Plan and a Health &amp; Safety Plan.</p> <p>6. If necessary, seek assistance from the international community for providing and funding of suitably qualified asbestos experts.</p> | 6-18 months | Shurob Municipality |

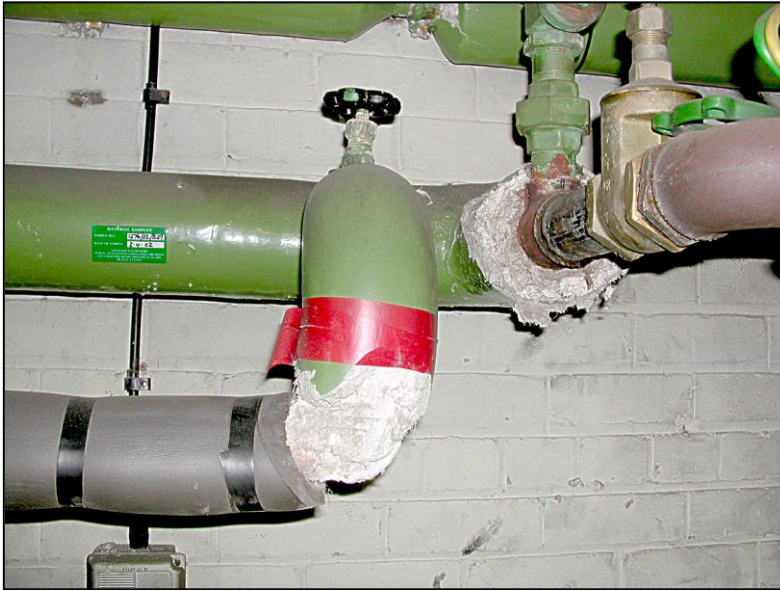
Blue and brown asbestos (Crocidolite and Amosite) is often used in hot-water pipes, boiler and tank insulation and is considerably more hazardous than the white asbestos (Chrysotile) typically contained within roofing sheets. Typically, blue and brown asbestos is found in basement areas of properties.

*Figure 5 – A comprehensive asbestos survey is required to determine the presence of other, potentially more hazardous, sources of asbestos throughout Shurob. Note that this image is for information purposes only and not taken in Shurob.*

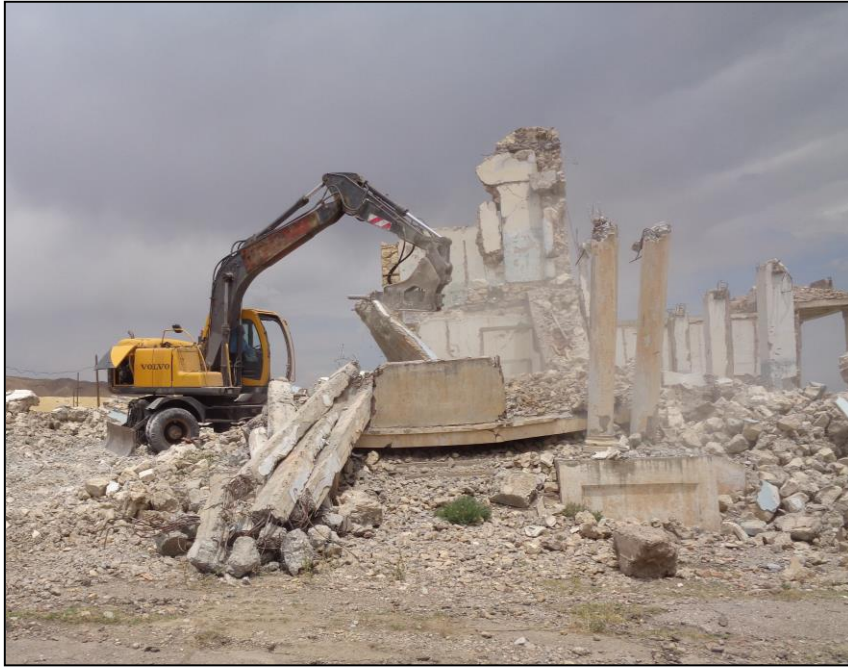
Additionally, demolition work was initiated within the pre-selected clearance site using heavy equipment on loan from the adjacent mine. During this phase of the programme participants learnt about the risks of working in proximity heavy equipment, measures to suppress health nuisances such as excessive dust generation. Also, participants got to wear the full range of PPE.

*Figure 7 – heavy equipment was sourced from the adjacent mine to commence demolition works.*

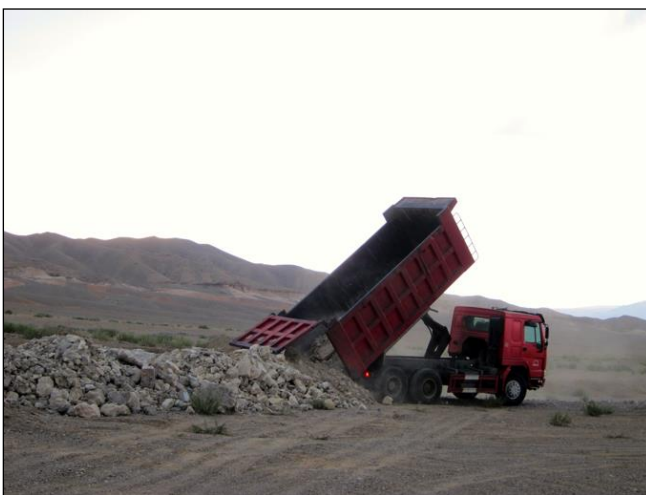
*Figure 8 – Construction rubble, from which asbestos has been removed, is used to expand town flood barrier.*
