Non-Structural Vulnerability Assessment of Hospitals in Nepal

**National Society for Earthquake
Technology-Nepal**

December 2003

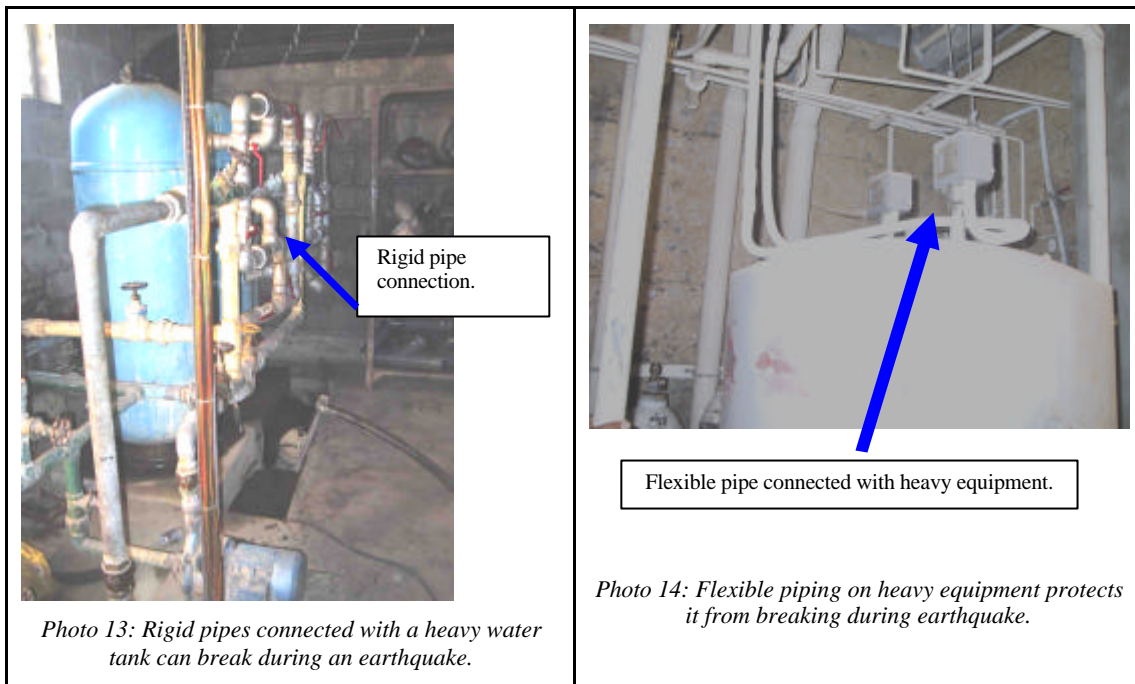
If there is a tank outside the building with a rigid connection pipe joining the building and the tank together, the tank will vibrate at frequencies, in directions and at amplitudes different to those of the building, which will cause the pipe to break. A flexible pipe between the two parts would prevent ruptures of this kind. Flexible couplings are necessary because separate objects each move independently in response to an earthquake; some move quickly, others slowly.

Consequently, flexible piping is necessary near heavy equipment, at the joint of two buildings and in seismic joints of the same building.

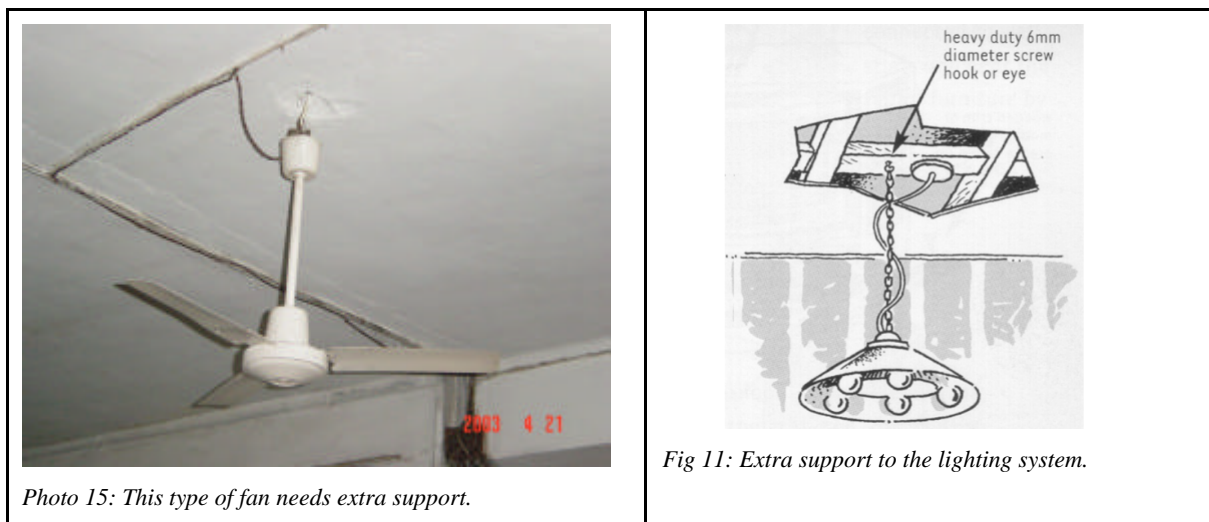
Supports are suitable in many cases. For example, ceilings are usually hung from cables that only withstand the force of gravity. When subjected to the horizontal stresses and torsion of an earthquake, they easily fall. They can cause serious injury to people underneath them and obstruct evacuation routes. Extra support by additional wires can protect the ceiling or light fixtures from falling.

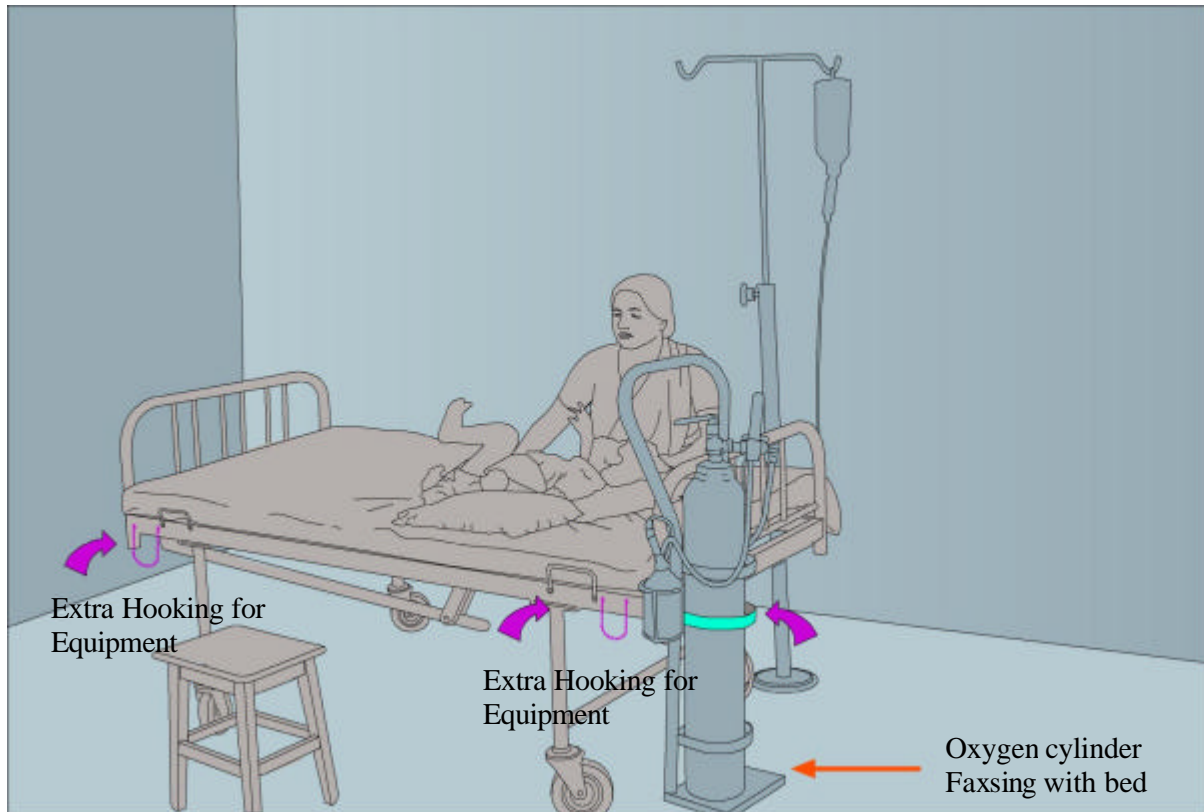
5.15 Development of Chaining System on Beds

During the survey, it was found that in important wards like ICU, CCU, post operative, and maternity wards the equipment and the accessories needed for the treatment are generally placed near to the beds but without any anchor or support. This equipment and accessories should be fixed to reduce the vulnerability and enhance the hospital performance after an earthquake. Providing chains and anchor hooks on each bed could solve the problem.

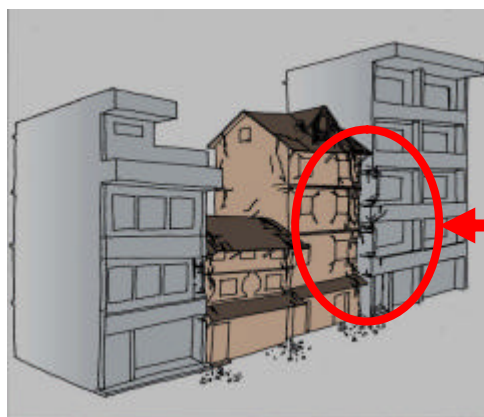
Fig A3-3: Pounding Effect on Buildings

Breakage of piping or ducts may occur at seismic joints or in the joint of two buildings due to differential displacement (separation and pounding).
