## Cobalt-60 Contaminated Metal Source Recovery Djibouti City, Djibouti April 2011

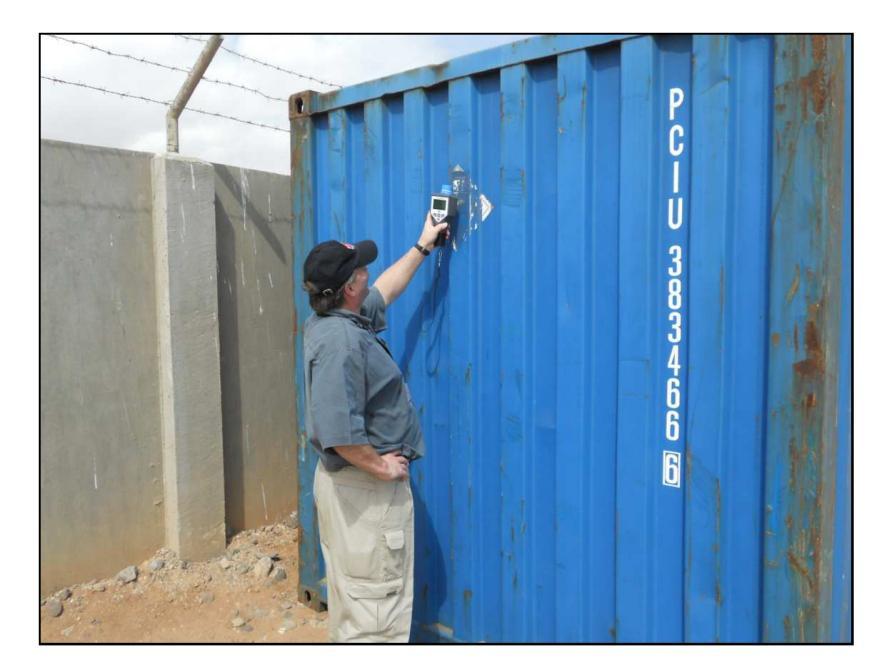
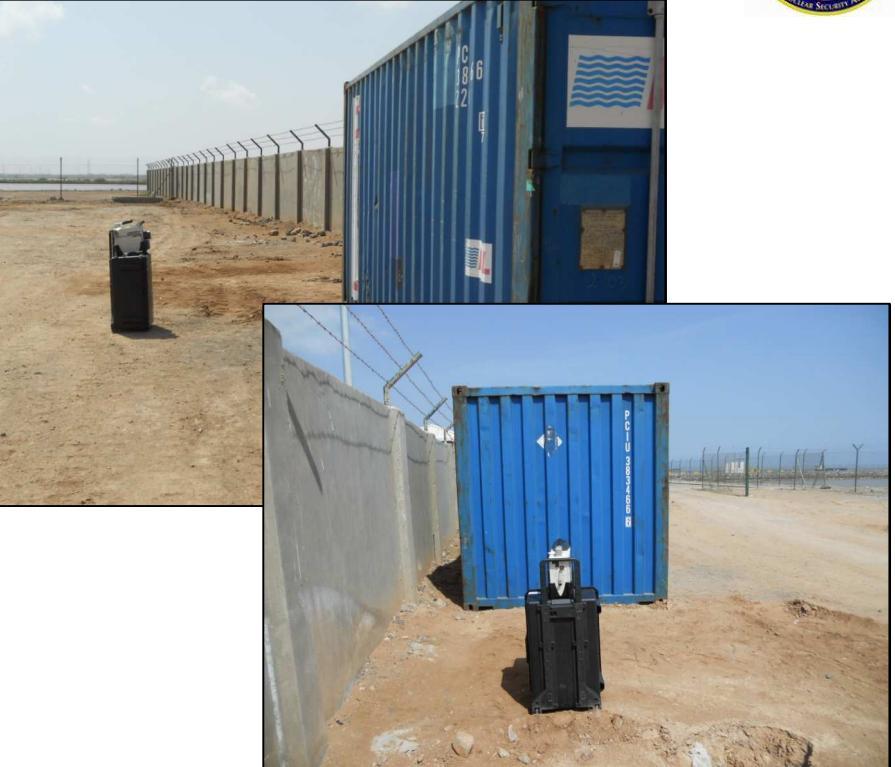
**HPGe Spectral Measurements**

A radiological safety evaluation was conducted on the container to verify no external contamination, safe dose rate levels and confirm the identification of Co-60. The information was used to develop the source recovery plan.

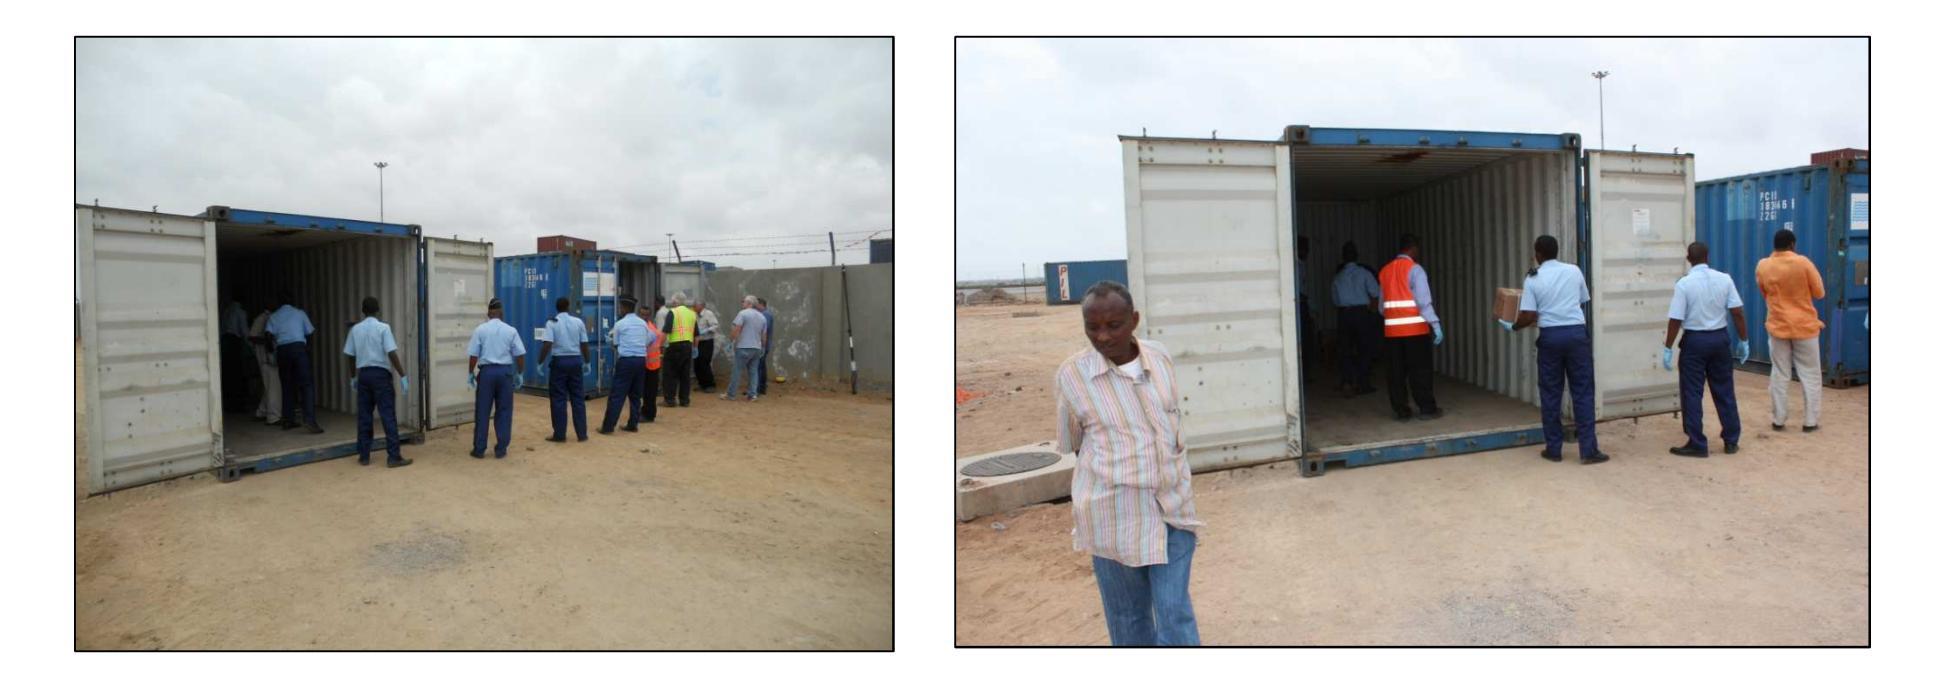
## Trainees Participate in Transferring Boxes to Second Container

Volunteer trainees participate in source recovery operations. They wore rubber gloves as a precaution and were not allowed to handle boxes having elevated readings.
