OCHA

Fuel Spill and Fire
Rapid Environmental Emergency Assessment
Mukuru-Sinai slum, Nairobi Kenya
October 2011

JOINT
UNEP / OCHA
ENVIRONMENT UNIT

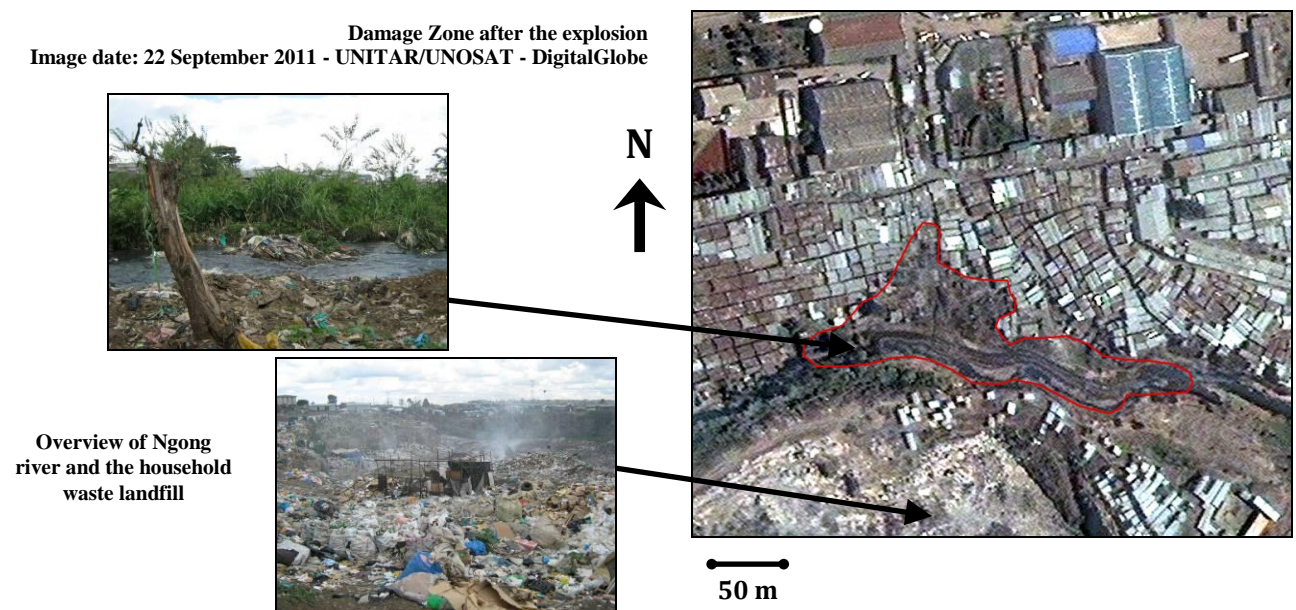
The first reconnaissance visit on 11 October 2011 clearly highlighted that at the impacted site a number of pre-existing environmental problems existed:

- Suspected pollution of the river system upstream (large amounts of solid waste, water polluted with suspended matter, suspected presence of industrial pollution);
- An outlet into the Ngong River of all or part of the storm drainage system coming from the industrial area;
- Discharge of waste water from the slum dwellings into the river;
- The presence of a household waste landfill (5 hectares) located less than 200 meters from the affected disaster site, on the opposite side of the Ngong river, allowing the dispersion of leachates and biogas into the environment;
- Use of the river to clean plastic residues collected from the landfill for recycling.

The affected area had been entirely cleared before the first field visit took place and only a few remnants, such as the floors of the destroyed dwellings and burned vegetation, were still visible.

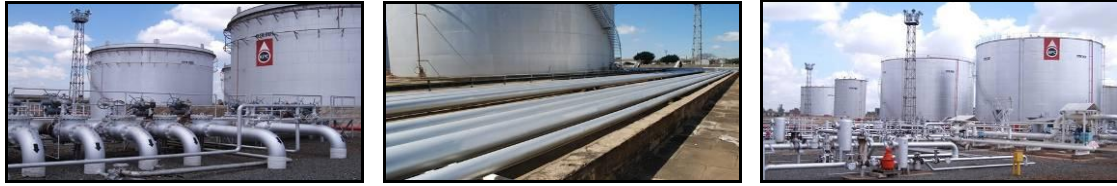
The press release issued by the Kenya Pipeline Company (KPC) on the 12th September 2011 accident and a Control Audit Report of the National Environmental Management Authority (NEMA) indicated that an accidental leak of petroleum products from the KPC deposit facility, located in the industrial area of Lunga Lunga, southeast of Nairobi, had occurred. Both the audit report and the press release are annexed to this report.

Photography of the KPC petroleum deposit facility - www.kpc.co.ke

According to KPC staff interviewed, construction works had recently been conducted on the site in order to connect the Nairobi-Eldoret pipeline to the main Nairobi-Mombasa pipeline, when a leak accidentally occurred in the by-pass located between the pipelines.
