A Brief Guide to Asbestos in Emergencies:

Safer Handling and Breaking the Cycle

shelter centre

ProAct
network

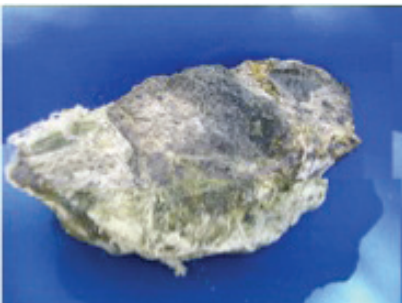
Chrysotile asbestos

- **Chrysotile** (white asbestos) has a very good resistance to alkalis. It is the most common type of asbestos, accounting for over 90 per cent of asbestos mined annually. It is most frequently found in asbestos-cement products such as roofing sheets.
- **Amosite** (brown asbestos) has a very good resistance to high temperature and is used in thermal insulation products and ceiling tiles.

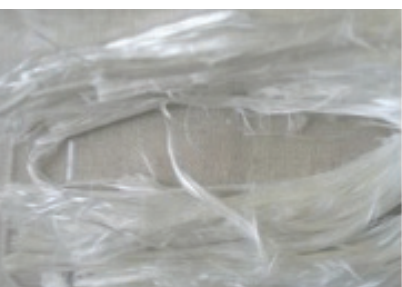
Asbestos fibres

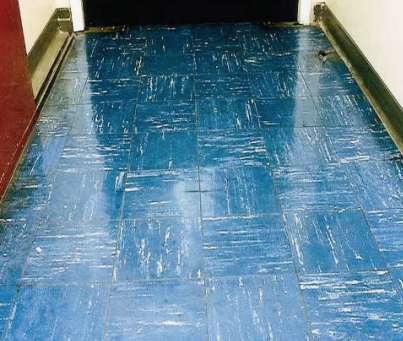
Asbestos Ceilings and Floors

Asbestos insulating boards have typically been used for ceiling boards and false walls. Asbestos vinyl floor tiles are also common. Bituminous tar paste was widely used to glue down linoleum tiles, particularly in commercial buildings and hospitals built in the 1970s.

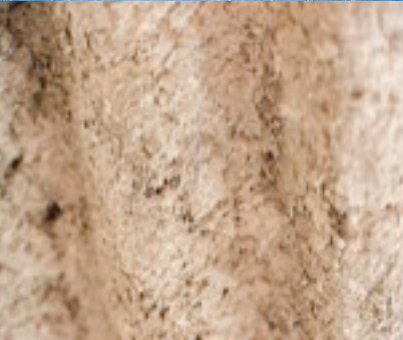
Asbestos Fire and Sound Insulation

Asbestos has been sprayed in buildings for sound-proofing and fire-proofing in developed countries. In the late 1950s, it became virtually standard practice for large buildings, hospitals and schools to have sprayed asbestos on steel columns, beams and roofing sheets. This form of asbestos is highly friable and highly dangerous if damaged or in poor condition, and has a high asbestos content of around 85 per cent.

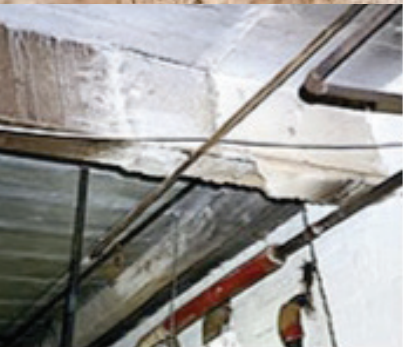
Asbestos Thermal Insulation

Since the 1950s asbestos insulating was commonly used for insulating boilers, hot water tanks and hot water and steam pipes. It can be sprayed or used as loose fibres, also known as fluff form. It can also be used as a cloth wrap for other non-asbestos insulating products. Insulation of this type is highly friable and dangerous and can contain over 90 per cent asbestos.
