Final report - Review of built infrastructures

Khammouane Province - Laos 2017

Title:	Construction review in Laos - Final report
---------------	--

Date and place:	Luxembourg – 2017.02.10
Project name & code	Laos constructions review – 24LA00
Service client	AI Croix-Rouge luxembourgeoise – Beatrice Winandy

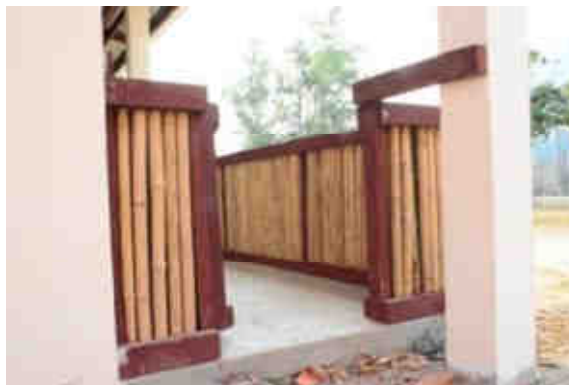
Side of ground slab and pillar

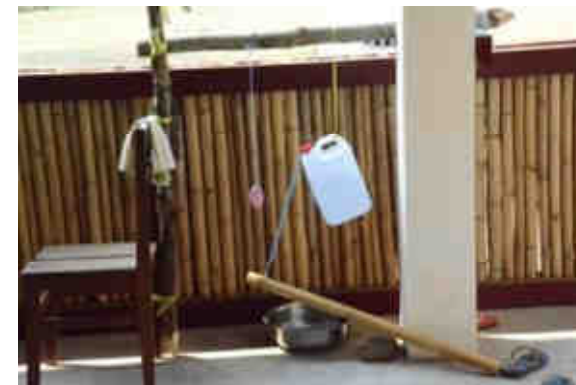
Interior picture pillar and ground finishing

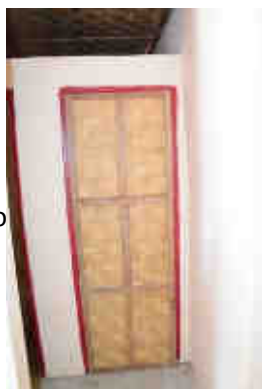
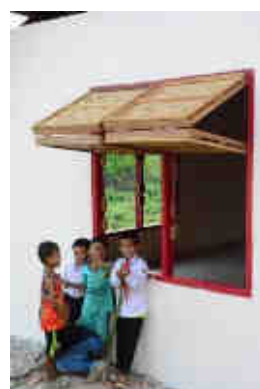
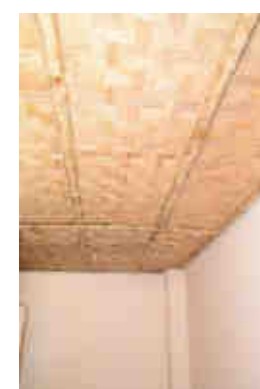
ENCLOSURE AND PARTITIONS	Date of visit	Measure of verification	Collected data	Comments
Enclosure of the interior spaces	2017.03.13	Interview + picture + measure	Regular measure of the rooms built following the plan including reinforced angles with bar d=16; h=270	Good finishing regular and painted
Door. Type D1	2017.03.13	Interview + picture + measure	(81x200) interior and exterior locking system included	Good finishing, good ambience artisanal handmade job Small pieces missing
Window. Type W1	2017.03.13	Interview + picture + measure	small variation with the total measure no mosquito net(180x160)	Good finishing, good ambience artisanal handmade job Small pieces missing, mosquito net missing
Ceiling of inner spaces -	2017.03.13	Interview + picture + measure	small variation with the total measure structure in half bamboo can	Good finishing, good ambience artisanal handmade job the structure in half bamboo can provide a better aspect inside the room

Interior door with bamboo panel

Classroom window

Interior space ceiling

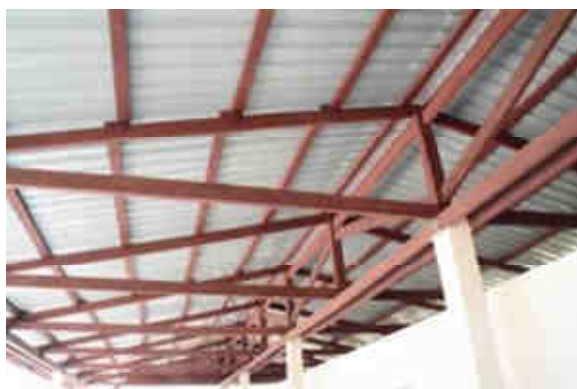
ROOF COVERING	Date of visit	Measure of verification	Collected data	Comments
Metal sheeting roof over wood ribbons and trusses	2017.03.13	Interview + picture	Small additional pieces in joints added additional metallic plates in place CGI E=0,47mm	Good finishing following the project good general aspect

Roof structure general view
ridge

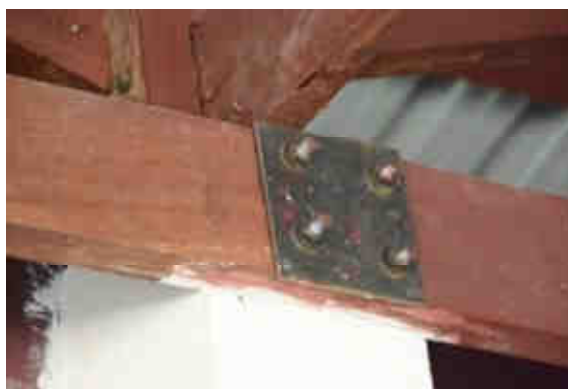
Bolts and metallic plate- joint over pillar

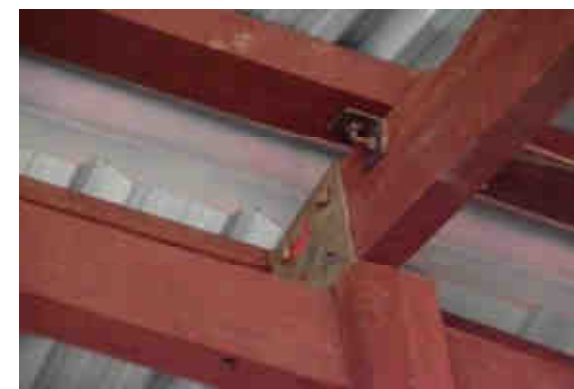
Bolt + metallic plate and L Dephile under the

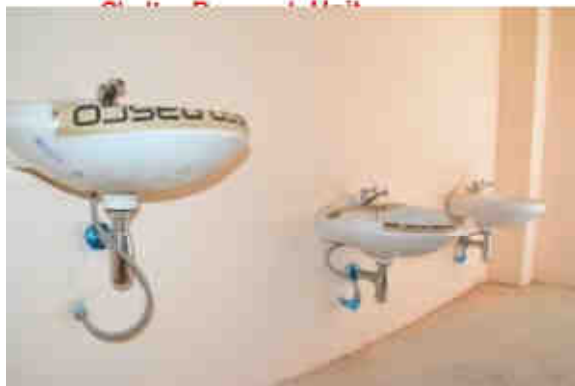
Urinary (water supply and siphon)	2017.03.13	Interview + picture	In place	good aspect No water supply No verification of use possible
WC (dual flush)	2017.03.13	Interview + picture	in place but different model	good aspect, different model No water supply no use verification
Pedestal Sink + faucet	2017.03.13	Interview + picture	Sink in place including siphon no pedestal	good aspect but different model No water supply no use verification

Toilet sink with siphon

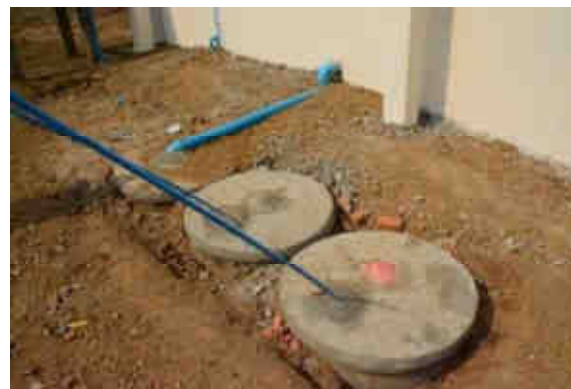
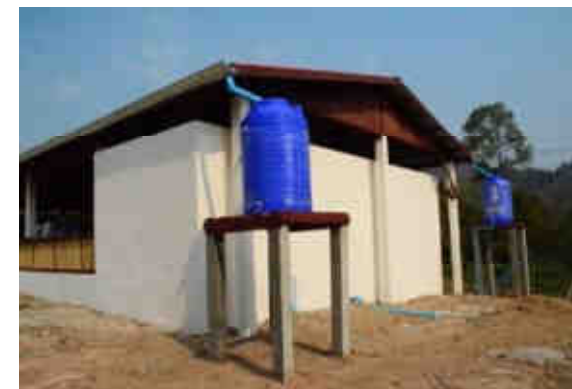
PLUMBING AND SANITATION	Date of visit	Measure of verification	Collected data	Comments
Filtrating pit. Concrete rings	2017.03.13	Interview + picture	the filtrating pit includes ventilation Deph=150	The ventilation pipes could be closed with T piece
Sand filtrating trench.	2017.03.13	Interview + picture	Deph = 150 1x2m surface	good aspect clean surface

Filtrating pit with ventilation

Water tanks

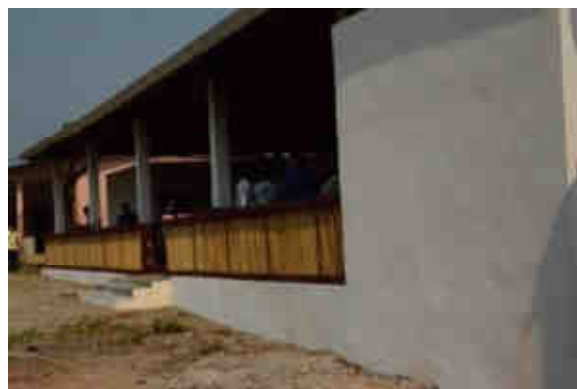
Exterior fence general view

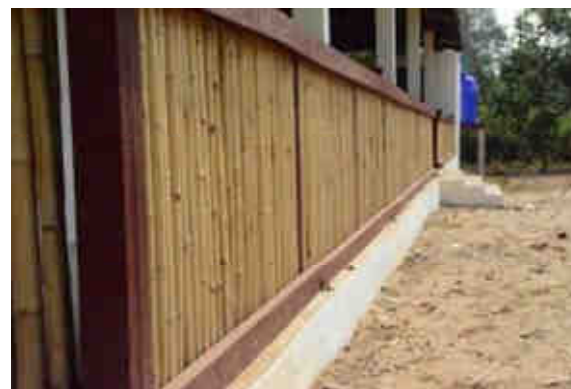
Exterior fence front facade

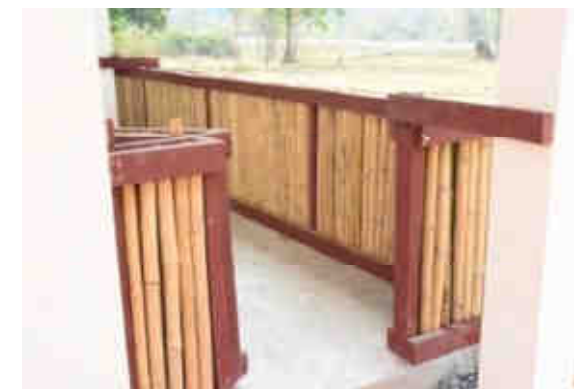
Pedestrian door

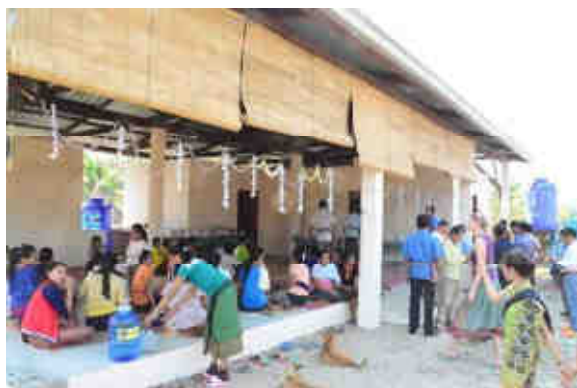
Front view with stairs

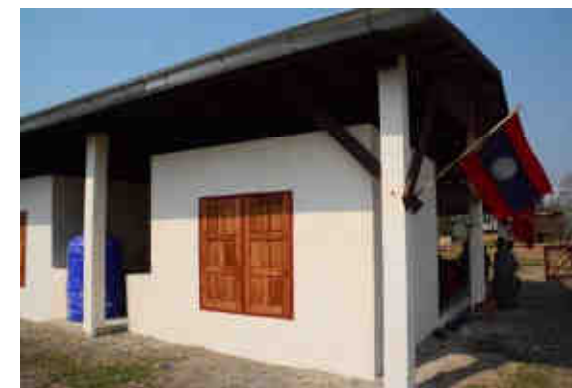
Rear view pillars and general finishing

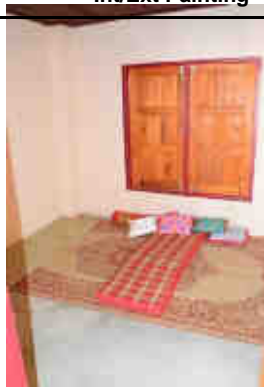
Interior view with window in wood

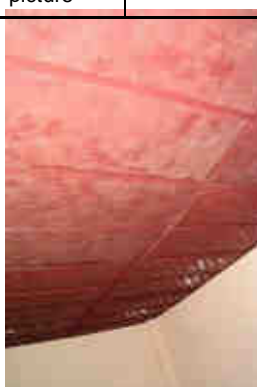
Interior view with ceiling in bamboo

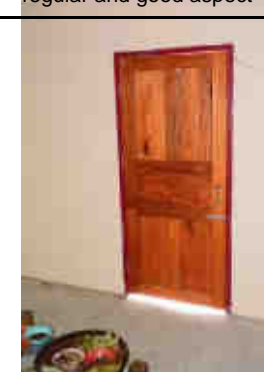
Interior view with door in wood

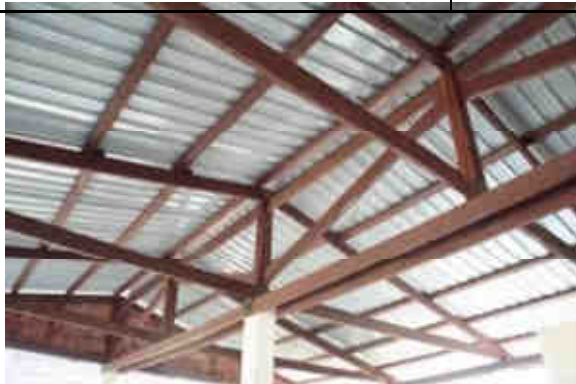
Metal sheeting roof over wood ribbons and trusses	2017.03.14	Interview + picture	They close the side of the gable with bamboo panel and wood structure	General good aspect According to plans visual inspection
PLUMBING AND SANITATION	Date of visit	Measure of verification	Collected data	Comments
Metal gutter	2017.03.14	Interview + picture		Good aspect
Tank to collect rain water 1000l	2017.03.14	Interview + picture	Solid wood structure but without bracing Tank in the plot but not connected	Waiting for the partners in the project LUX Dev for WATSAN component

Roof structure with bracing in 2 directions

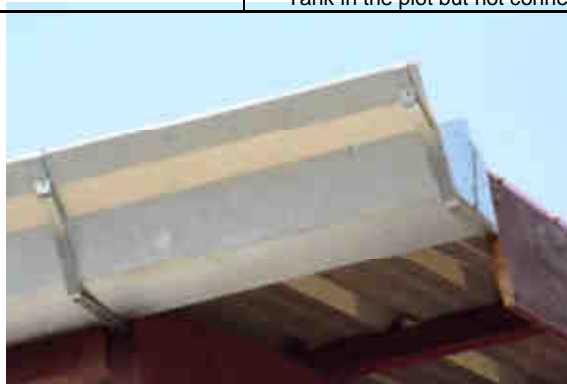
Metallic Gutter

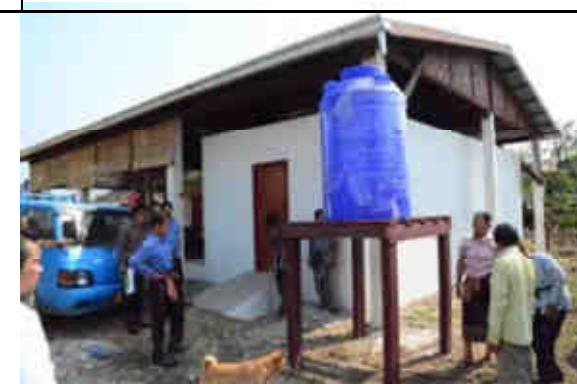
Water tank

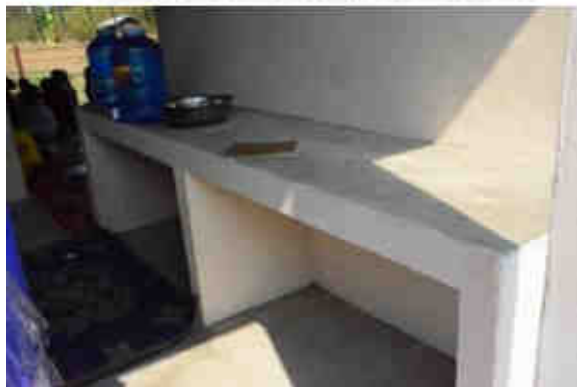
Kitchen counter

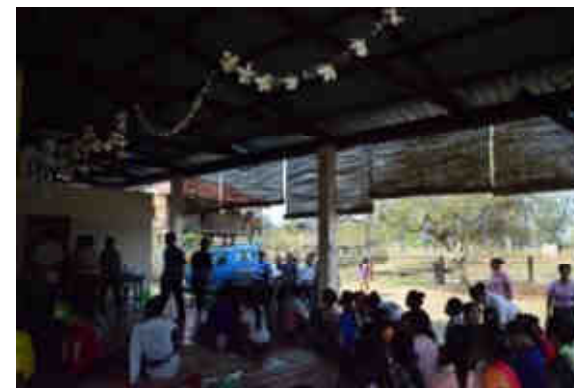
Inside view and Bamboo rolling shutter

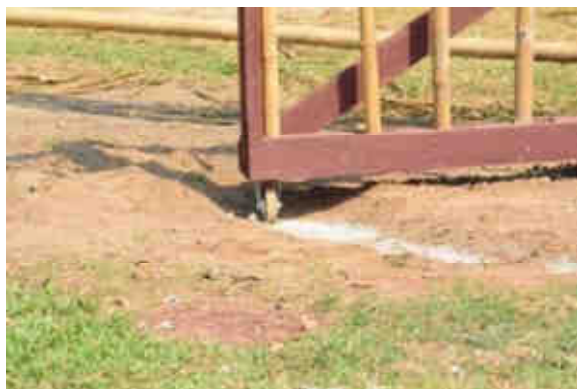
Fence door detail with wheel

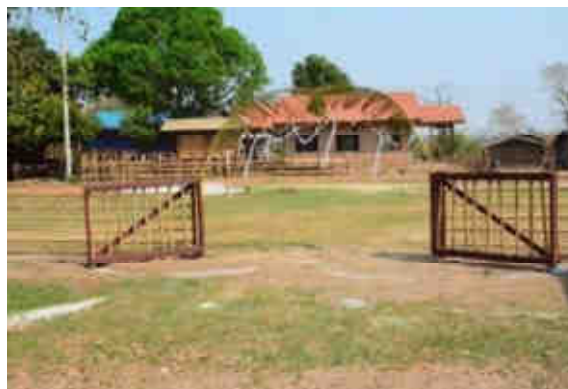
Vehicles gate

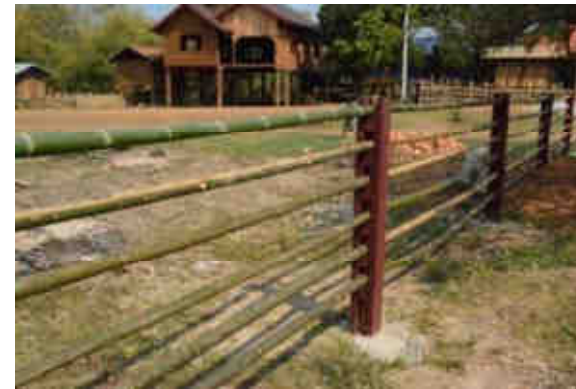
Fence general view

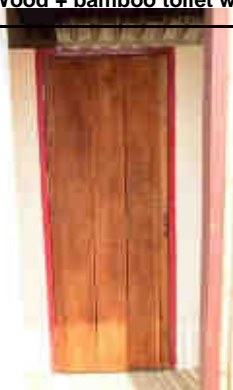
Toilet door in wood

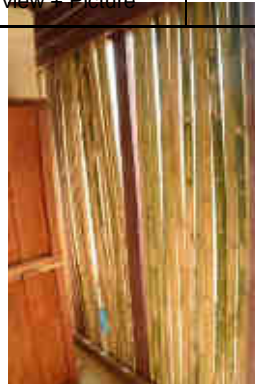
Bamboo wall

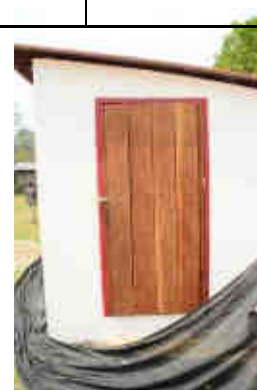
Exterior view with door and walls with plaster and painted

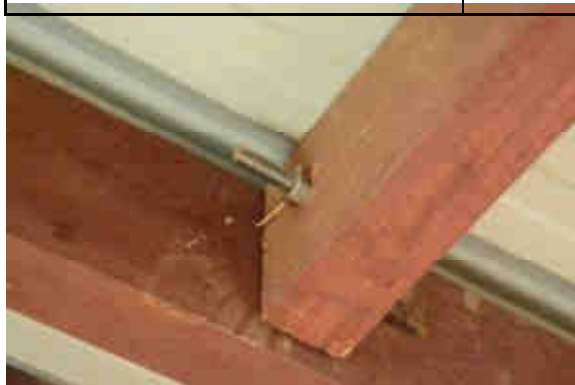
Roof structure joint with bolt and metallic plate

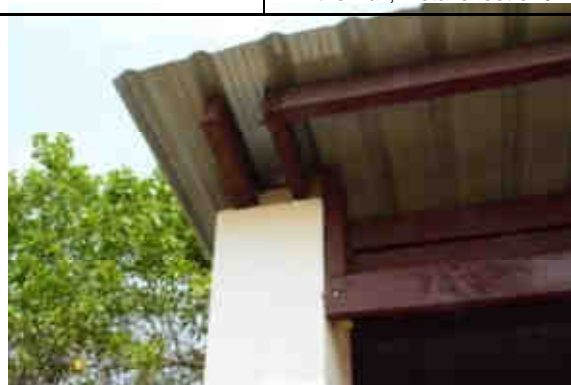
Roof structure detail over the corner

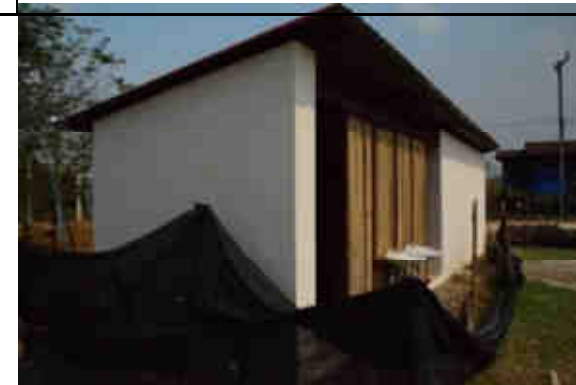
General view roof finishing

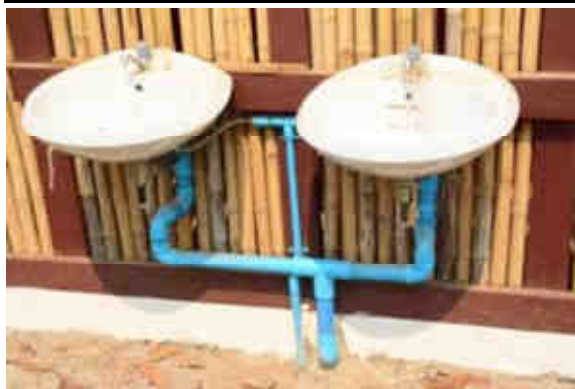
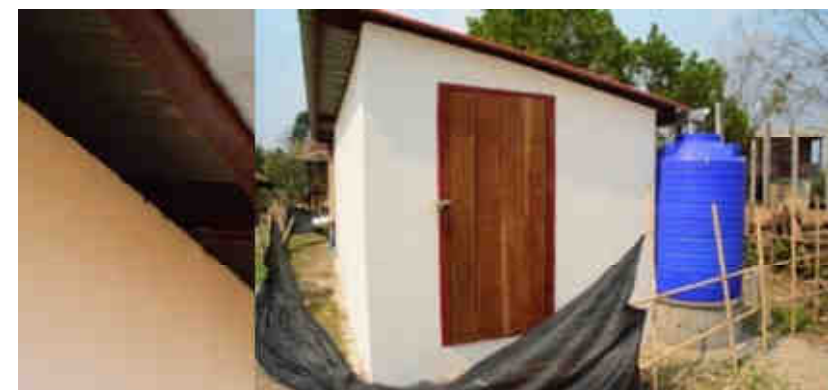
PLUMBING AND SANITATION	Date of visit	Measure of verification	Collected data	Comments
Filtrating pit. Concrete rings	2017.03.14	Interview + Picture	150 deep cover 1m diameter	well closed form outside
Sand filtrating trench.	2017.03.14	Interview + Picture	100x170x 150cm	there are additional connections from the toilets for cleaning (drains) but need to be connected to the trench
Metal gutter	2017.03.14	Interview + Picture	Placed and operational	NO comment
Tank to collect rain water	2017.03.14	Interview + Picture	Tank in place	The H of the tank is not adequate to the H of the tap but it is not possible to move the tank higher apparently it is a mistake of design
PVC sanitation pipe (D 100 mm; siphon)	2017.03.14	Interview + Picture	in place and connected to the pit filtrating	connected and operational
PVC sanitation pipe (D 40 mm; siphon + bracing))	2017.03.14	Interview + Picture	in place and connected to the sand filtrating New added pipes in the toilets without connection	The new pipes need to be connected to the sand filtrating

Double sink and PVC pipe/ Bamboo wall
Metal gutter
General view and water tank

Phonselerm	Latrines + warehouse	There are additional connections from the toilets for cleaning but need to be connected to the sand filtrating trench	<ul style="list-style-type: none"> The level of the water tank can't be raised. But it is recommended that the bottom part of the tank is at least at the same level as the highest tap. If the tank height does not allow this, two tanks of 500l each can be placed in line connection and with the criteria of height described before. 	<ul style="list-style-type: none"> Document all the changes and relevant actions according to the agreed documents

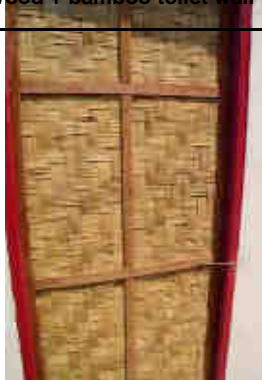
Bamboo door detail

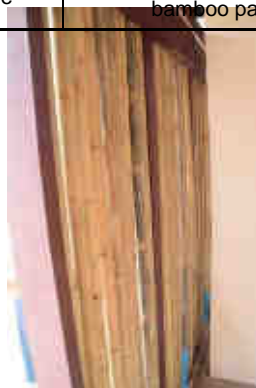
Bamboo wall detail

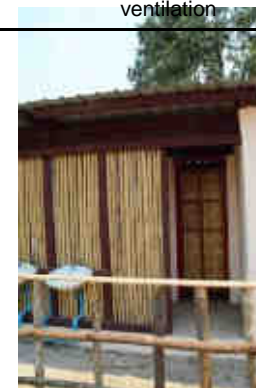
Front view with Bamboo wall and door

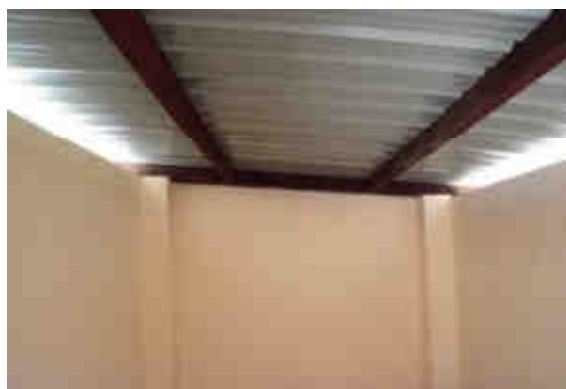
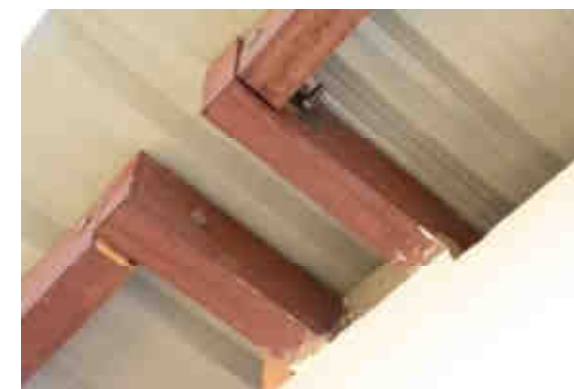
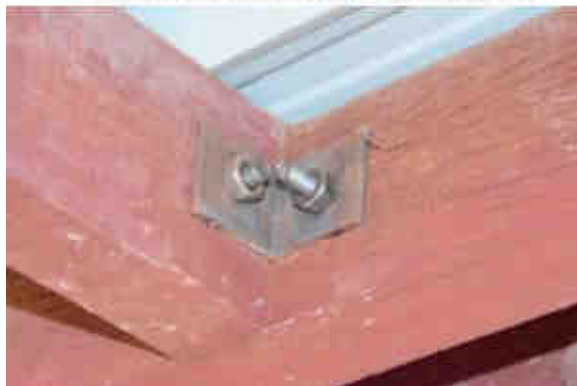
ROOF COVERING	Date of visit	Measure of verification	Collected data	Comments
Metal sheeting roof over wood substructure (TOILET)	2017.03.14	Interview + Picture	Additional lath added by the construction company some additional reinforced parts over the wall; Metal sheet e=0.47mm	In general well finished including metallic plates and bolt

Reinforced joint with metallic angle and bolt
Joint angle, exterior view

Interior view

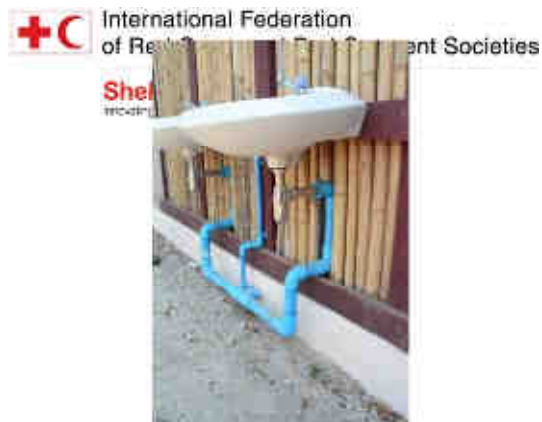
Sink with PVC pipe

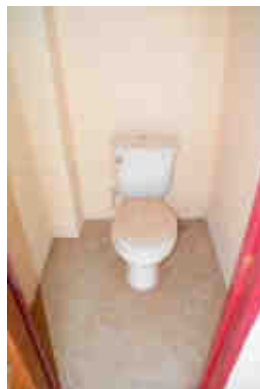
WC in place

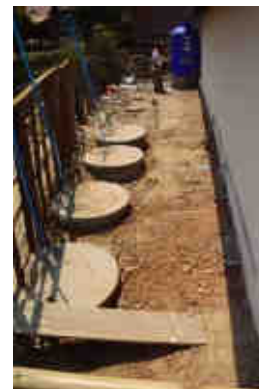
PLUMBING AND SANITATION	Date of visit	Measure of verification	Collected data	Comments
Filtrating pit. Concrete rings	2017.03.14	Interview + Picture	150 deep cover 1m diameter	well closed form outside
Sand filtrating trench.	2017.03.14	Interview + Picture	100x170x 150cm	there are additional connections from the toilets for cleaning (drains) but need to be connected to the trench
Metal gutter	2017.03.14	Interview + Picture	In place and operational	
Tank to collect rain water (1000L)	2017.03.14	Interview + Picture	Tank in place	The H of the tank is not adequate for the H of the tap but it is not possible to move the tank higher apparently it is a mistake of design
PVC sanitation pipe (D 100 mm)	2017.03.14	Interview + Picture	in place and connected to the pit filtrating	connected and operational
PVC sanitation pipe (D 40 mm)	2017.03.14	Interview + Picture	in place and connected to the sand filtrating New added pipes in the toilets without connection (for drainage)	The new pipes need to be connected to the sand filtrating

Pit Filtrating system and drainage

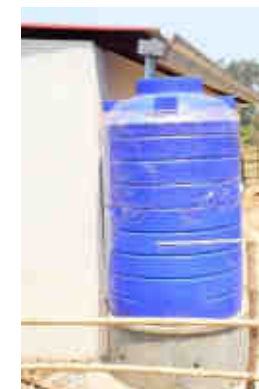
Water tank

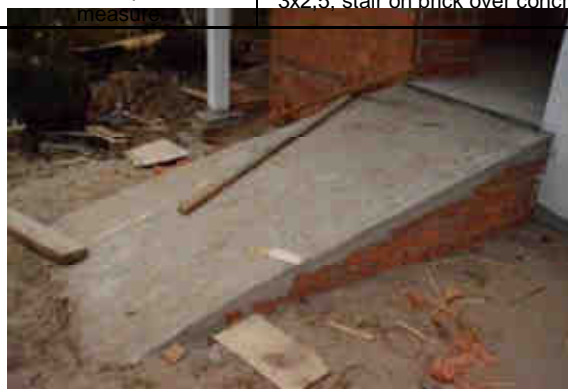
the sand by itself.	
Stairs to access.	03.08.2017	Interview + picture + measure	L=4m; stair in brick changed only one stair built	The stair in the rear side of the building have to be done
Stairs to access.	03.08.2017	Interview + picture + measure	L=9.35m; stair on brick over slab	General aspect is good but the dimensions in the steps are different
Ramp to access.	03.08.2017	Interview + picture + measure	3x2.5; stair on brick over concrete slab	High pendent on the ramp

Stairs with brick and concrete slap

Side view with ramp

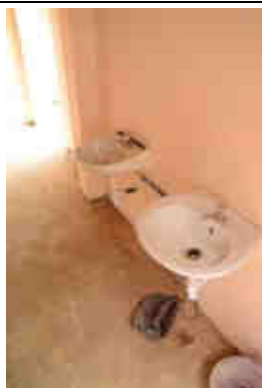
Pedestal sink + faucet

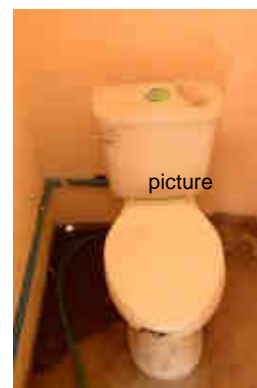
PVC pipe for water supply (3/4"/18,75mm)	03.08.2017	picture	In place	
PVC pipe for water supply (1"/25mm)	03.08.2017	picture	In place	
Shower	03.08.2017	pictures	Not built	No shower just tap Construction company changed without information, district does not approve but did not inform.
WC	03.08.2017			simple model not the same than in the plan

WC

different model

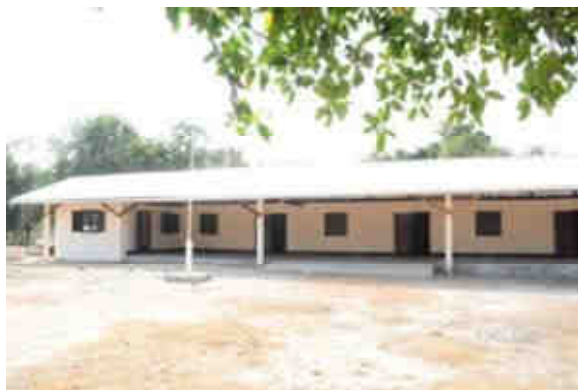
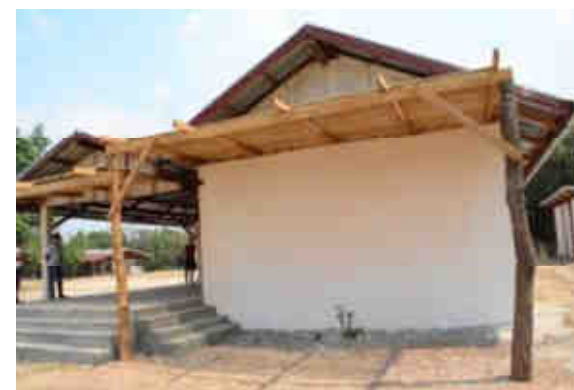
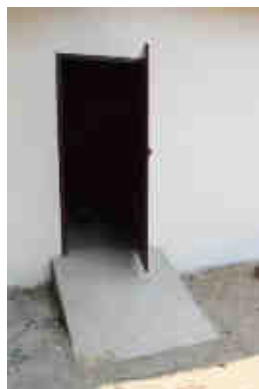
General view including stairs and finished slab

Ramp to the warehouse

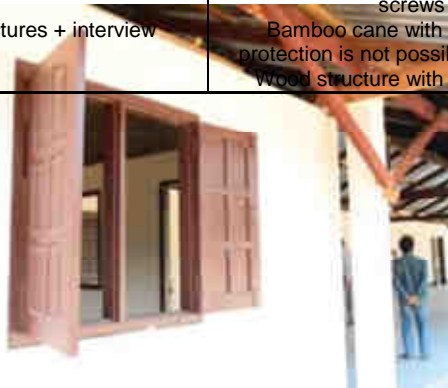
Interior view including ceiling

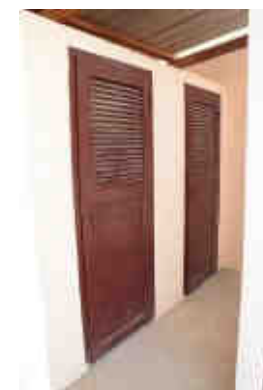
Toilet door in wood

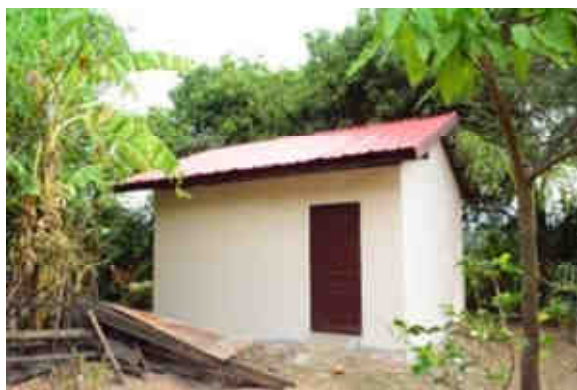
Front view with ramp

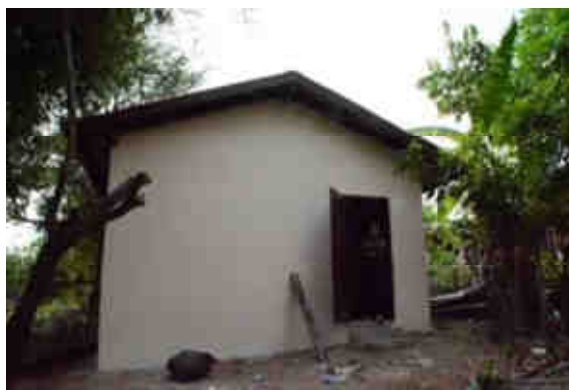
Side view with stairs

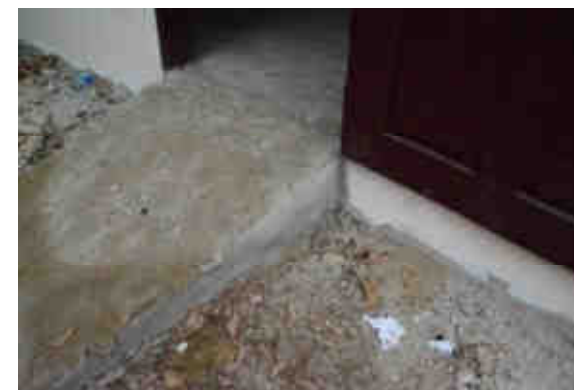
Ramp details

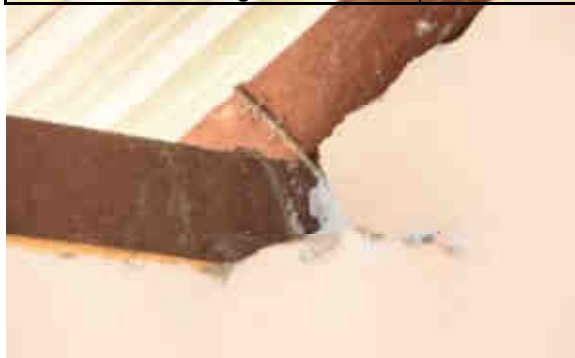
Junction wall and wood structure
Joined wood

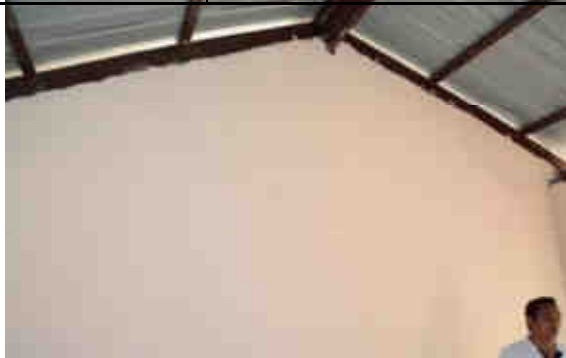
General interior view

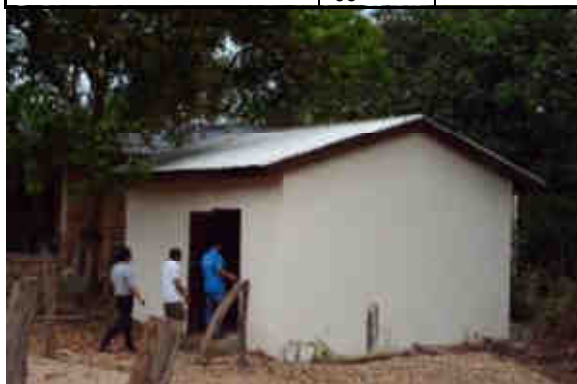
General view with ramp

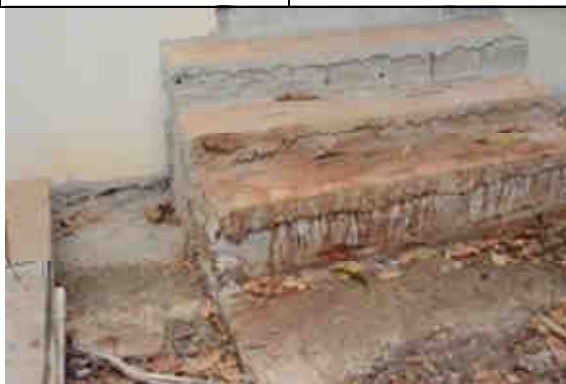
Stairs detail

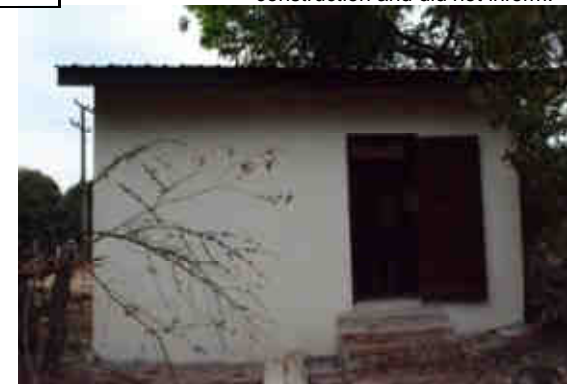
Rear view with stairs

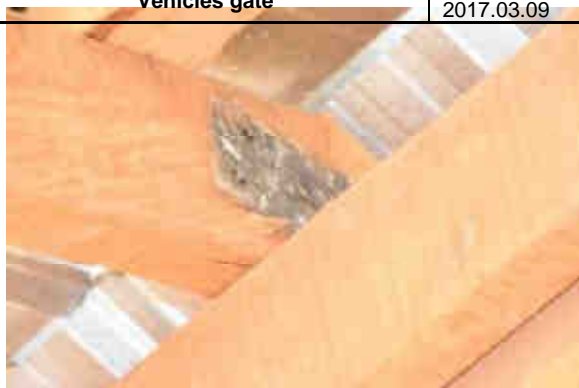
Wood structure with metallic plate and nails

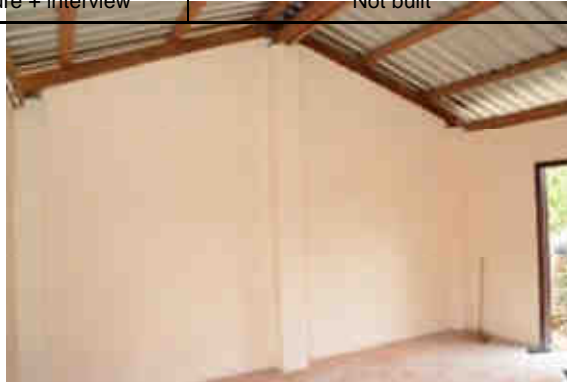
General interior view with plastered walls and paint

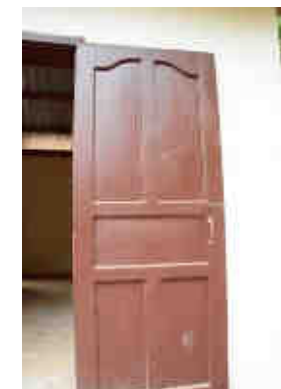
Wood door. Type D1	2017.03.09	Picture + measures	Green wood, no full insect protection W+=0,805 h=2,00	The changes where suggested by district, construction company accepted and LRC delegate informed HQ. In general the quality of the doors is poor. The wood needs to be dry and protected against insects
Int/Ext painting	2017.03.09	Picture	Painted	N/C
ROOF COVERING	Date of visit	Measure of verification	Collected data	Comments
Metal sheeting roof over wood substructure	2017.03.09	Pictures + interview	Metallic sheet e=0.47mm Structure: Nailed joint over the walls in the wood beam (no danger because is over the wall). Wood not fully protected beam on the bridge with nails and metallic plate	The construction company changed or built the roof structure differently. The technical control/follow-up didn't inform about changes, missing pieces or irregularities.
URBAN AREA	Date of visit	Measure of verification	Collected data	Comments

Wood door

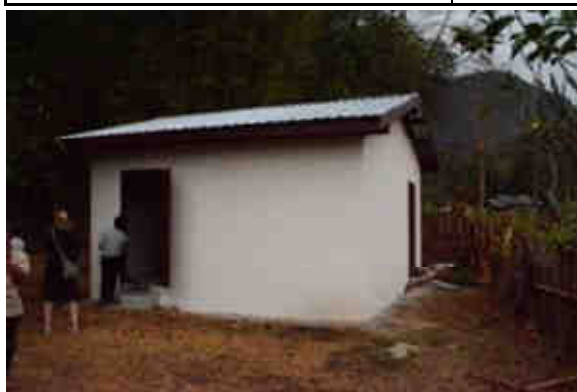
Front view with stairs

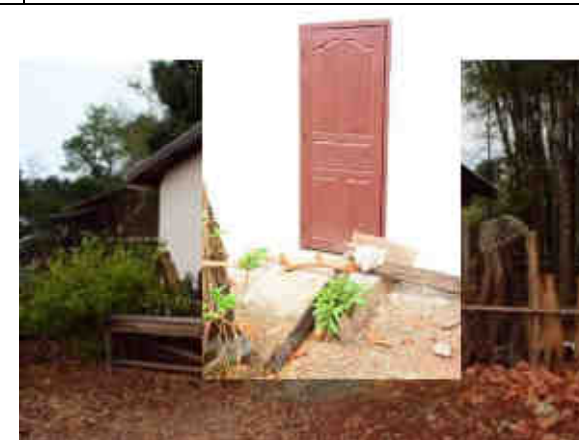
Side view with ramp

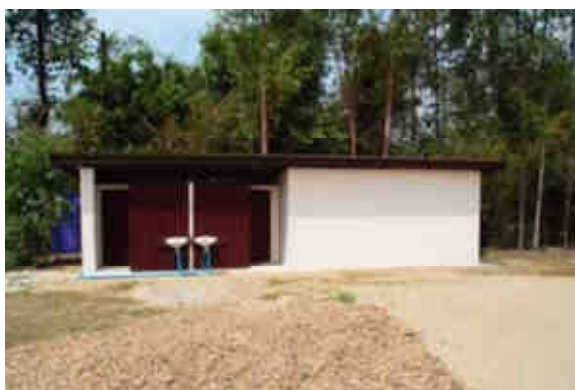
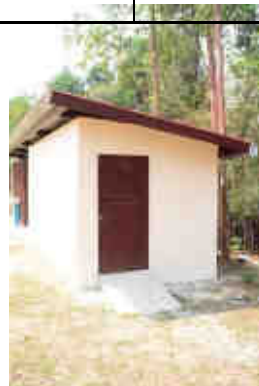
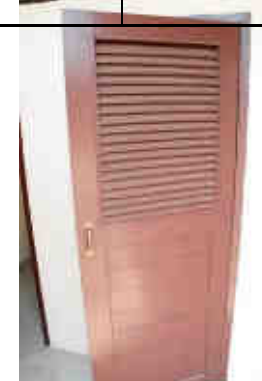
Door. Type "toilet"	2017.03.10	Picture+measure	Green wood, no full insect protection W+=0,805 h=2,05	
Int/Ext painting	2017.03.10	Picture	Painted	N/C
Wood + bamboo toilet wall	2017.03.10	picture +interview+	Framework painted and nailed No bracing Metallic L piece + screw for junction with ground	The general exterior aspect is friendly and good finishing. The bamboo solution on the walls allow ventilation

General view including bamboo wall

Side view with wood door and ramp

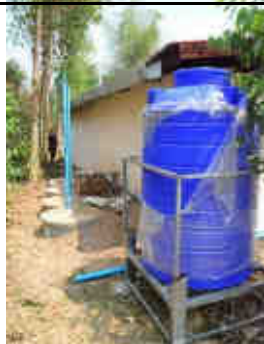
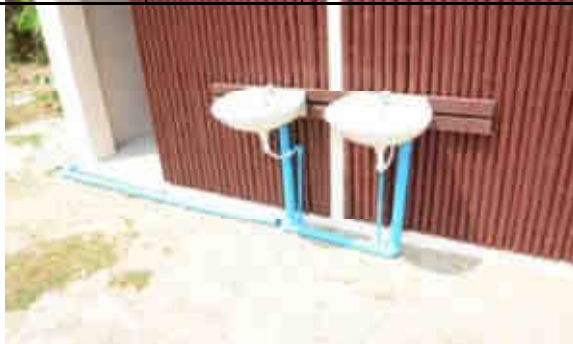
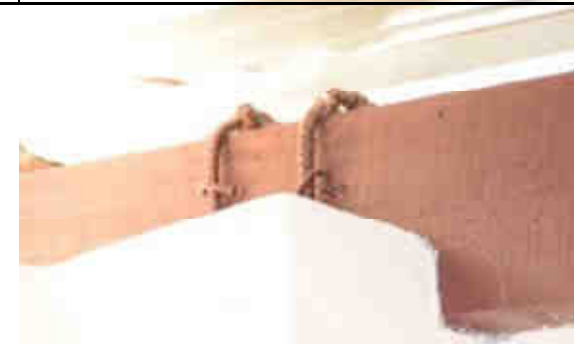
Tank to collect rain water	2017.03.10	Pictures + interview	1000L tank is in place but in a low position in relation to the taps.	It is recommended to raise the water tank until the bottom level of the tank is placed at the same level as the highest tap.
PVC pipe (D 100 mm)	2017.03.10	Pictures	In place connecting the pit latrine	In place but no water needs to be tested before final reception of works
PVC pipe (D 40 mm)	2017.03.10	Pictures	In place connecting drainages	
PVC pipe for water supply (18mm)	2017.03.10	Pictures	In place	
PVC pipe for water supply (25mm)	2017.03.10	Pictures	In place	
WC	2017.03.10	Pictures	in place but different model	
Pedestal sink + faucet	2017.03.10	Pictures	in place but different model	In place but not functional Needs to be tested

Water tank and pit filtration

Sink and PVC drainage system

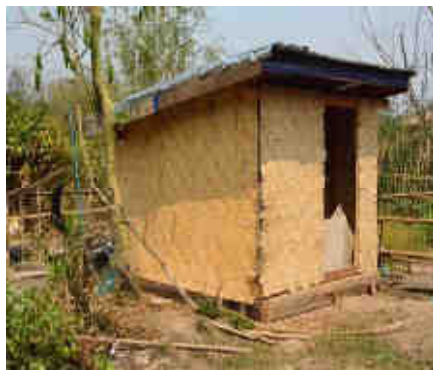
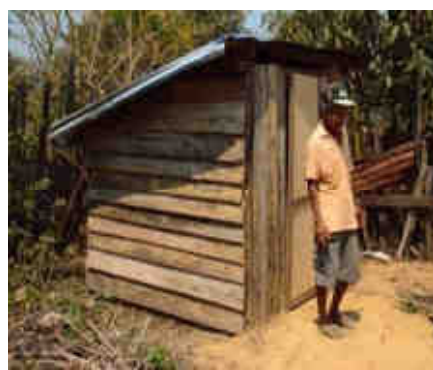
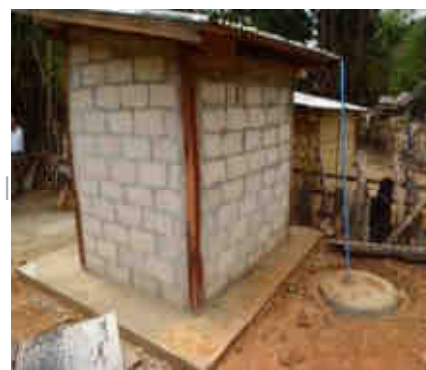
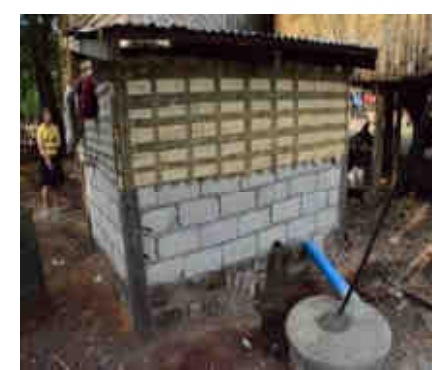
some common point where identified: filtrating pit system using the distributed concrete rings and roof using the distributed CGI. In general we can classify the latrines according to the enclosing system: bamboo, wood, block or mix.

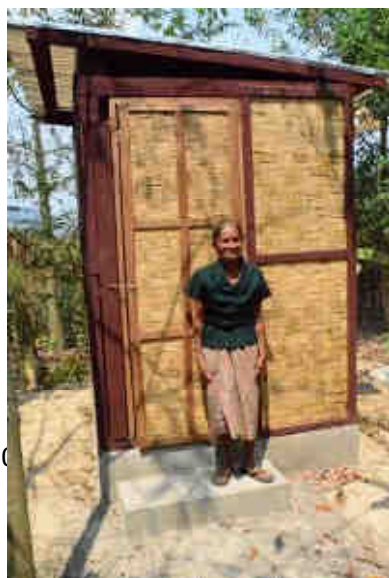
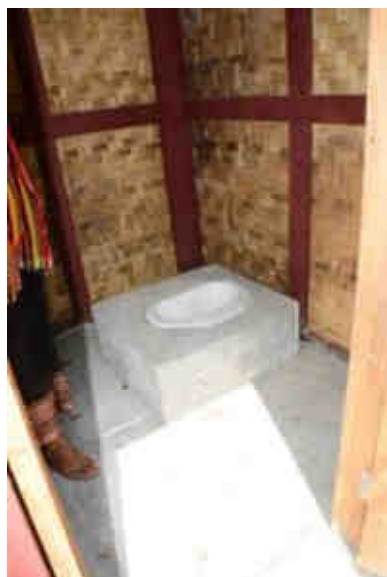
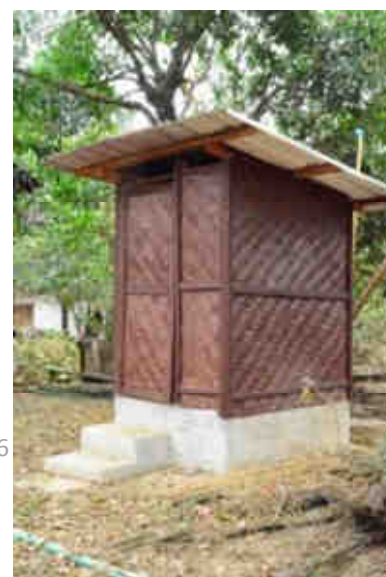
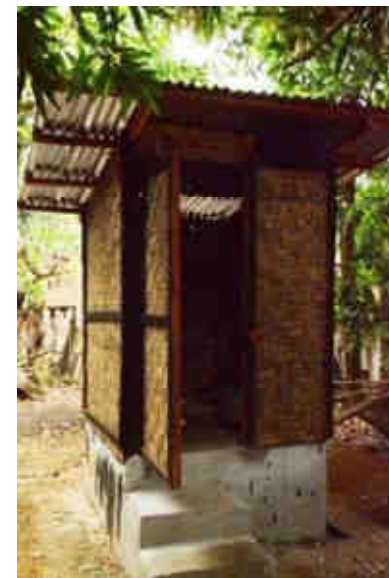
These latrines have been built with the objective to help the most vulnerable people and all of them where 100% built by a construction company following the predefined design. With bamboo wall, filtrating pit and elevated base in blocks, the latrines are very well adapted to the local context. The major difference with the self-built units is that the surface is smaller approx. 2.25m² in total.

Latrine with beneficiary

Latrine interior view
